Town Hall Accessibility & Building Renovation Study

Sharon, Massachusetts
December 2, 2015

KAESTLE BOOS
associates, inc

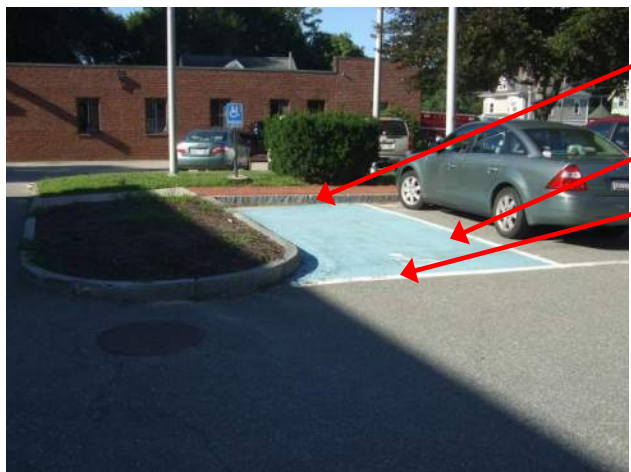
HC parking at front town hall lot

None of the four spaces meets current code, however, missing either loading zones, curb cuts to sidewalks or accessible ways. The parking space in the town hall lot has a slope of between 3.7 and 4.1%, no curb cut to the sidewalk, and no striped accessible lane that is discernable from the actual parking space. Code currently requires all parking spaces and loading zones to be under 2%.

No curb cut to side walk
No separate loading zone
Slope over 2%

1. Modify ADA parking spaces to provide correct slopes, signage and access paths.
2. Remove access ramp to south door and build an accessible ramp to the door.
3. Provide the necessary clearances to Town Hall office door that is accessible from the outside.
4. Provide curb cut and ramp at corner of Bradford and East Chestnut Street.
5. Provide concrete stoops at fire department building accesses and widen the doors to provide clearance.
6. Provide crosswalk at front entrance and/or passenger loading zone striping and signage.

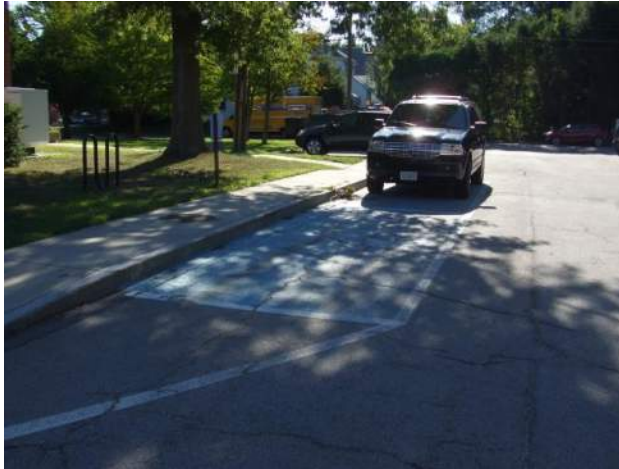
HC parking on south side of town hall

The two spaces on the south side of the town hall have no loading zone, with a curb cut for access to the sidewalks, and abut an entrance ramp to the building that has a 15.6% slope. These spaces are 8' wide x 22'. Two signs call out the HC parking with one additional sign directing the disabled to the rear door for access to the building.

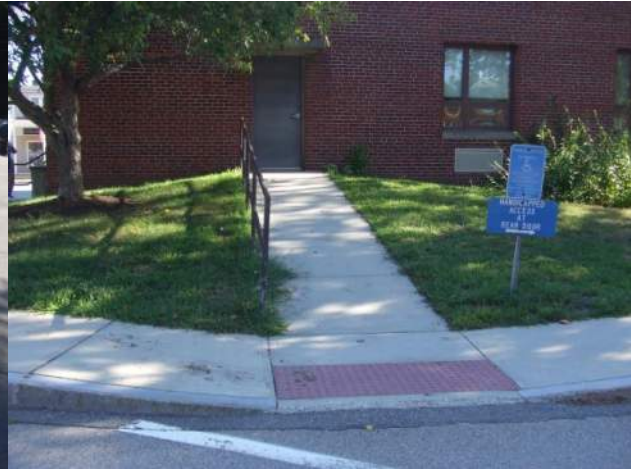
Ramp to building at 15.6% slope

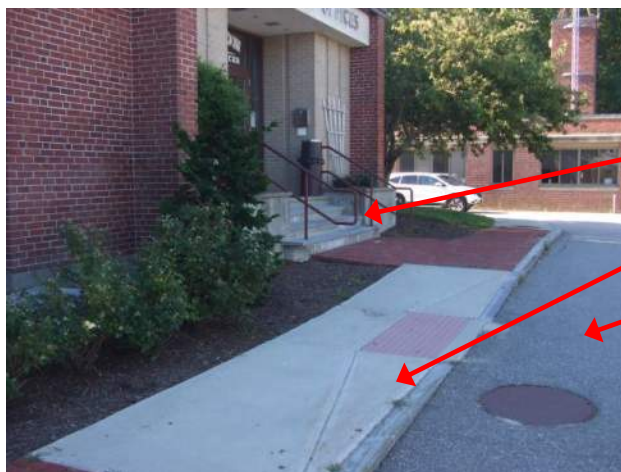
Curb cut at front of Town Hall

- Stairs to front entrance
- Curb cut from sidewalk to drive
- No crosswalk to opposite sidewalk

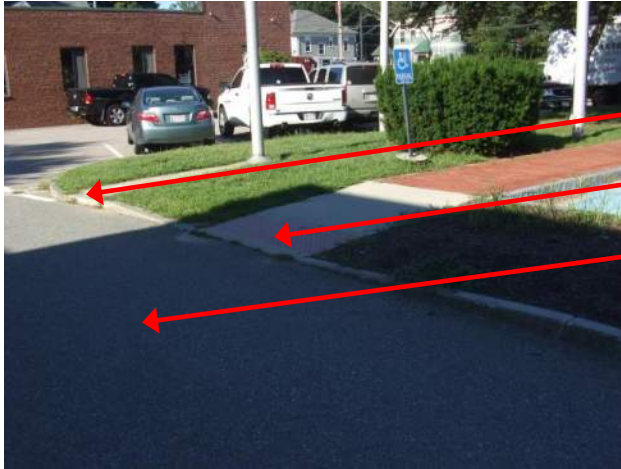
Curb cut opposite the Main Entrance

- Narrow walk with no curb cut
- Curb cut from sidewalk to drive
- No crosswalk to opposite sidewalk

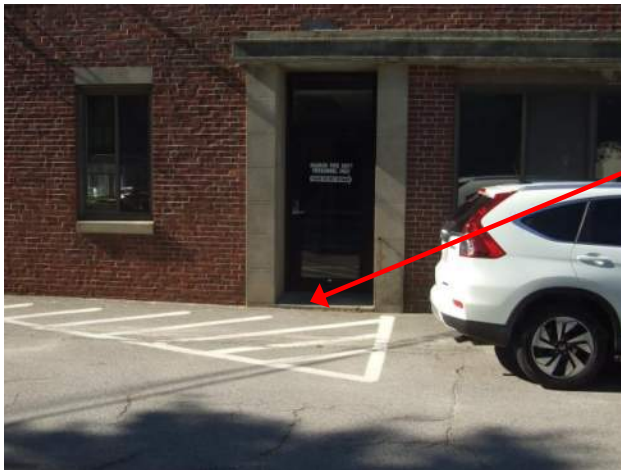
Fire Department door

- Inadequate clearance for door use
- Threshold too high for accessibility

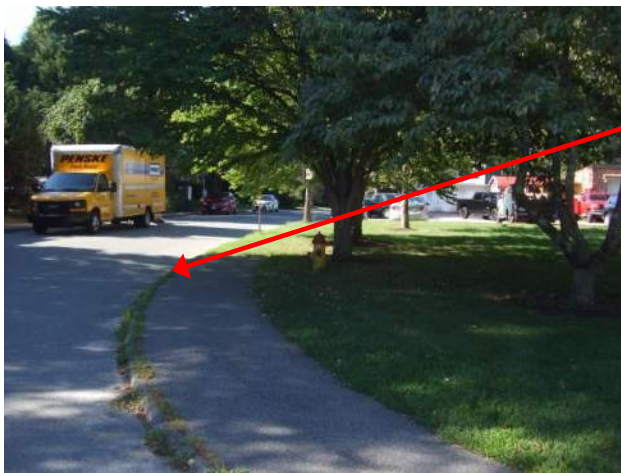
Sidewalk at Bradford and East Chestnut Street

- No Curb cut to roadway

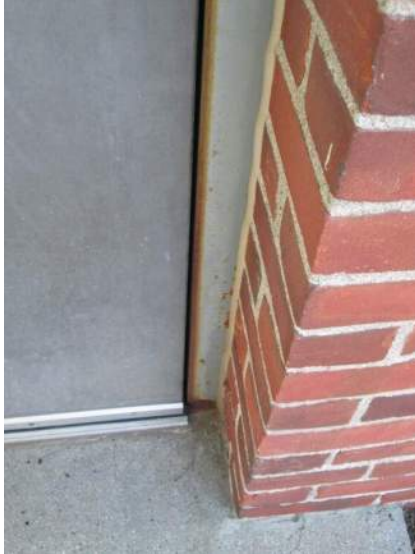
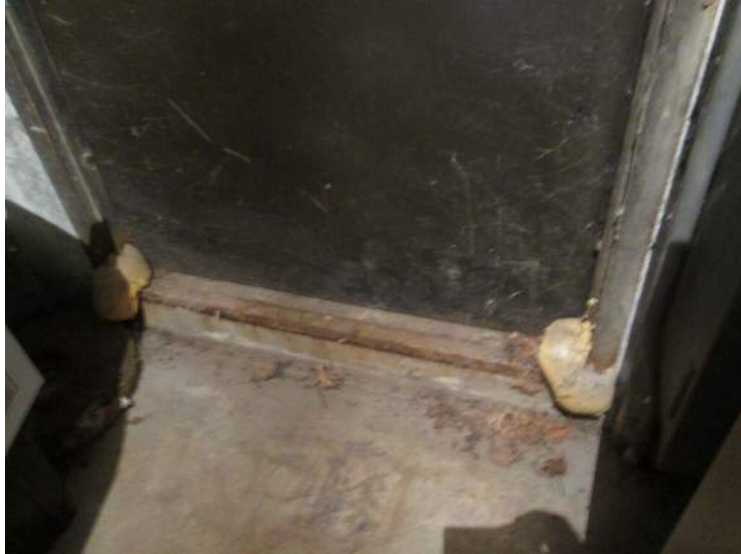
Exterior steel doors and frames show rust and wear. The exterior door to the basement areaway is rusted and has spray foam insulation inserted into the frame and below the threshold.

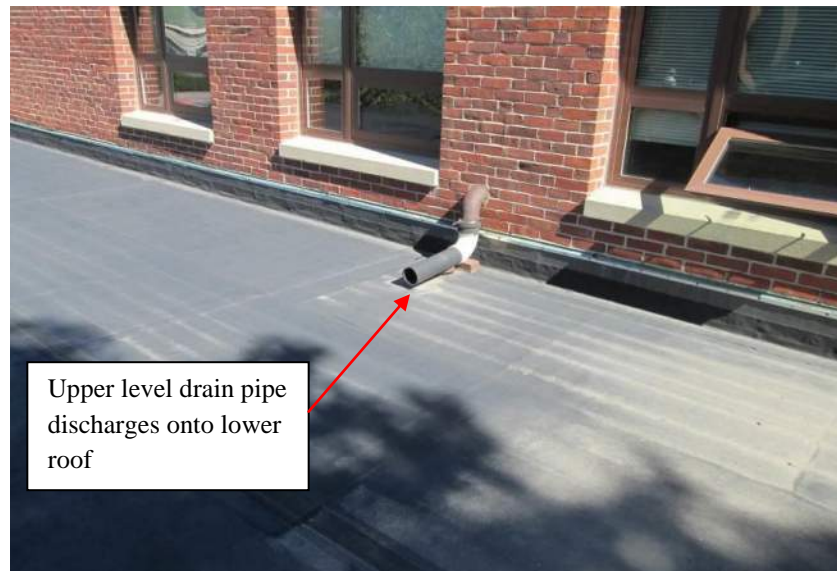
There is only one drain on each level; typically the industry recommends a minimum of 2 drains per roof level in order to have an alternative outlet in case of an emergency. In this facility however, the upper level drain is more like a scupper since it only pipes the water out onto the roof below.

4. The existing EPDM membrane roofs are in good condition and will not require replacement for a number of years. At that time it will be important to provide a ¼" per ft. tapered insulation assembly to provide proper slopes to the drains per the current building code. The replacement drains should also be replaced with code compliant drain bowls that provide the maximum capacity to evacuate the water from the roof surfaces.

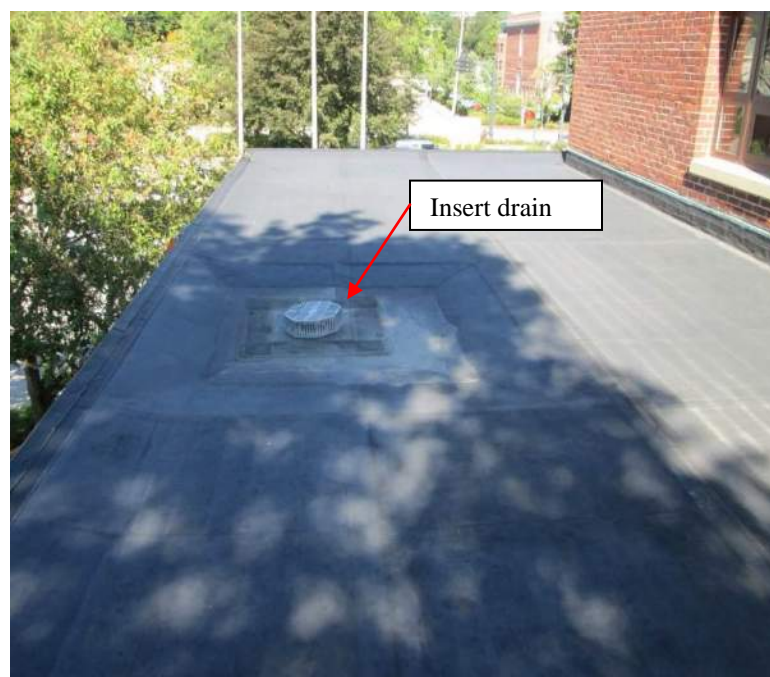
The drains on both levels are insert replacement products that do not meet the Massachusetts plumbing code because they eliminate the drain bowls and are installed by inserting a sleeve into the drain pipe which reduces both the diameter and capacity of the vertical leader pipe.

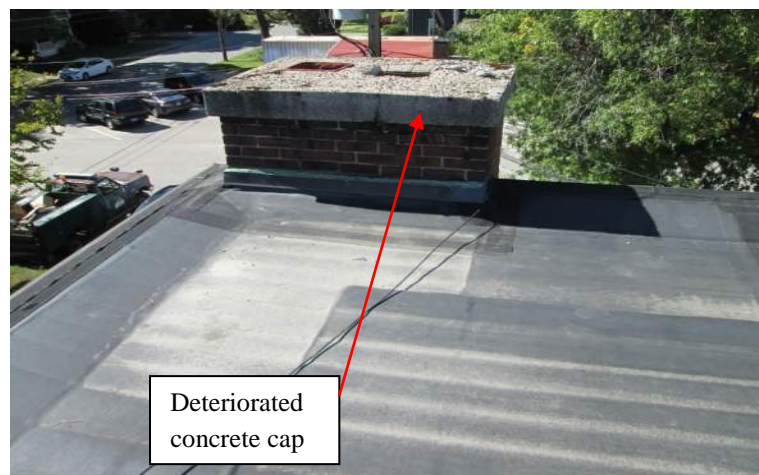
The concrete chimney cap is cracked and deteriorated allowing water to enter the facility.

- The second item will require the removal and replacement of the chimney cap and repairs to any damaged brick below the chimney cap.
- The canopy repairs will require the removal of all loose concrete, cleaning rust from the reinforcing steel, reattaching the reinforcing steel to the concrete slab and covering the damaged area with a cementitious repair product. The top of the canopy must be covered with a waterproof roofing material to seal the concrete from water intrusion.

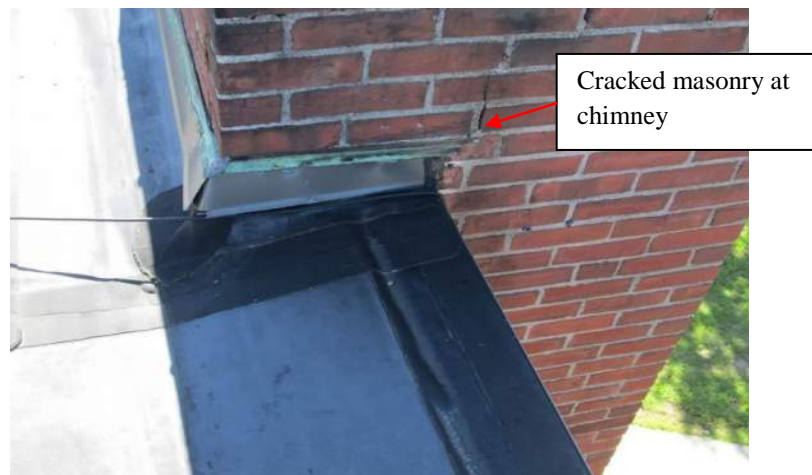
Masonry around chimney is cracked; water most likely migrates into the bricks causing further deterioration due to repeated freeze thaw cycles.

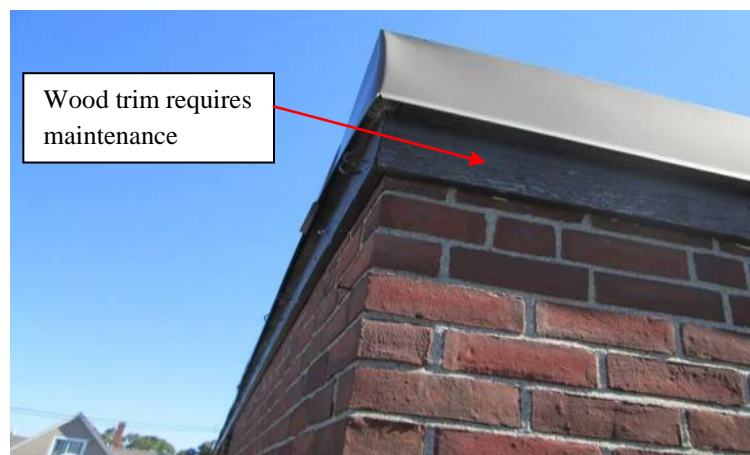
Painted wood fascia board beneath the metal fascia is in need of maintenance, wood should be clad in aluminum and color to match metal fascia to eliminate maintenance issues.

5. Clad the exposed wood trim below the roof gravel stop in aluminum sheet metal to eliminate maintenance and increase life expectancy.

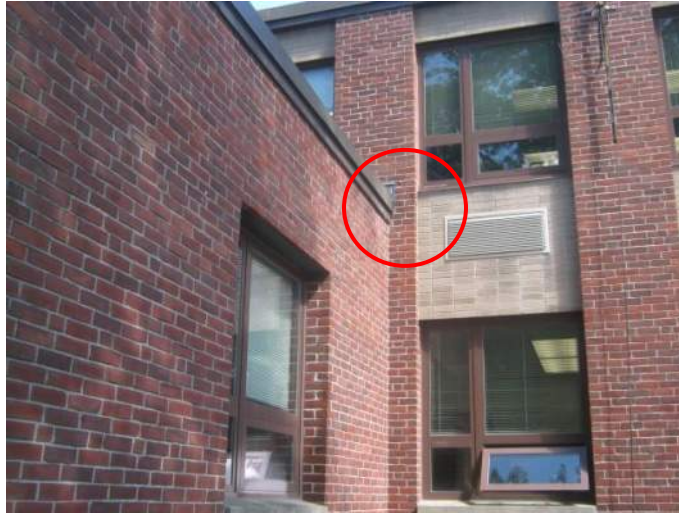
- The masonry walls both interior and exterior are stable with only one location where a diagonal crack developed in the exterior brick. This is located on the east face of the single story structure where it is attached to the south wall of the multi-story building. The crack developed due to differential movement at the intersection of the two brick faces.

The south east corner where a diagonal crack developed in the brick wythe

- The first involves the repair of the exterior brick at the intersection of the east wall of the single story wing and the south wall of the multi-story building. This work will involve the removal and replacement of all damaged brick, construction of a brick expansion joint and installation of a vertical brick expansion joint to allow differential movement between the two walls and possible helical anchors to tie the brick to the inner wythe block at the new vertical joint.

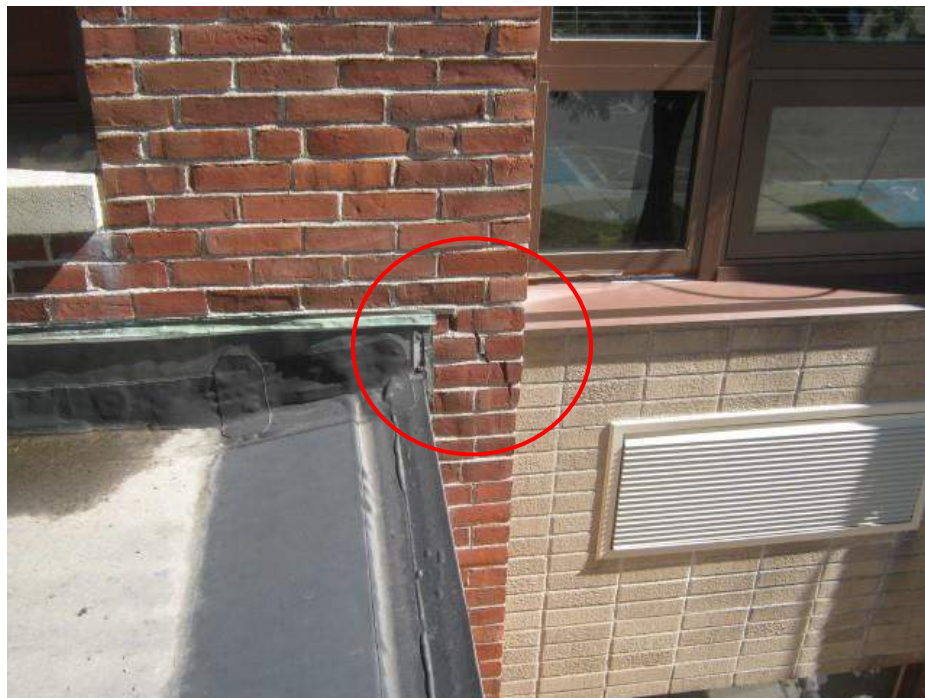
Close up of the crack.

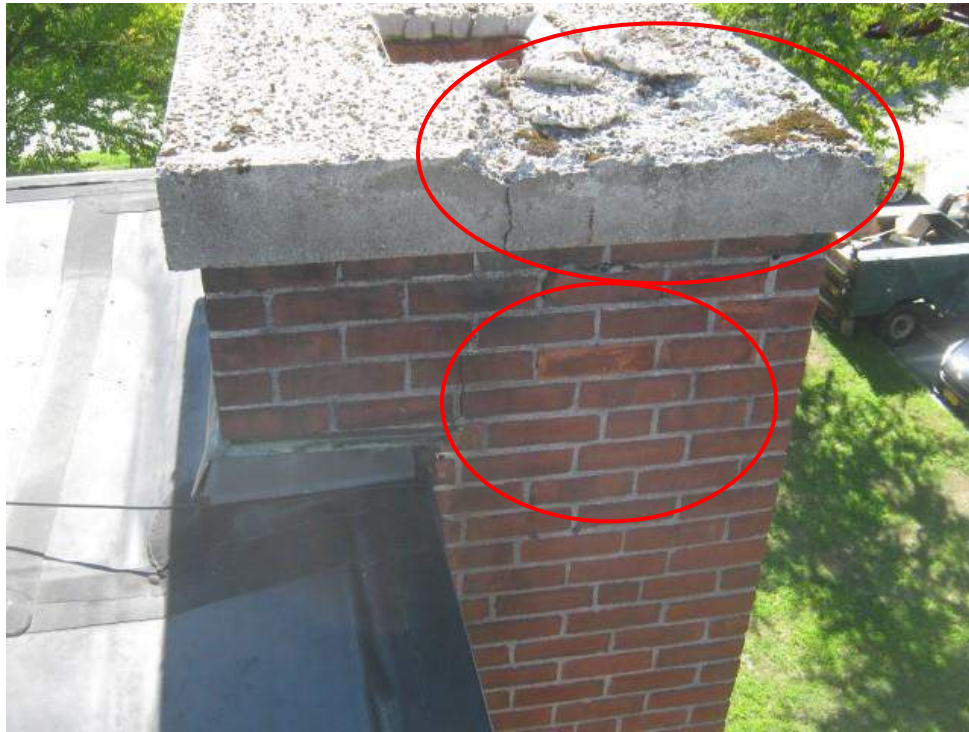
- The concrete chimney cap has spalled and cracked exposing reinforcing steel. In addition the first 2 feet of brick directly below the cap has spalled and cracked allowing the intrusion of water.

Cracked and Spalled concrete cap and brick

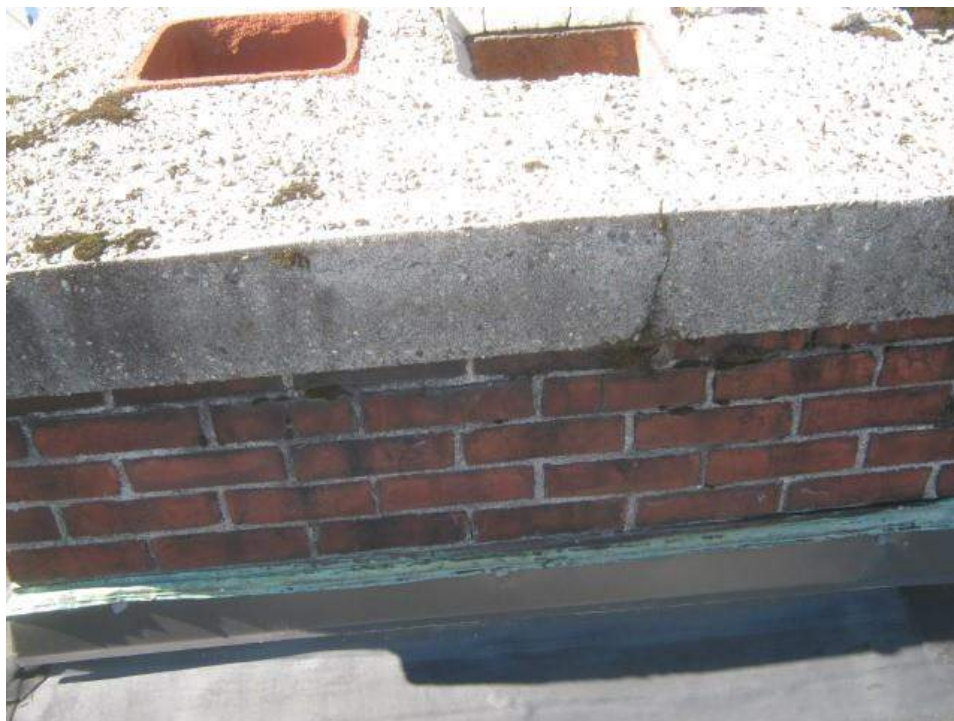
Vertical Cracks in the concrete cap on the north side of the chimney

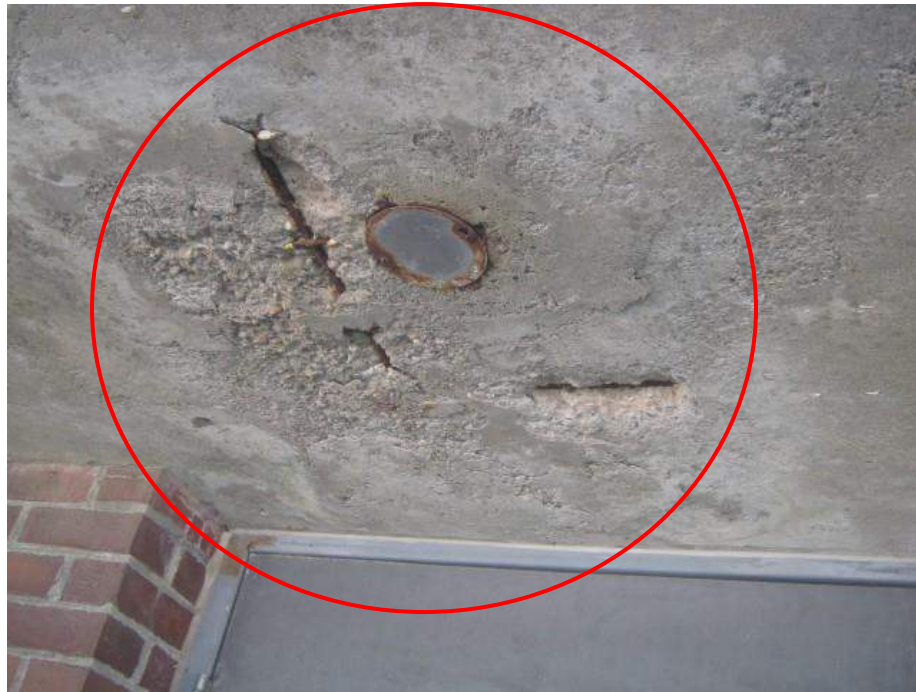
- A concrete cantilevered canopy on the south face of the single story wing has spalled the concrete surface on the underside of the canopy exposing the reinforcing steel. The top surface of the canopy is not protected with roofing material so is as able to absorb water through the slab.

Exposed corroded rebar and spalled concrete surface

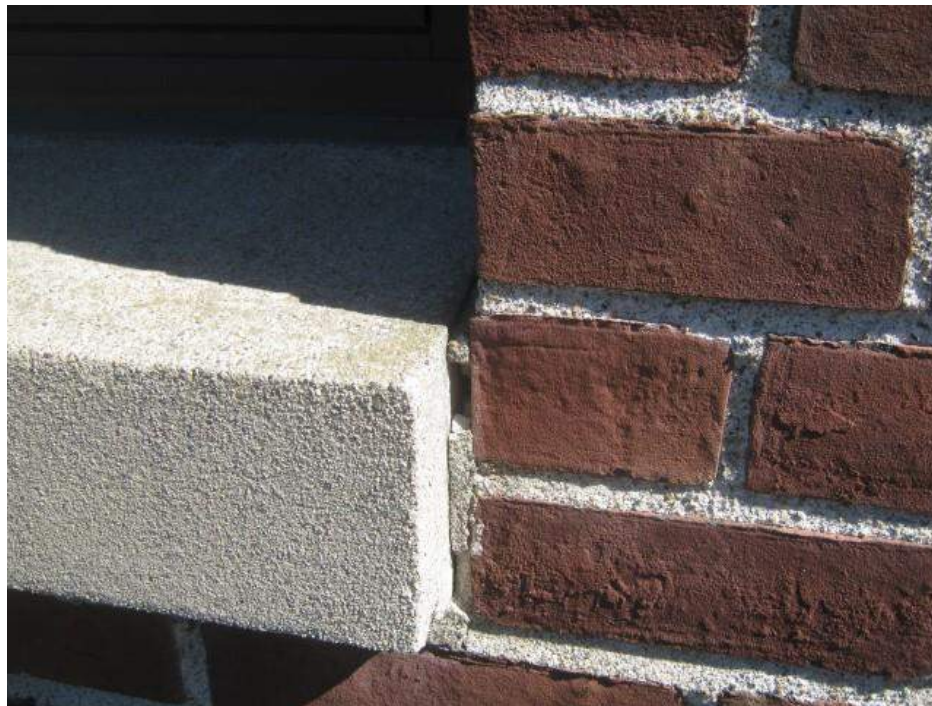
- Repointing of the brick mortar joints is necessary on a limited basis. Small areas have spalled but typically the brick joints are acceptable.

Spalled mortar joint

- Repoint the mortar joints to prevent further water damage to the mortar joints and brick.
