## Report of Findings

**SHARON PUBLIC LIBRARY**  
**PROPERTY CONDITION ASSESSMENT**  
**ENERGY AUDIT**  
**FUTURE USE STUDY**

**RBC File No: 100027408**

**SHARON PUBLIC LIBRARY**  
**11 NORTH MAIN STREET**  
**SHARON, MA 02067**

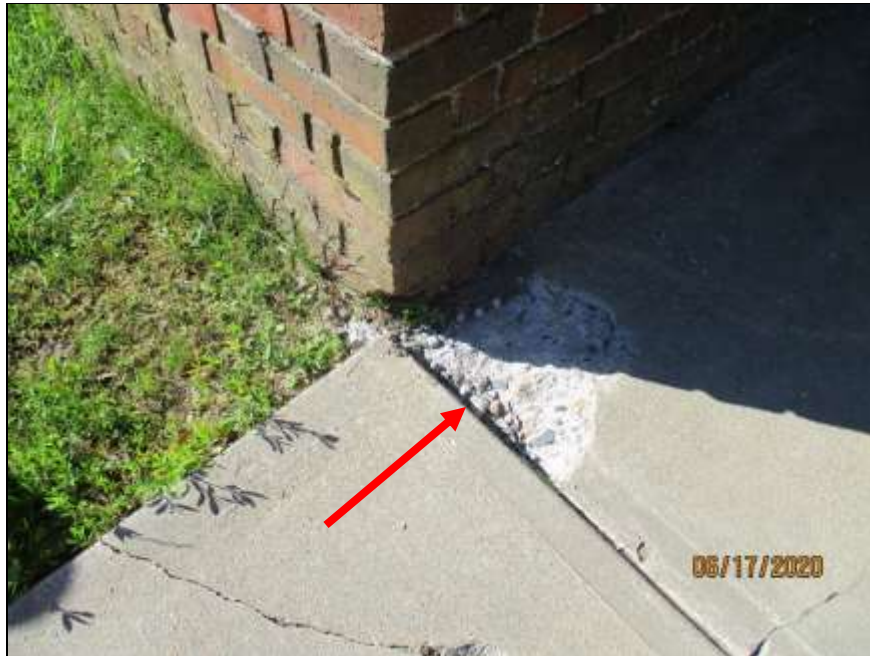
**Photograph 11**

Concrete pavement, sidewalks, and curb and gutter sections were in fair condition. We noted localized areas of cracked and chipped edges in the concrete sidewalk and retaining wall **(Photographs 11 and 12)**. There was no guardrail on the concrete retaining wall between the street level and lower level sidewalk **(Photograph 13)**. This was a fall hazard condition, and we recommend installing a code complying guardrail. Based on conversations with the Library staff, the concrete platform in front of the secondary entry

Deteriorated parts of the concrete sidewalk observed.

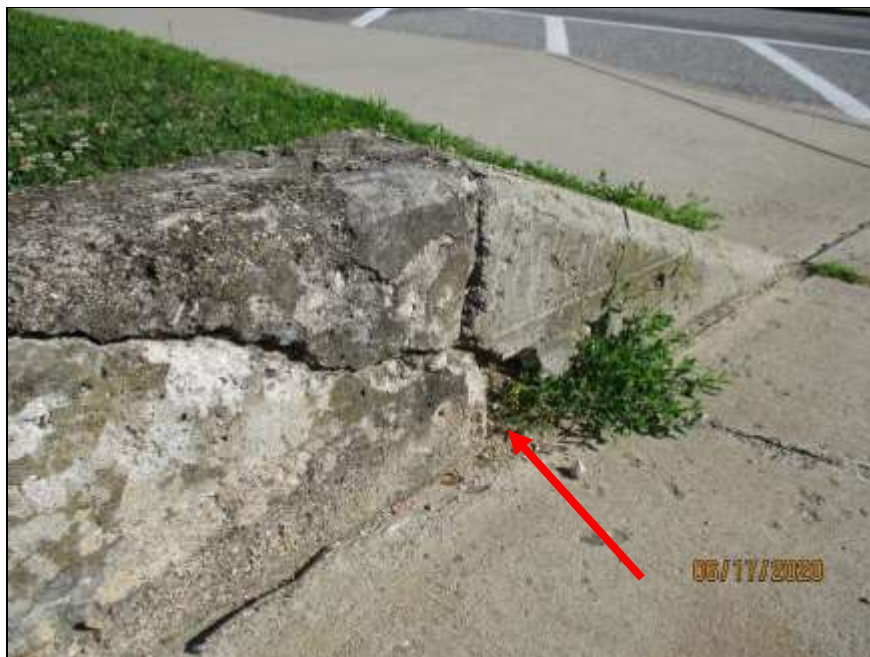
**Photograph 12**

Cracks in the concrete retaining wall observed.

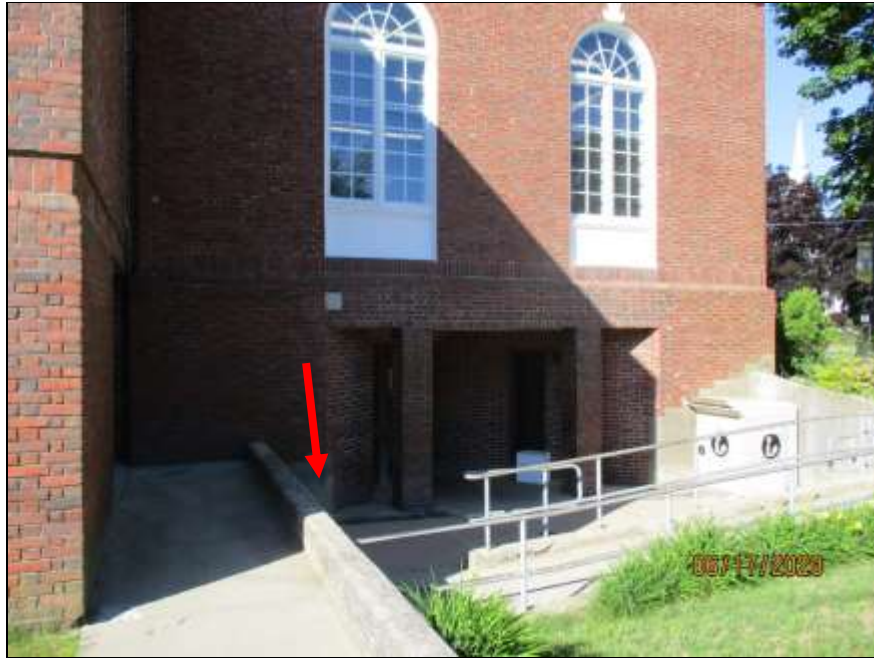
**Photograph 13**

No guardrail was present on top of the retaining wall between the street level and lower level platforms.

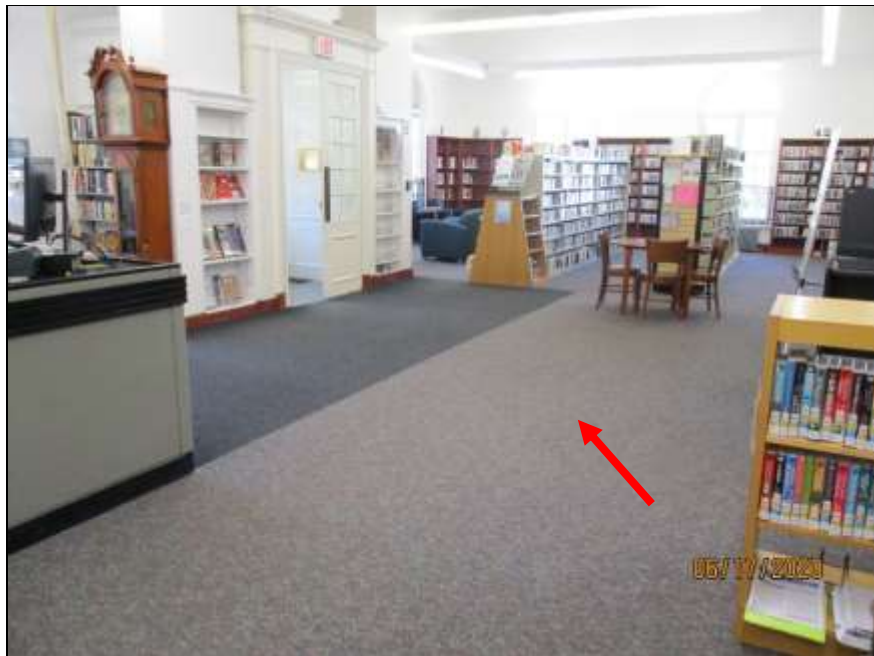
**Photograph 14**

a variety of future uses. However, we observed a deflection of the wood beam supporting the upper floor in the original 1914 building **(Photograph 14)**. There have been two temporary columns installed underneath at the lower level to stabilize the deflection **(Photograph 15)**. Currently, it was reported that this area of the floor is not suitable for live loads exceeding 60 pounds per square foot (PSF). Additional studies by a structural engineer would need to be performed to evaluate the loading requirements for any future use of the building. Once the additional structural support is designed and implemented appropriately, the live load requirements can be increased without further concern.

Deflection in the floor observed on the upper level in front of the front entry (inside the 1914 portion of the building).

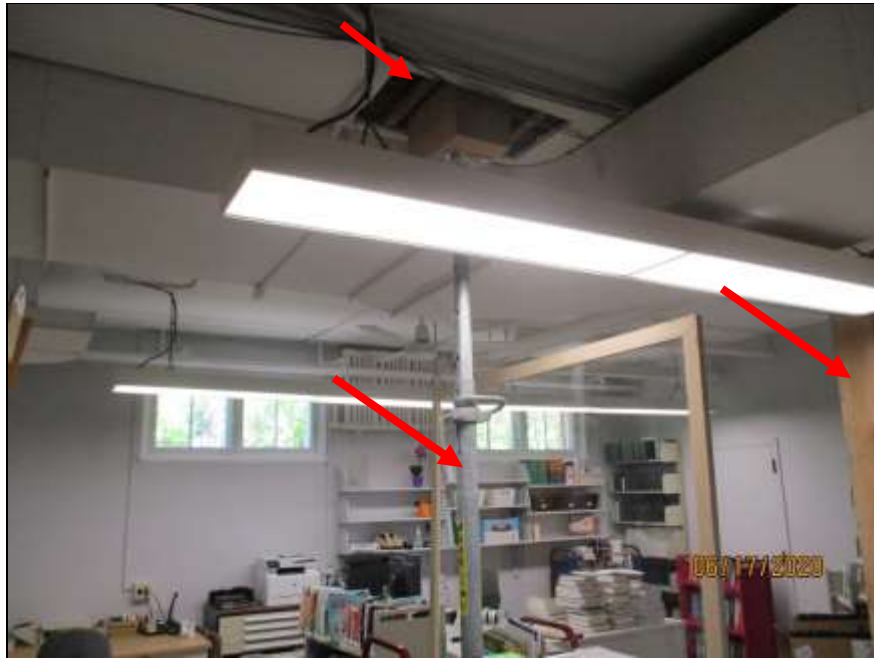
**Photograph 15**

Two temporary columns supporting the deflected beam

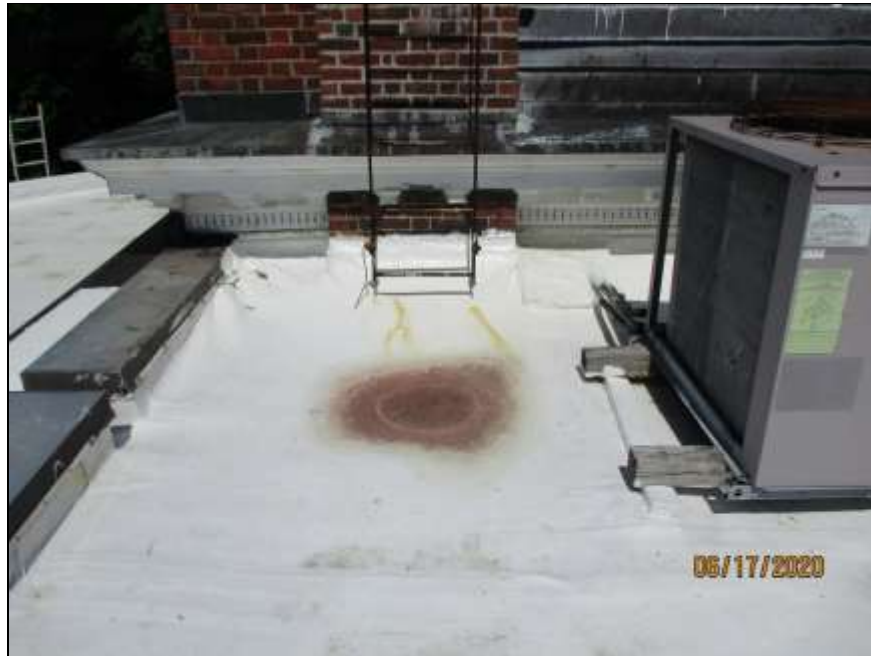
**Photograph 17**

There were some areas on the roof that had visible signs of ponding (**Photograph 17**). These areas will require periodic inspection and maintenance to ensure watertight conditions remain. Some debris was observed around the roof drains (**Photograph 18**). Regular cleaning and inspection of the roof drains is recommended to avoid clogged drains and Rimkus recommends that a secondary drainage system be installed.

Areas of ponding were observed throughout the roof.

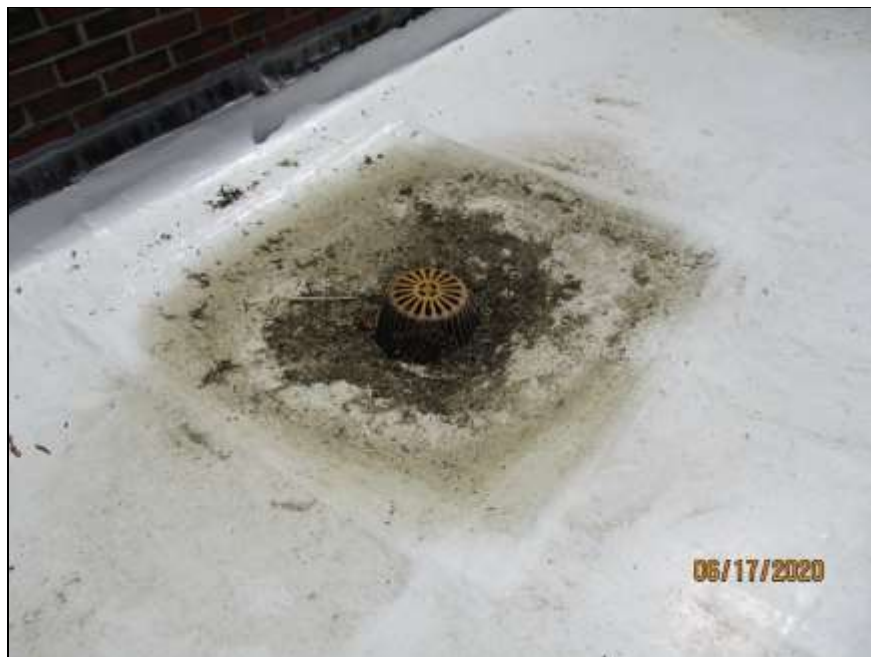
**Photograph 18**

Some debris and potential clogging observed around the existing roof drains.

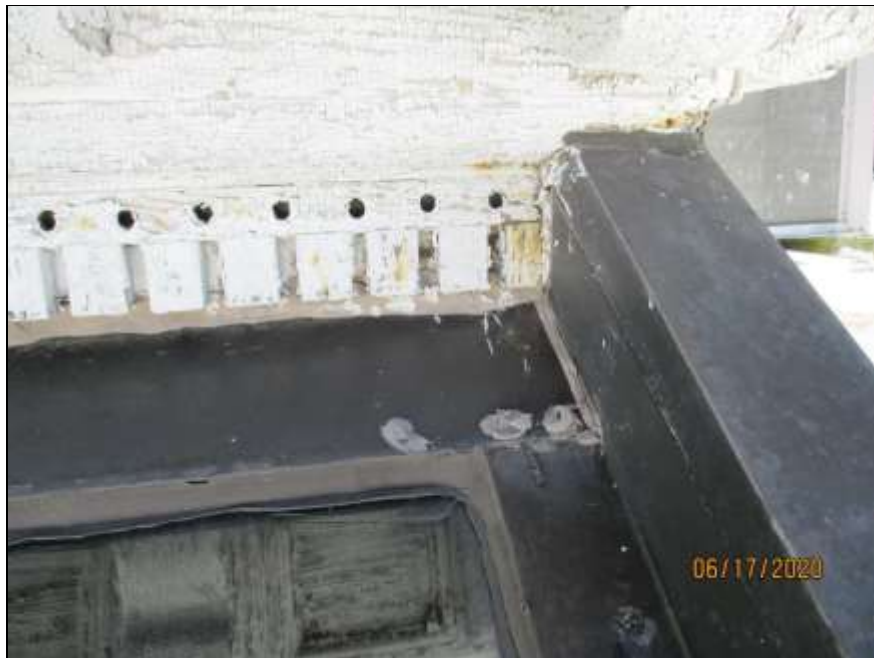
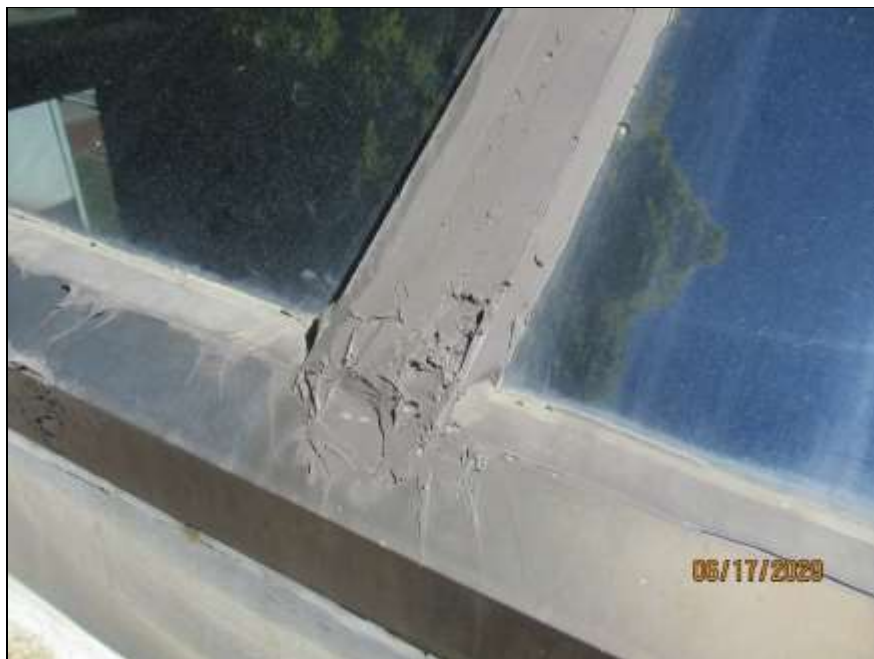
**Photograph 19**

Heavy caulking around the window panels and around the frame of the skylights indicated continuous attempts to address water leakage through these windows (**Photograph 19**). It was also mentioned that the interior areas below the skylights are either uncomfortably cold in the winter or hot in the summer. We recommend replacing these glazing panels with new energy efficient glazing panels properly sealed and/or gasketed to the existing skylight frames. We also recommend having an operable shading system installed on the inside to control heat gain and glare when needed. Alternatively, glazing panels with low solar heat gain coefficients in combination with low-e coatings can be further evaluated to reduce the heat gain from the skylights.

Multiple layers of caulking observed around the skylights.

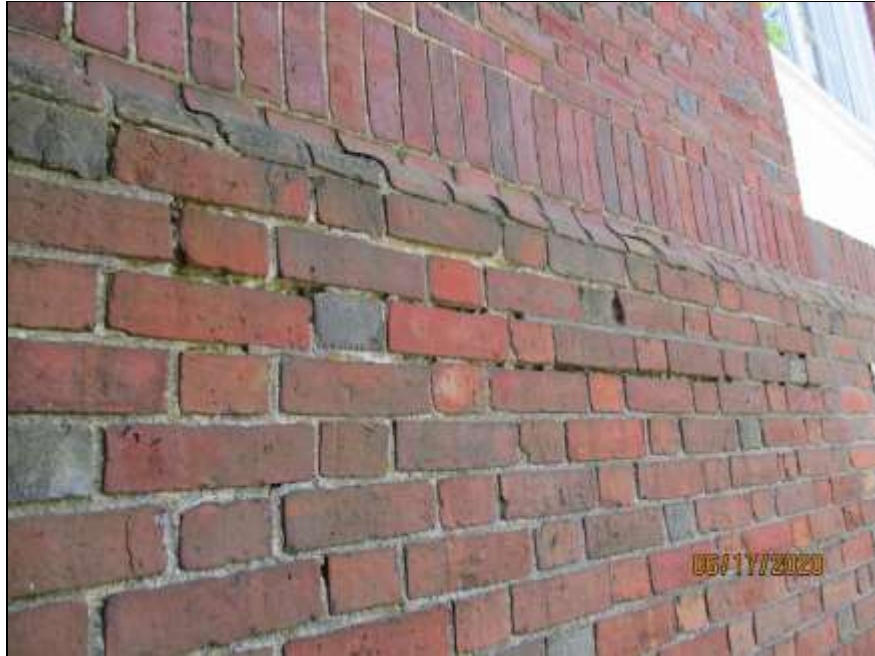
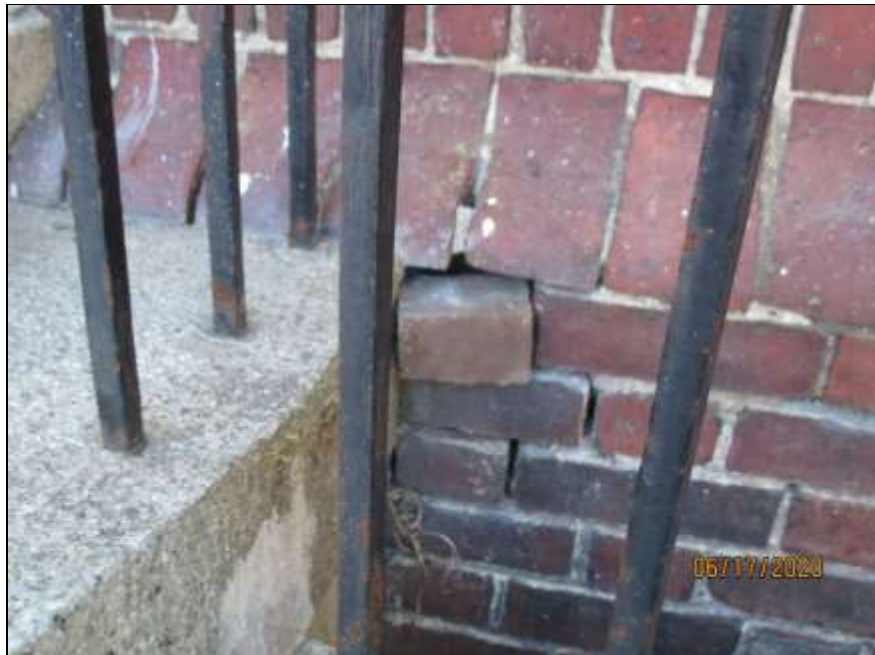
**Photograph 20**

The exterior wall system of the original building and the 1960 addition consisted of load bearing multi-wythe brick masonry and the exterior walls of the 1979 addition were CMU walls faced with brick veneer. The front of the 1914 building with the original brick reportedly had been recently repaired; however, we did notice areas of spalling brick and missing mortar (**Photograph 20**).

Missing mortar and spalling brick observed on the exterior portions of the 1914 building.

The exterior wall system was in overall good condition. The areas of spalling brick and missing mortar will need to be addressed to avoid further deterioration and/or damage. Separated portions of the wood cornice (**Photograph 24**) under the parapet of the 1914 building will need to be resealed to prevent moisture damage.

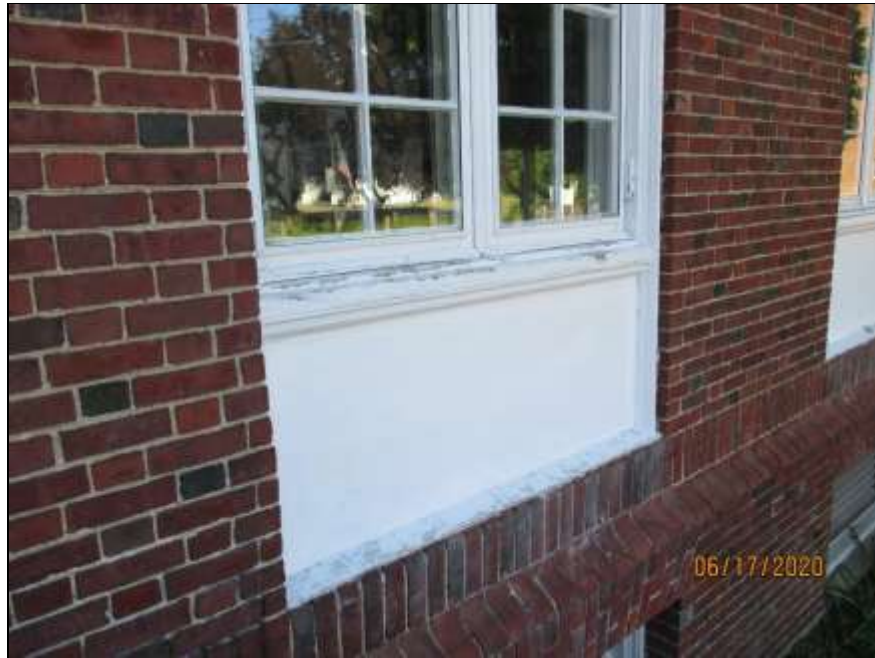
**Photograph 21**

The white paint was peeling at the wood framed windows.

Window systems appeared to be in good condition. No fogged or cracked units were observed. The sealant between the window frames and surrounding materials was good. Typically, façade sealants have a useful service life of 7 to 10 years. The sealant will need to be cut out, the mating surfaces surface cleaned and primed, new backer rod installed, and new sealant installed in the coming years. The wood trims at the 1914 building windows will need to be sanded, cleaned, and repainted.

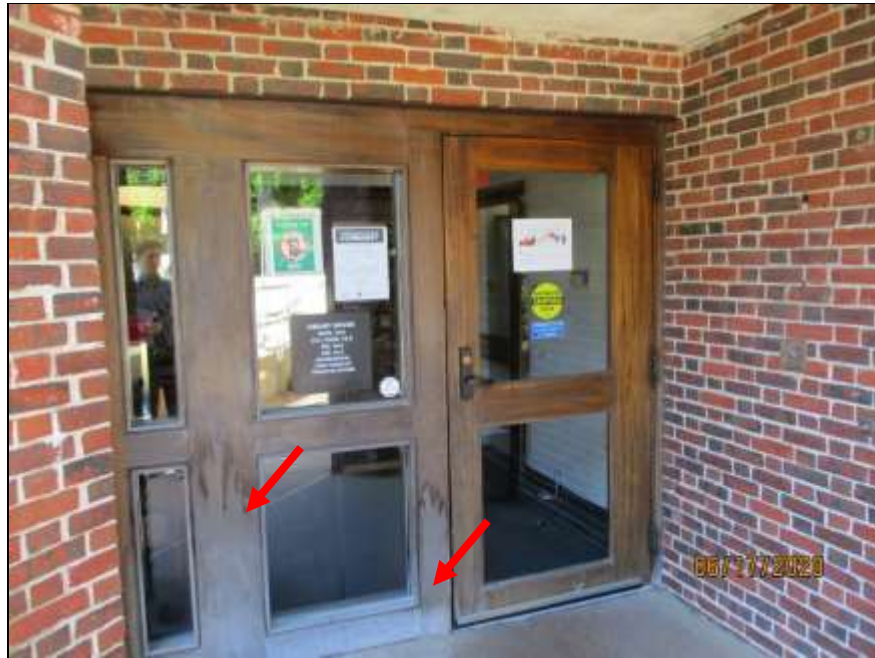
**Photograph 23**

There were discolorations on the wood frame of the lower level entry door and storefront.

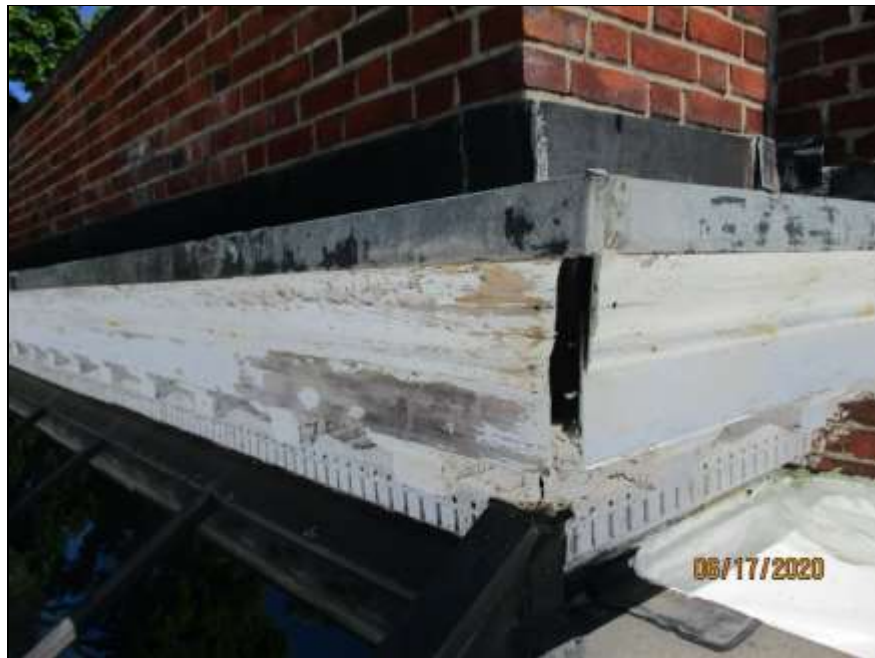
**Photograph 24**

Paint peeling and corners separating of the existing wood cornice.

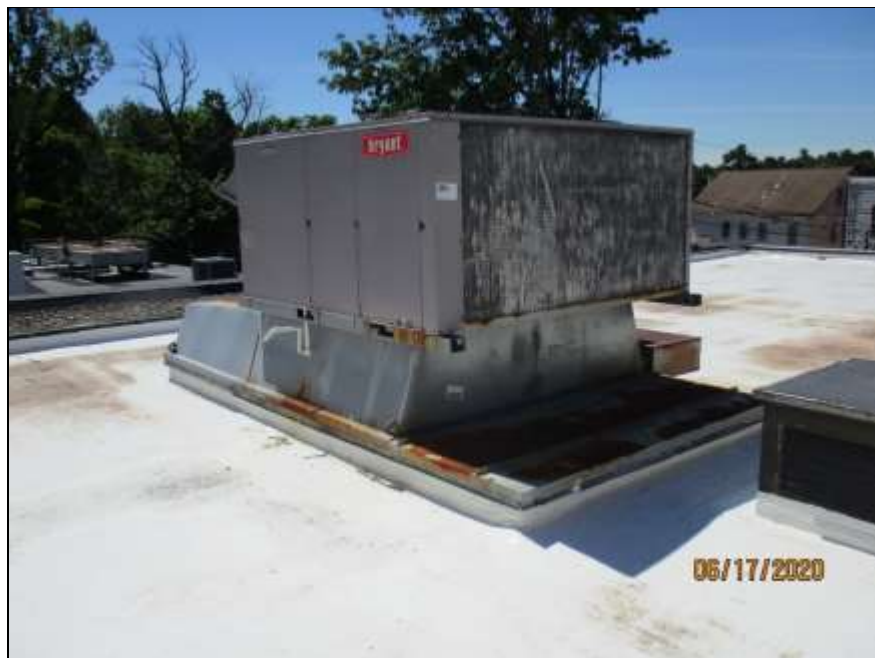
**Photograph 26**

Older Bryant rooftop packaged unit.

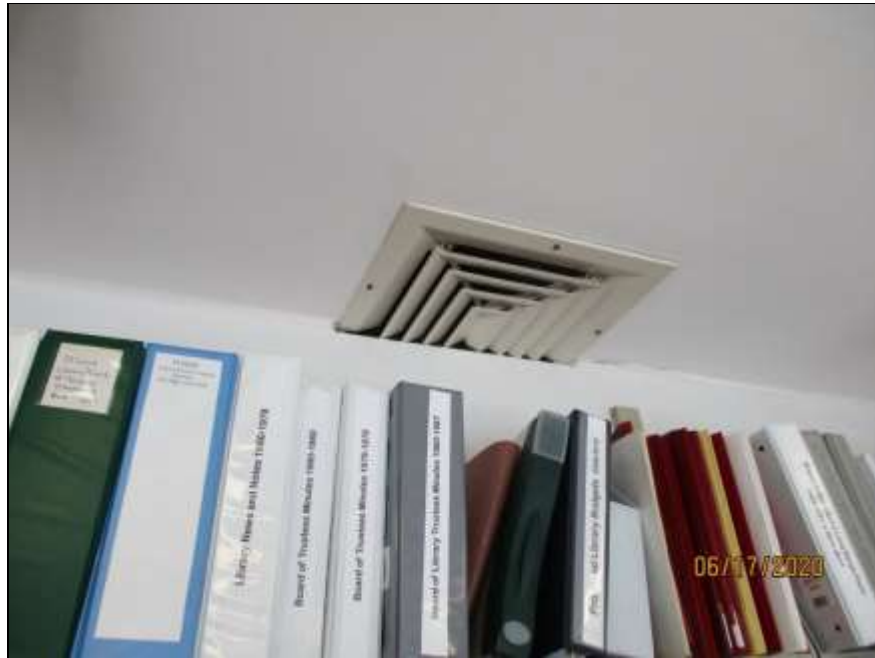
**Photograph 29**

The upper level office room partition wall was built over the mechanical diffuser.

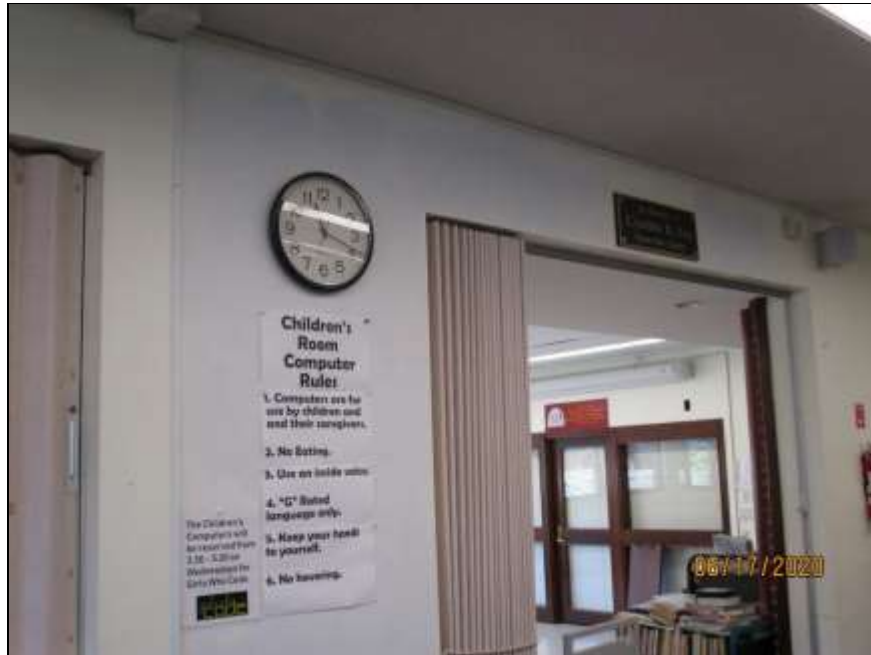
**Photograph 42**

Portion of the lower level paint color at the multipurpose room was different from the rest of the wall.

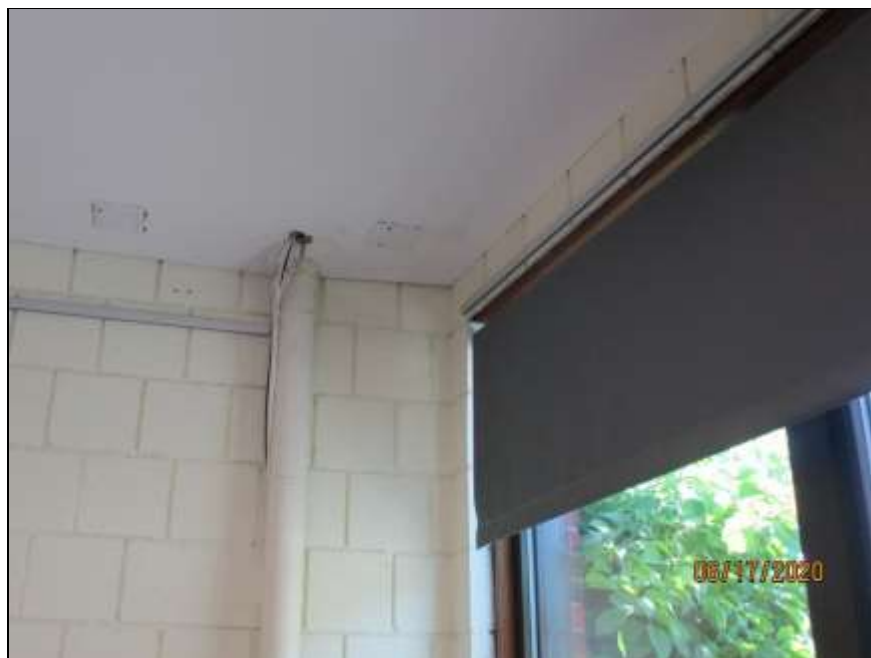
**Photograph 43**

There was some visible water damage around one of the drainage pipes at the ceiling in the multipurpose room of the lower level.

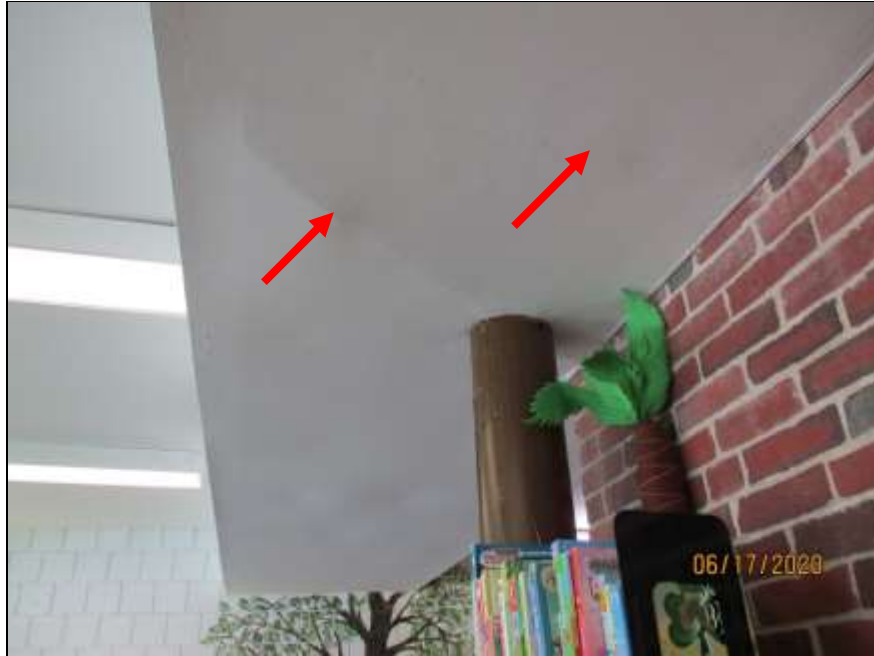
**Photograph 44**

We observed cracking of the gypsum board at the ceiling in some areas.

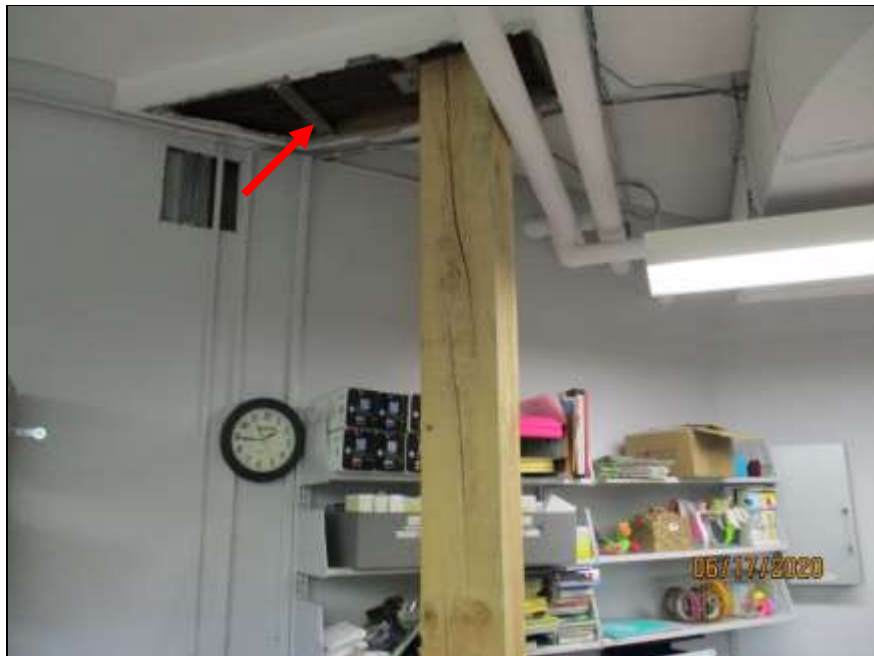
**Photograph 45**

Portion of ceiling finishes removed for installation of temporary columns in lower level.

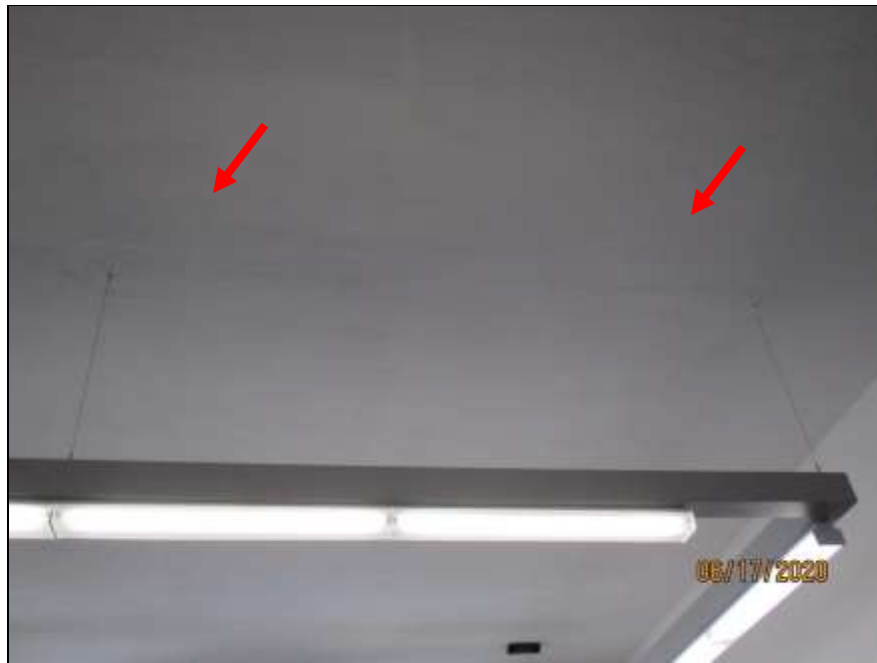
**Photograph 46**

Some patchwork at the upper level ceiling appeared to be concentrated above the suspended light fixtures.

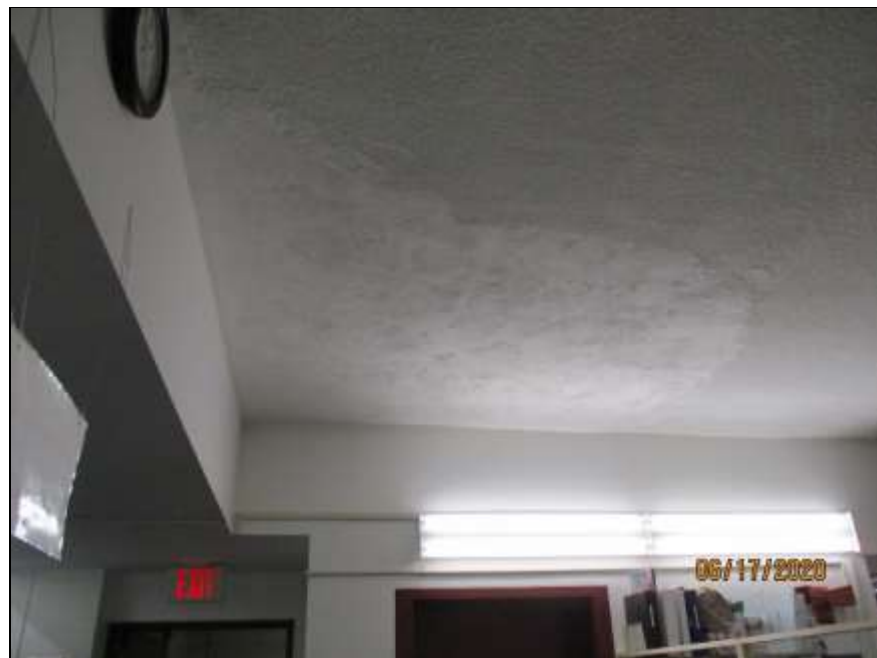
**Photograph 47**

Inside the main library space on the upper level, there was visible repair work at the ceiling near the elevator.

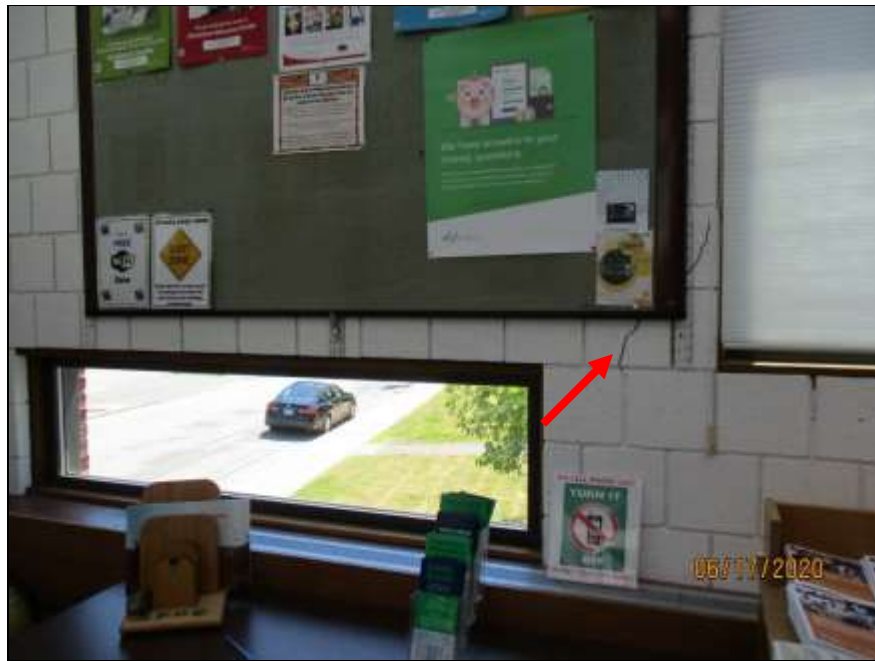
**Photograph 48**

Inside the 1979 rear addition at the northeast side of the building, we noted cracking of the exterior block wall near the window.
