# Restoration and Revitalization Of the Sharon Great Cedar Swamp Progress Report

Requested by: Sharon Conservation Commission

Prepared by: Peter C. Fletcher, Aimlee D. Laderman, and Pamela T. Polloni

June 2012

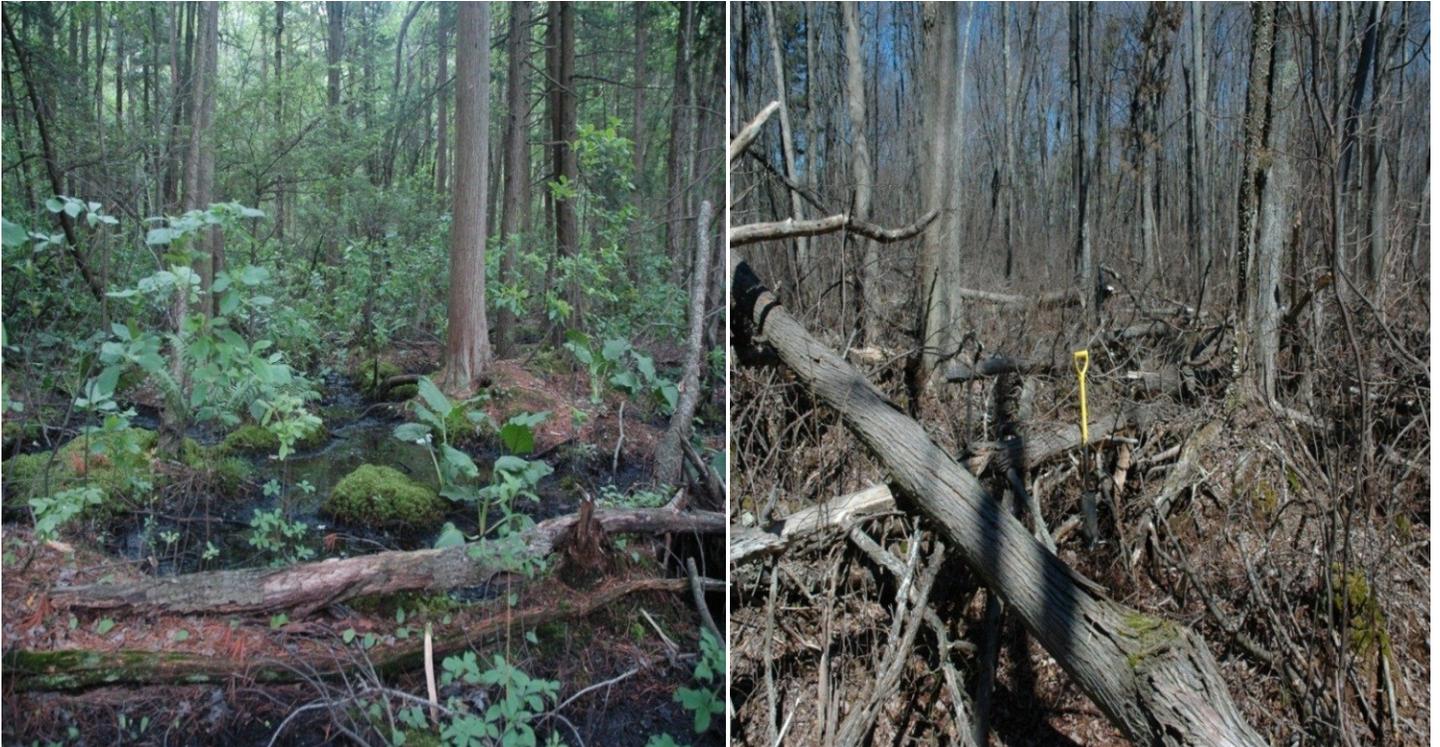
**Figure 3. Healthy Atlantic White Cedar swamp (left); drained/degraded Atlantic White Cedar swamp (right).**

Unfortunately, this huge ditch has effectively drained a large area of the western portion of the Swamp. Large quantities of pristine groundwater, once held within the Swamp, now discharge into the ditch only to flow out of Town. This valuable supply of clean water is now lost to the citizens of Sharon. Lowering of the groundwater table has had major detrimental effects on the wetland ecosystem. Remains of the formerly vigorous stands of cedar now lie on the ground (Figure 3). The characteristic assemblage of wetland species is being replaced by more common plants, some of which are exotic and dangerously invasive. Extensive areas of formerly thick black organic soils are now dry. Rather than accumulating and sequestering organic matter to form peat, the organic matter now decomposes and volatilizes at an accelerated rate. The ground surface has subsided by several feet in much of the western portion of the Swamp. The oxidation of peat has global implications: the formerly sequestered carbon is released as greenhouse gases, contributing to global climate change.

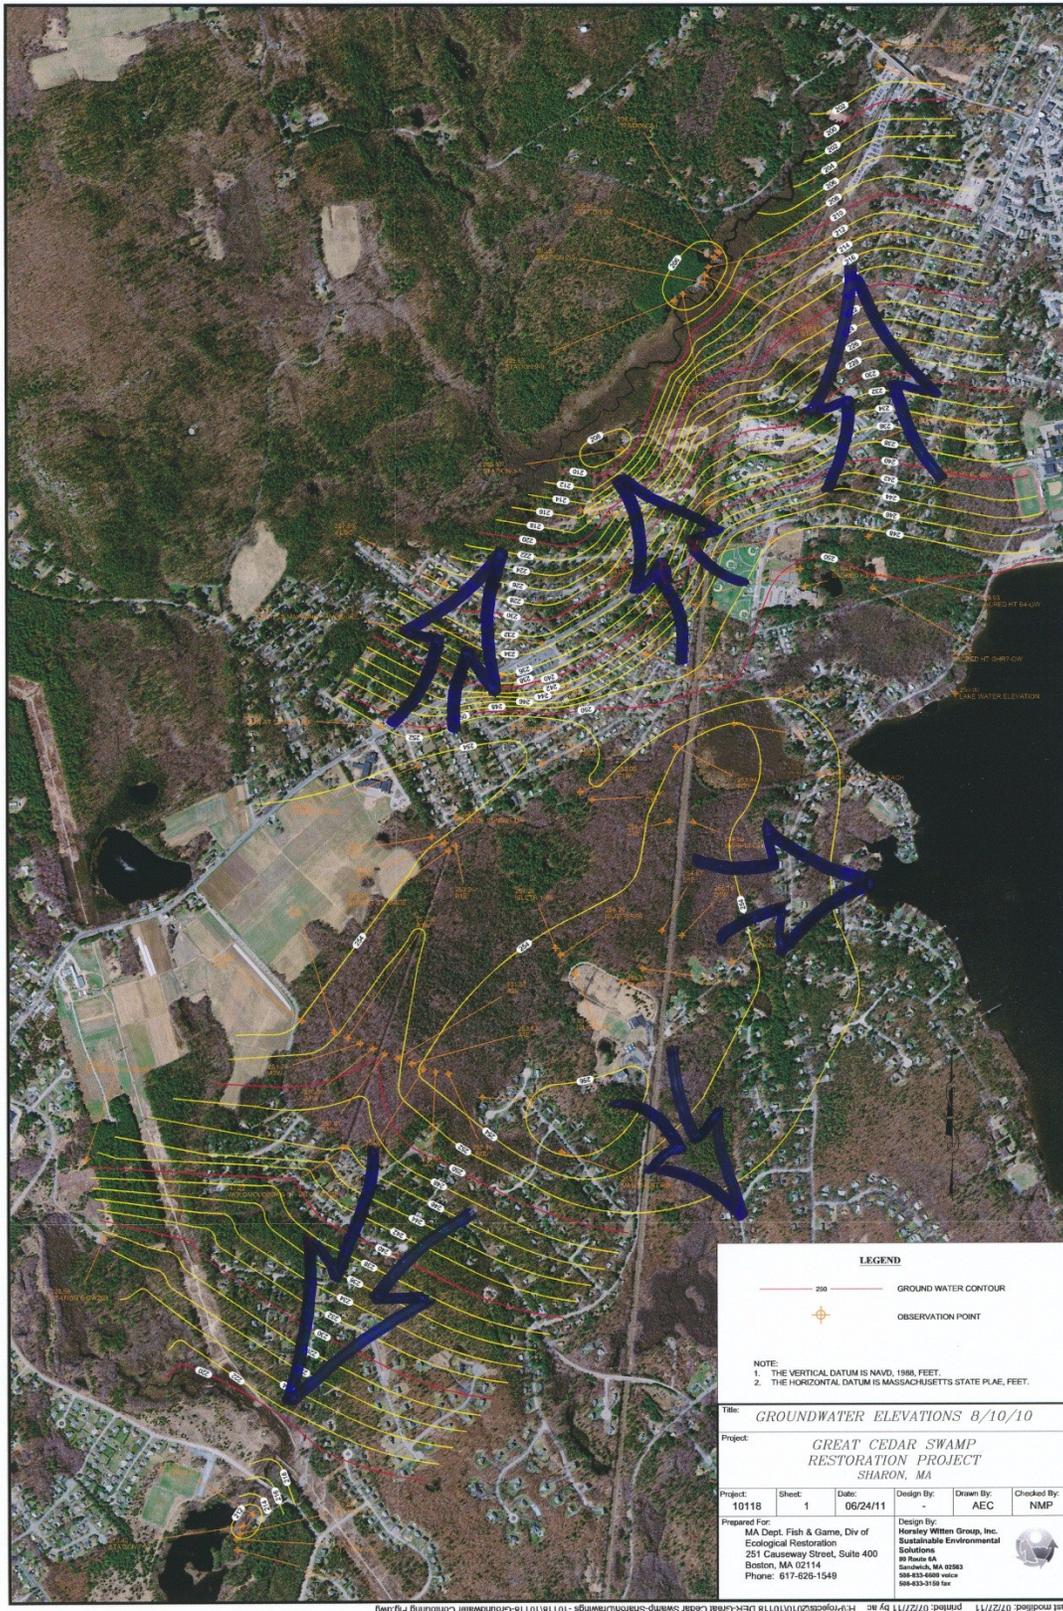
Figure 6. August 10, 2010 Groundwater flow directions from Sharon GCS. **Note two unusual factors:** groundwater readings used to create this contour map took place: 1.) during a prolonged period when a total watering ban was imposed; and 2.) during a year (2010) with the wettest March, wettest month, wettest spring, fifth wettest August, and sixth wettest year on record (1891-2010).

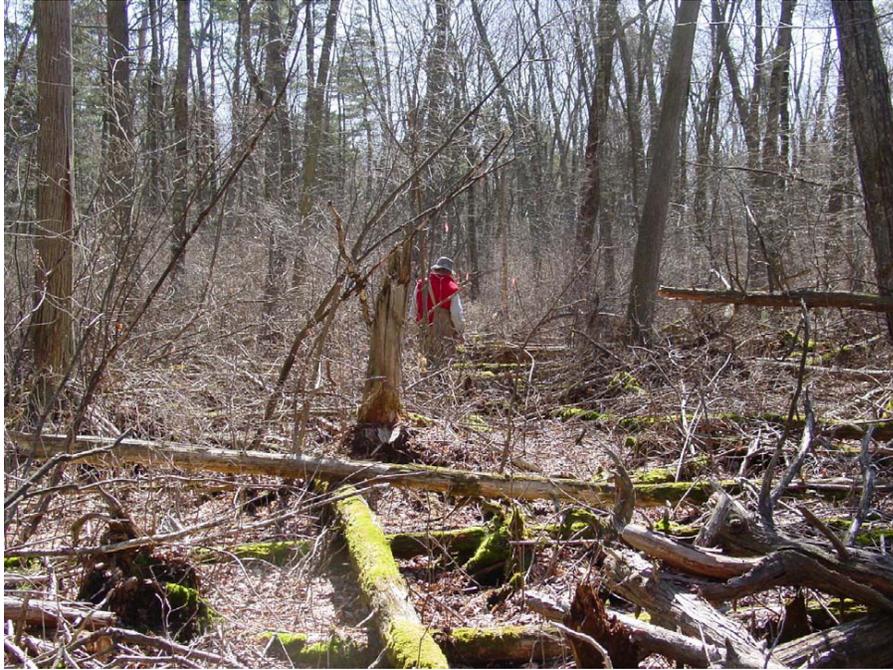
**Section 1.** Plant community and wildlife descriptions are being recorded along two transects in this section where restoration of natural hydrologic conditions is a goal (Figure 11). Seven established study plots are being monitored.

Figure 11. Fallen AWC in drained area east of Sunset Drive (Section 1).

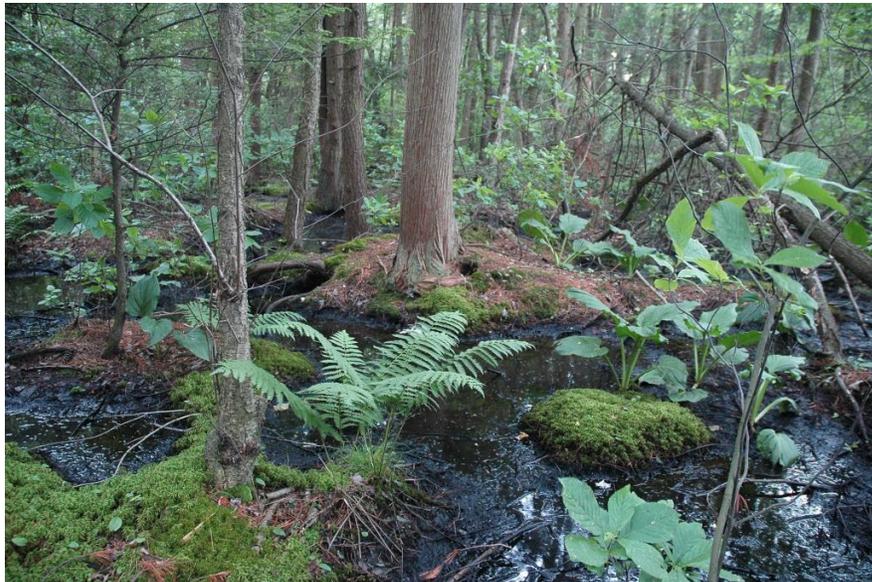
**Section 2.** Monitoring at Plot # D1E (Figure 12) continues, providing status information on the least disturbed portion of the Swamp. Here AWC trees averaging ~20 cm diameter at breast height (dbh) dominate the canopy.

Figure 12. Late spring view of AWC swamp with normal groundwater elevation (Section 2).

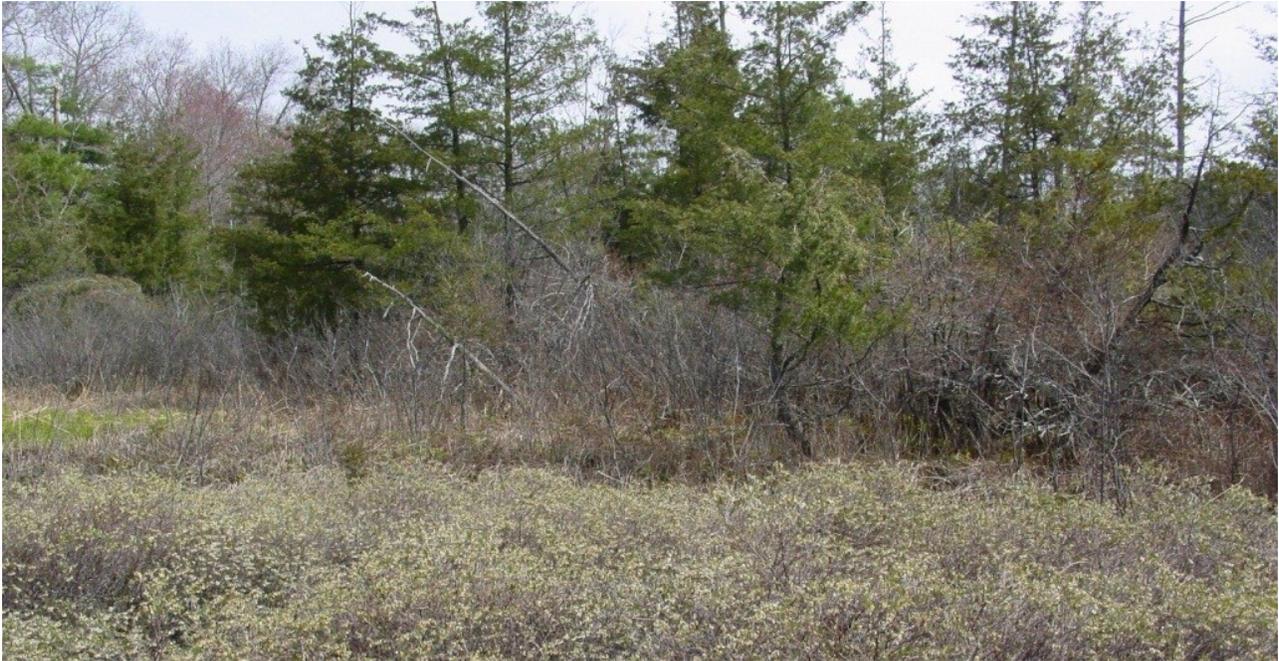
**Section 3.** This separate northeastern area, a portion formerly drowned by water retention, is important to the Swamp in that there are several stands of reproducing Atlantic White Cedar with both seedlings and saplings evident (Figure 13). Survival of these cedars is dependent on water level management and is threatened by the spread of rapidly growing invasive glossy buckthorn (*Frangula alnus*) and by browsing white-tailed deer. During 2009-11, unusually wet winters prevented easy access to study plots here where glossy buckthorn has taken hold. Site visits in 2007 through early 2011 have documented the rapid growth of this problem invasive. Using Plot #E1N as a control, we have initiated establishment of test plots nearby with selective cutting of glossy buckthorn.

Figure 13. Regenerating AWC with blossoming leatherleaf (*Chamaedaphne caliculata*) in foreground, (Section 3).

Continuing Action: to protect the regenerating AWC in Section 3 and determine feasibility of repopulating AWC within degraded areas of the GCS.

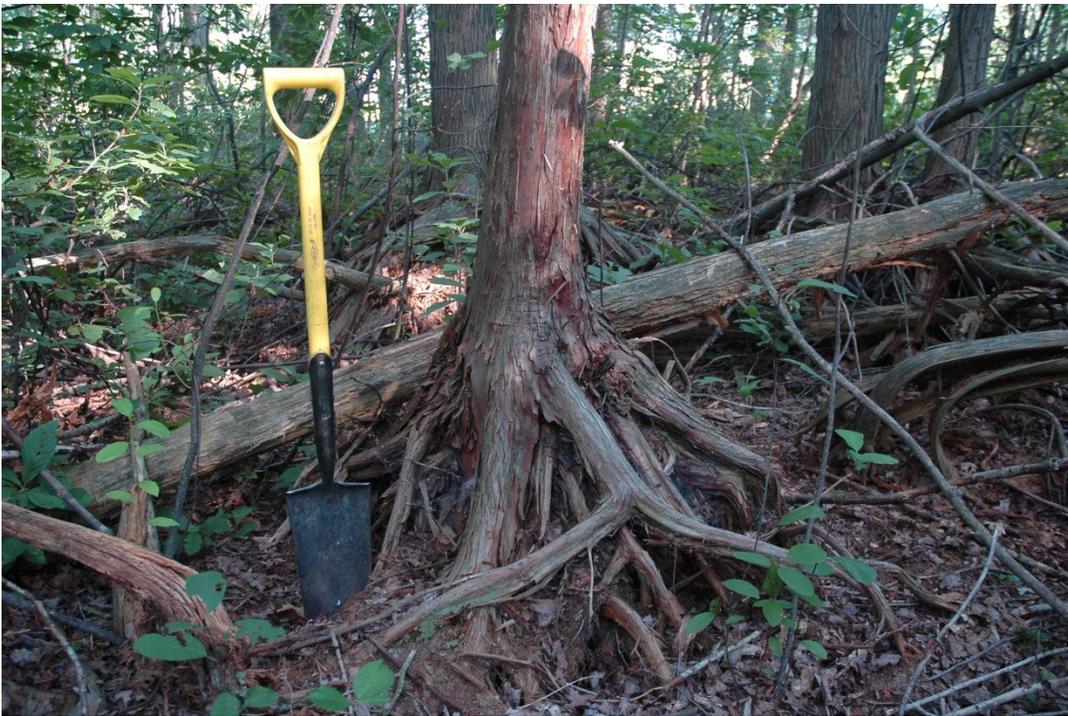
Figure 14. Exposed AWC roots indicate severe soil subsidence near the ditch.

The effects of soil subsidence are unique to this section of the Swamp. Organic soils (peats) form within areas that are very wet for long periods.. Organic litter (leaves, needles, and animal matter) falling within this wet anaerobic environment accumulates over time. In areas where the peat has been drained, gases replace the water in the soil pore spaces. Under these conditions the organic matter decomposes at an accelerated rate and the ground surface sinks. Evidence of significant soil subsidence can be verified by studying the exposed root systems at the base of trees (Figure 14). Soil subsidence weakens the support of the trees making them less stable and more susceptible to wind-throw. Within many areas of Section 1 of the Swamp, there are thousands of dead trees lying on the ground surface. Using the height of exposed root systems on standing trees as a gauge, the degree of subsidence within the organic soil areas can be determined. The amount of soil subsidence was estimated to range from 1 foot to greater than 3 feet. The degree of subsidence was greatest in the organic soils that are closest to the drainage ditch.

Because groundwater has been lowered, especially in those areas closest to the drainage ditch, organic matter in the upper part of the soil is no longer saturated. In many of these areas the upper 1 to 1.5 feet of organic matter becomes very dry in summer. This makes these areas prone to forest fires that are notoriously difficult to control and extinguish.

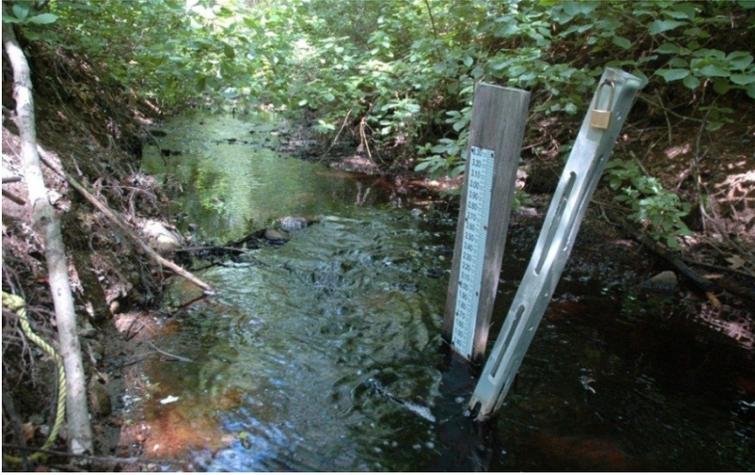
Figure 17. Normal flow within the ditch.

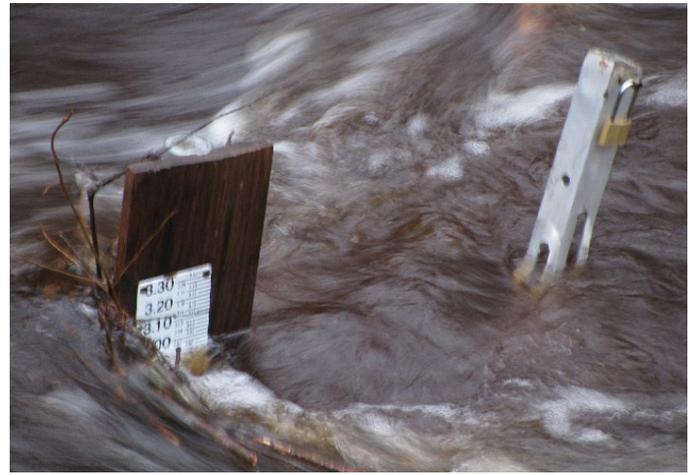
Figure 18. Stormwater flow within the ditch, March 2010

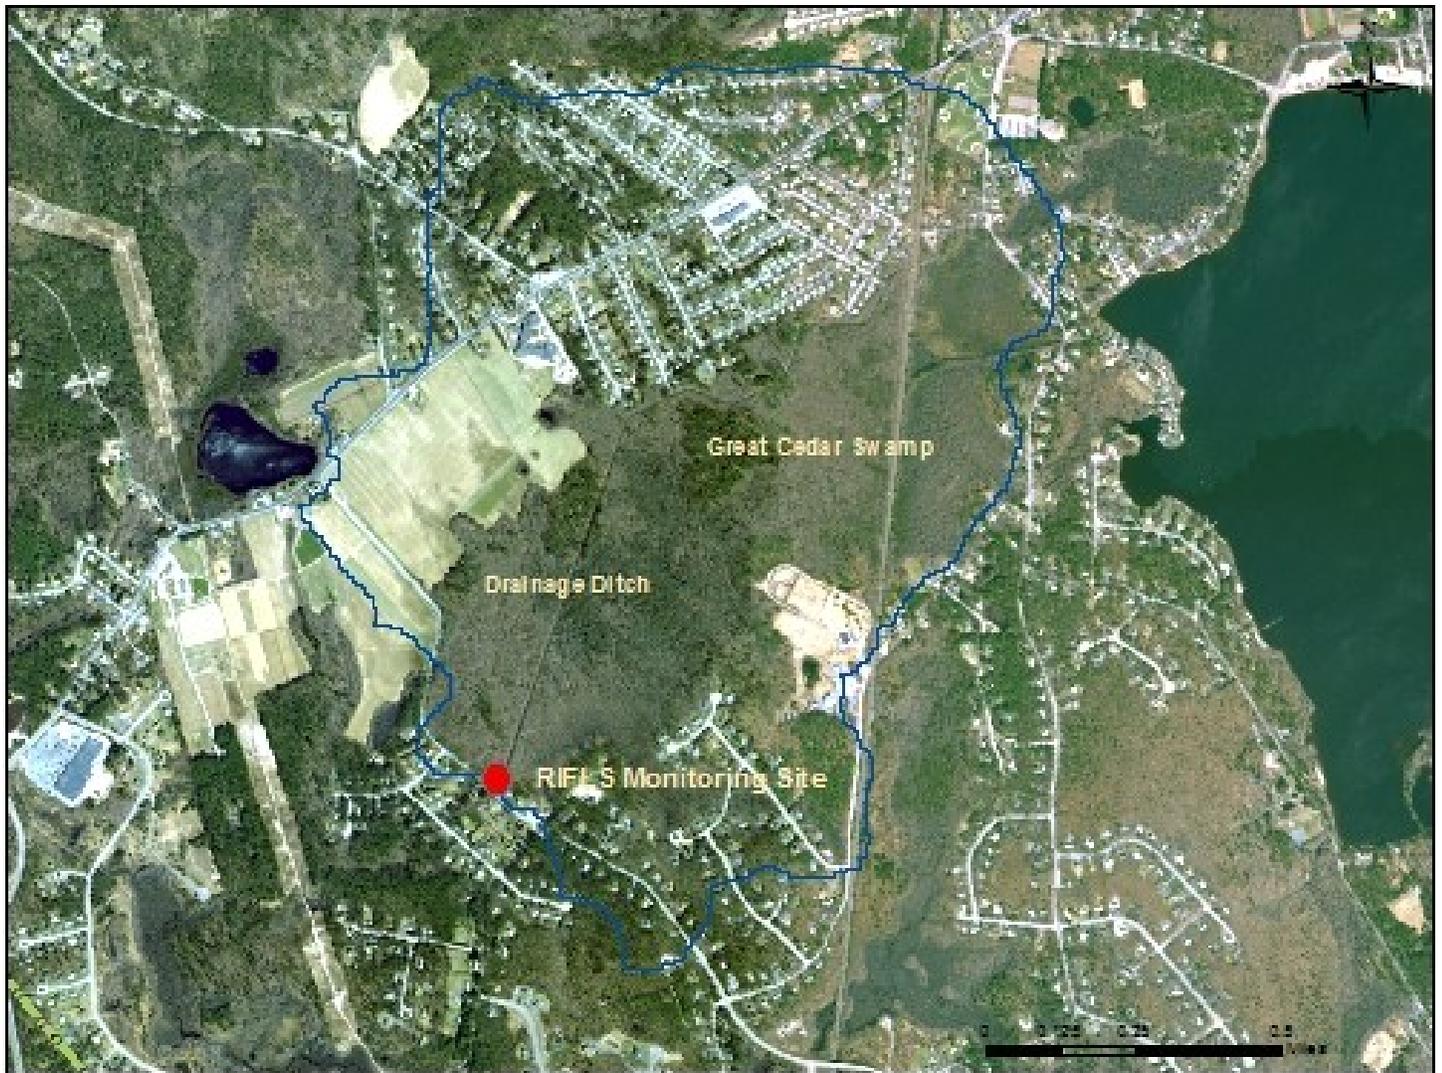
**Figure 19. Wolomolopoag Street RIFLS Monitoring Site.**

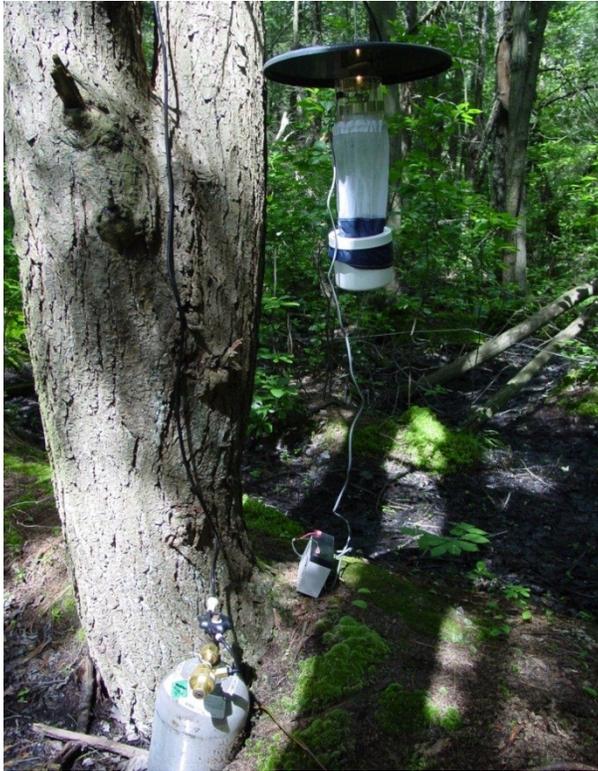
Figure 21. Gravid Trap for adult mosquitoes.

The Sharon Conservation Commission and the Technical Team invited the Norfolk County Mosquito Control Project (NCMCP) to work with us at the inception of this project. The NCMCP has now been monitoring Sharon GCS mosquito populations for four years. Their work has provided a valuable service to the population of the Town, with vital information protecting the health of humans, their pets and Sharon's wildlife. Four traps for adult mosquitoes (Figure 21) were placed within the general area of the Swamp. Eastern Equine Encephalitis (EEE) virus was detected in 2011, in one of the NCMCP traps. Crypts, the cavities formed beneath trunks of Atlantic White Cedars, are breeding areas for *Culiseta melanura*, a species of mosquito that is a vector for EEE. NCMCP is monitoring populations of mosquito larvae in the GCS crypts (Figure 21).

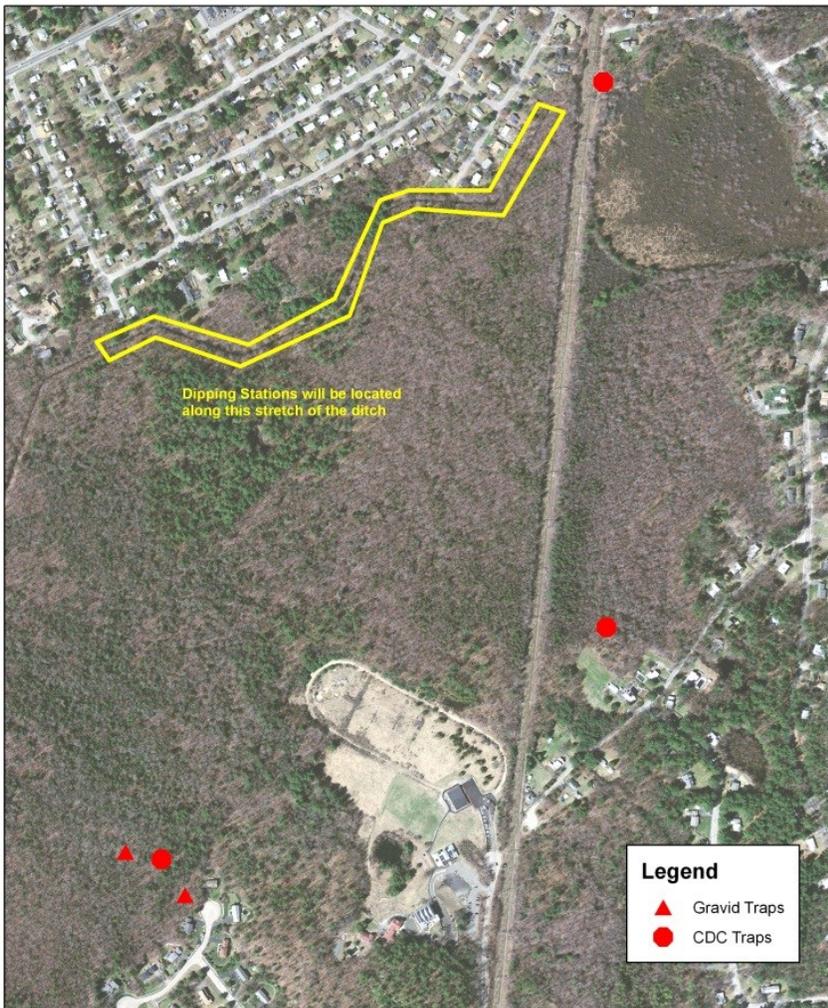
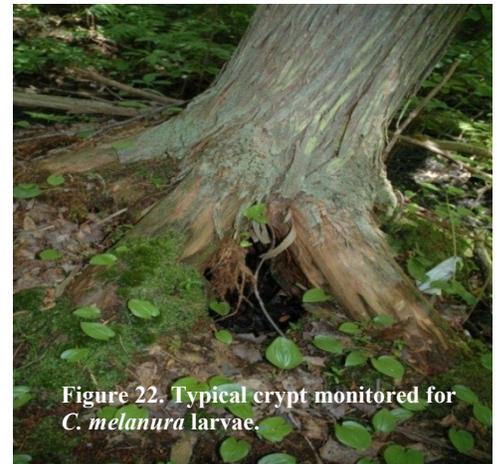
### Sharon Cedar Swamp -- Trap Sites and Dipping Area

Figure 23. Norfolk County Mosquito Control District (NCMCD) 2012 monitoring sites in GCS.

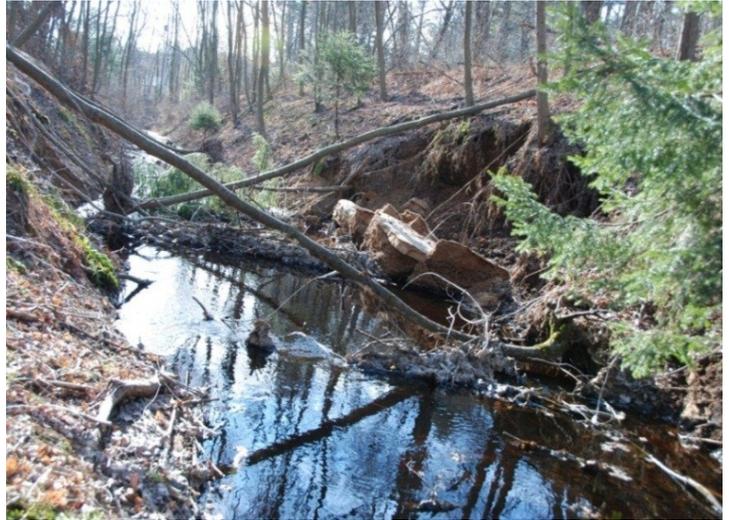
Figure 29. Undermined banks and trees collapsed into the ditch.

For ditches to function as they were originally designed, they require routine maintenance. If not regularly maintained there is a natural progression: the ditch gradually fills in with debris and sediment. Vegetation growing on the sides of a ditch deposits leaves and woody debris into the ditch. Strong flows during storm events and following snowmelt erode and undermine the banks causing the sides to slump. Erosion and strong winds cause trees to fall into the ditch (Figure 29). Street storm drains from subdivisions carry road sediments

into the ditch. The combination of these processes results in the infilling of the ditch, reducing its effectiveness to convey water. During the five plus years that these studies were conducted significant changes were observed and documented within the ditch. Both natural sediments and foreign debris have accumulated.

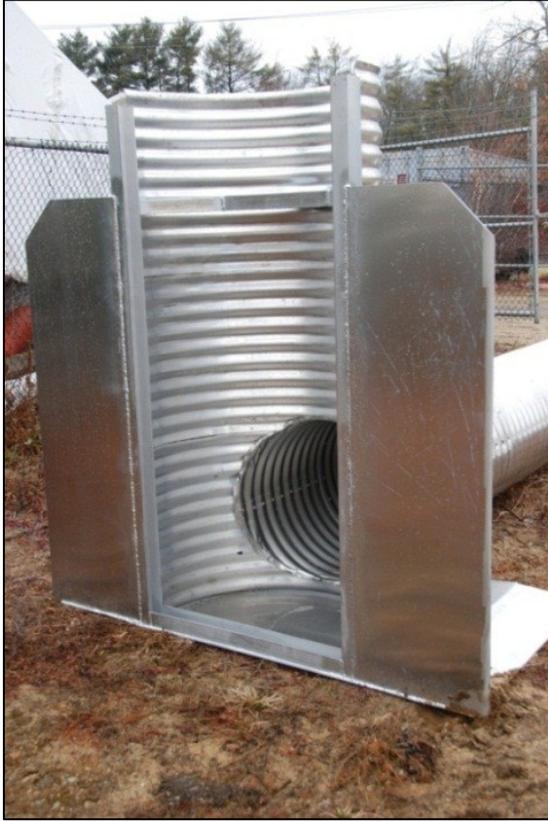
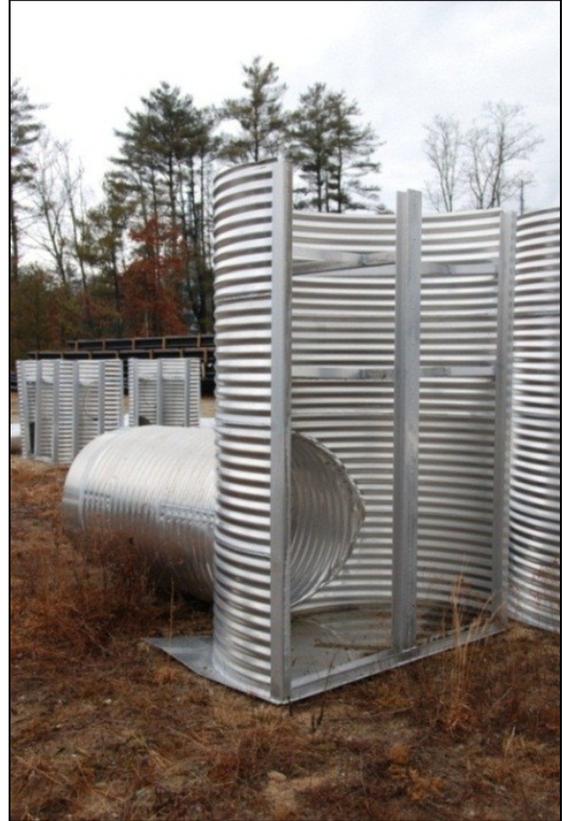
Figure 35. Aluminum water control structures manufactured by Stearns Irrigation, Inc. Wareham, MA, using Cakounas design specifications for USDA-NRCS water control structures.

Place a prefabricated aluminum water control structure within the ditch. The US Department of Agriculture, Natural Resources Conservation Service (USDA-NRCS) design is used by cranberry growers throughout Southern New England. The Stearns Irrigation, Inc. model

(Figure 35) is used extensively by cranberry growers and is made locally. The structure would be located in the lower portion of the ditch close to where it exits the Swamp through culverts beneath Wolomolopoag Street. The purpose of the water control structure would be to back up flow within the ditch. This would reduce the rate of groundwater discharge into the ditch and subsequently raise groundwater elevation within the adjacent wooded swamp.
