SHARON GREAT CEDAR SWAMP

Restoration and Revitalization

FIELD GUIDE

Atlantic White Cedar Symposium Field Trip
May 25, 2016

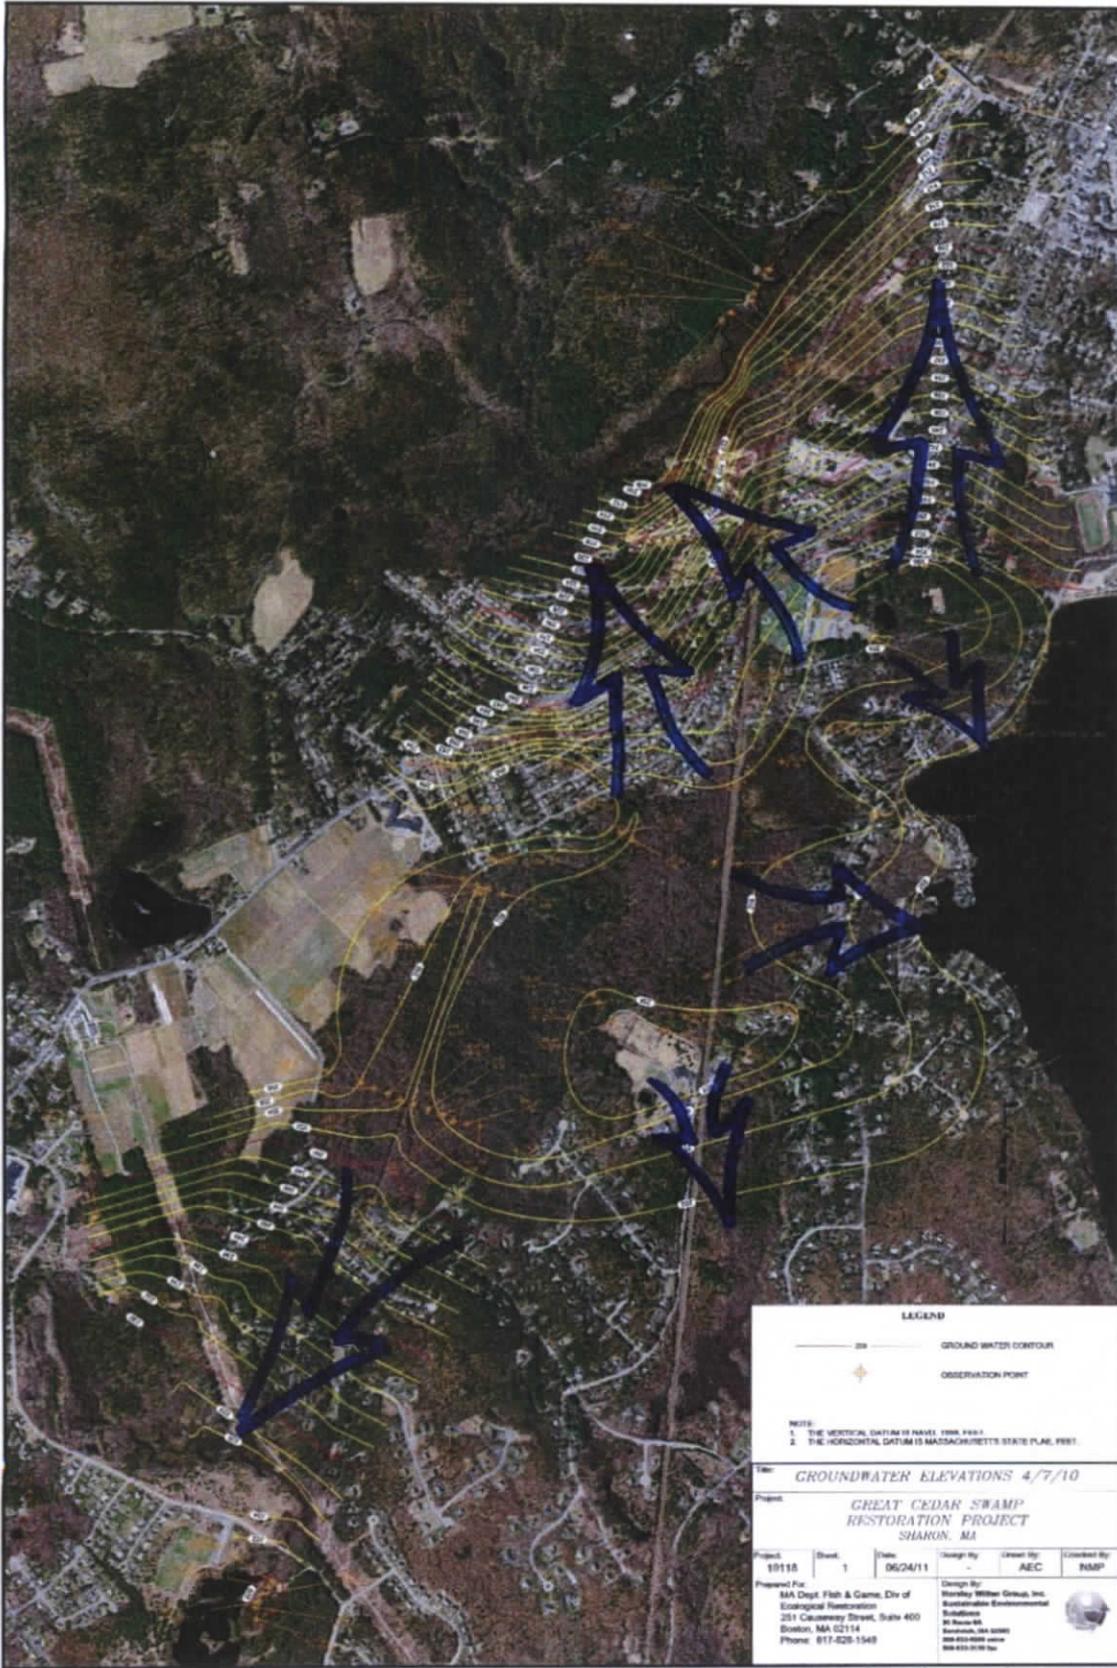
FIGURE 6 & 7. With combined Town and State funding, the Horsley Witten Group was contracted to develop a groundwater contour map of the area.

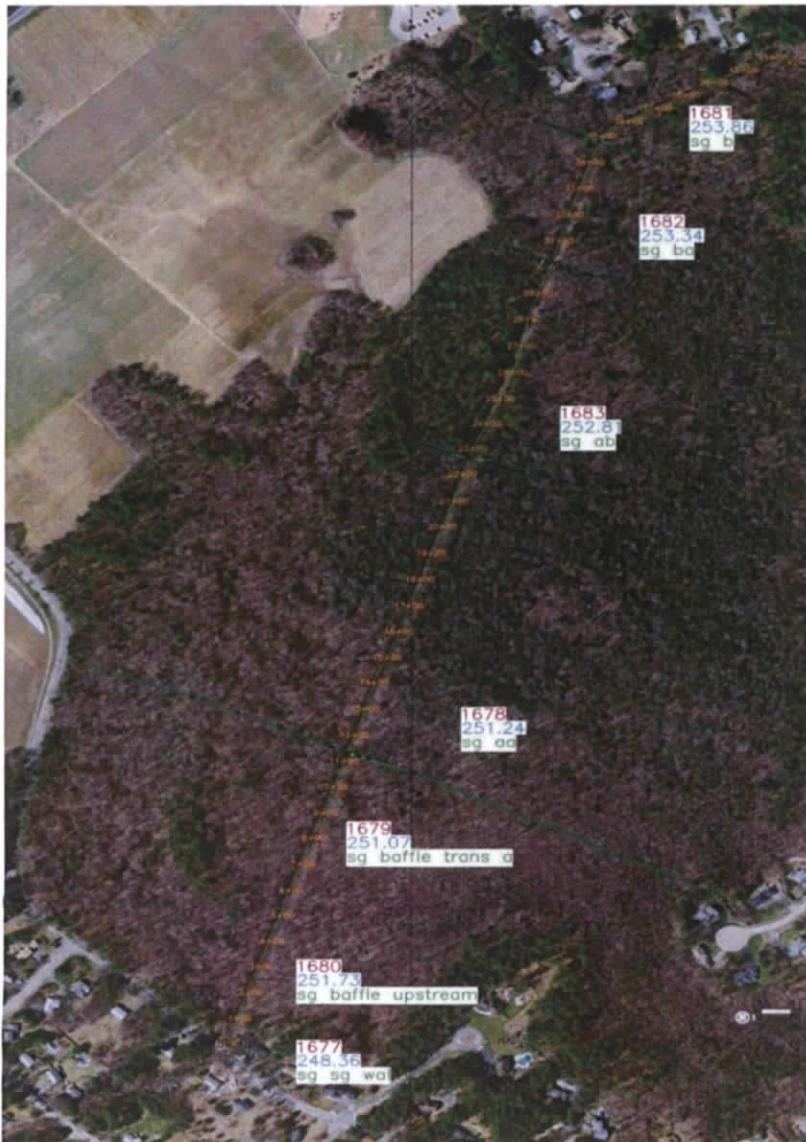
FIGURE 11. The most important concern when evaluating the feasibility of restoring the hydrology within areas of the Sharon Great Cedar Swamp was to prevent any deleterious hydrological impact on the abutting residential development (Heights Area).

To measure the impacts of the baffle within the ditch, monitoring well transects were positioned at different intervals along the length of the ditch to record groundwater elevations. In addition, stream gauges were placed within the ditch to record flow elevations

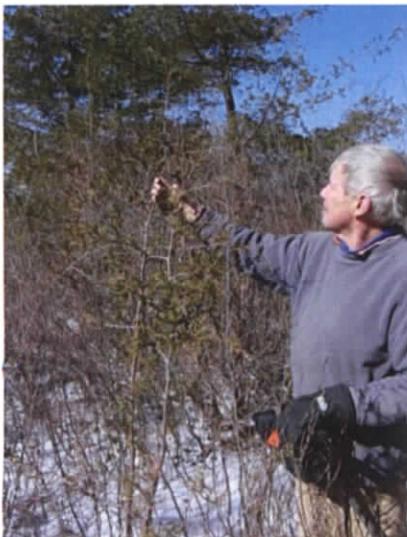
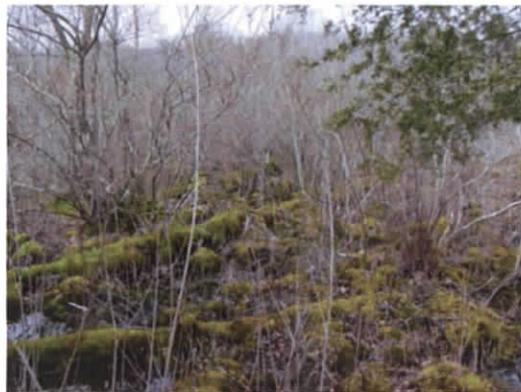
FIGURE 13. Tree counts and measurements are summarized here. Atlantic white cedar regeneration in Section 3 is evident in plot 10 (photos below).

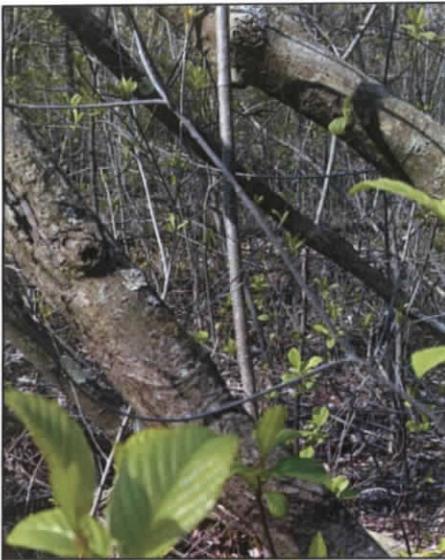
FIGURE 15. Glossy buckthorn (*Frangula alnus*) spreads near head of ditch.

INVASIVE SPECIES. Along with the loss of AWC and the increasing abundance of upland species within the swamp, several exotic invasives are spreading rapidly. Near the head of the ditch glossy buckthorn is the dominant shrub, both in Section 1 and across the rail line in Section 3. Several amur cork trees, patches of Japanese knotweed, and barberry occur along the ditch and have recently been removed. Garlic mustard is spreading north along the ditch from near Wolomolopoag Road. All of these will require control as they can have permanent impact on the AWC community. Carolyn Danforth, Peter Fletcher, and Madison Meister have assisted with invasives control.

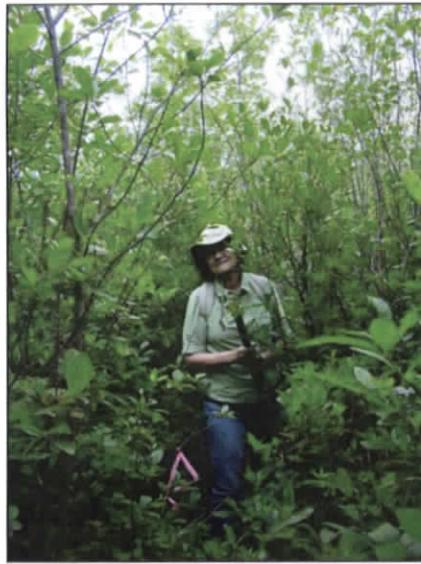
FIGURE 16. Glossy buckthorn overtops sweet pepperbush in Section 3.

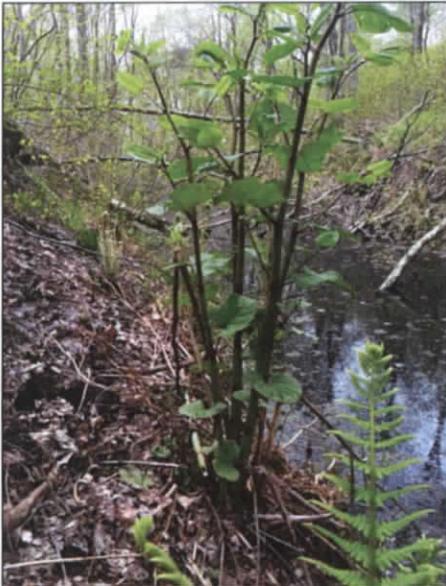
FIGURE 17. Japanese knotweed (*Fallopia japonica*) takes hold along the ditch bank

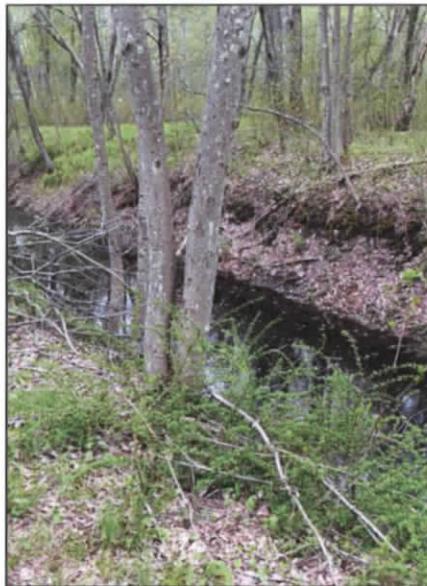
FIGURE 18. Barberry (*Berberis thunbergii*) on the ditch berm.

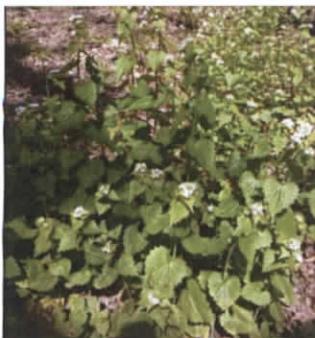
FIGURE 20. Garlic mustard (*Alliaria petiolata*) spreads up from near Wolomolopoag Road.
