OXBOW ASSOCIATES, INC.

**Professional Botanical Services Summary
Lake Massapoag Invasive Aquatic Plant Control Project (2018)
Sharon, MA**

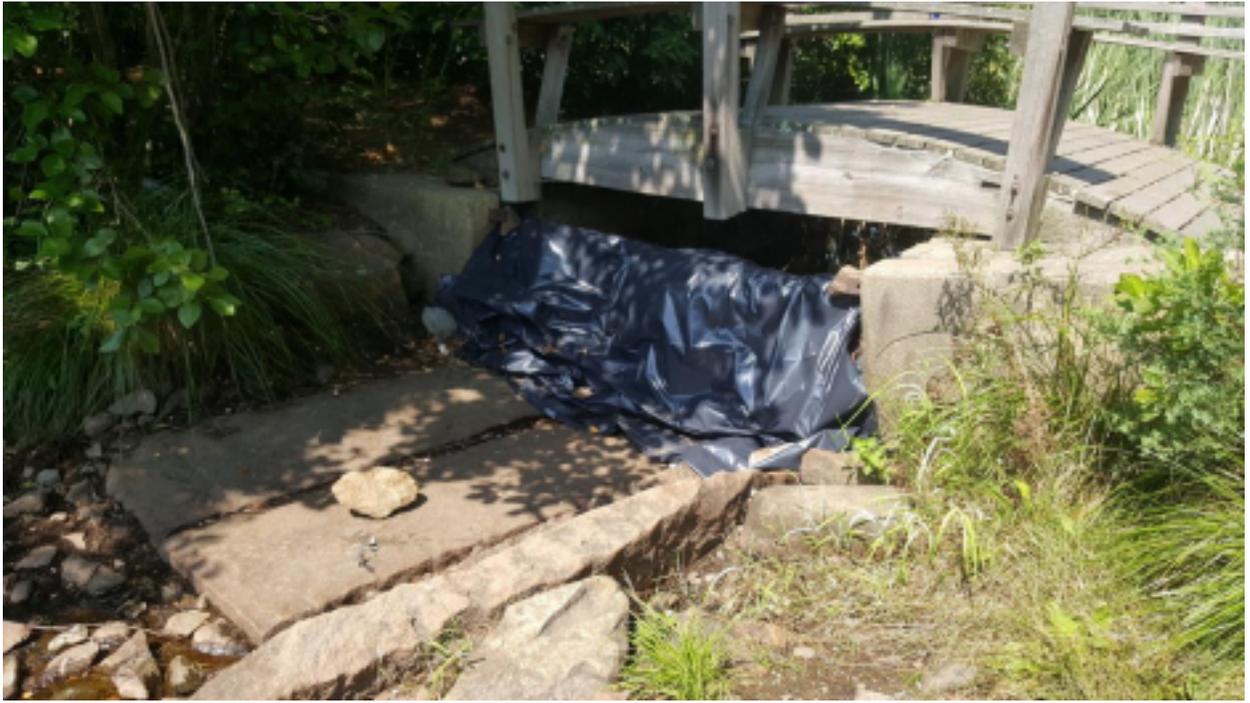
Figure 1. The non-permeable barrier in place at the lagoon spillway (08/05/18).

On July 16, 2018 A. Weise conducted a pre-project site inspection to evaluate lake water level, overall conditions, and placement of protective barriers prior to herbicide application planned for the “lagoon” area. The staff gage read approximately 9.8 ft at the lake outlet (northeast) and up-stream sources to the lagoon were dry. Flow boards installed at the lagoon spillway sufficiently held back flow and a non-permeable plastic barrier was added for additional protection (Fig. 1). In addition, a haybale barrier was been installed around the outer edge of cove where toothcup was previously documented (Fig.2). The bales were covered in long sheets of thick plastic and were staked through the bales into the substrate to anchor the barrier in place. A staff gage was placed inside the cove to monitor interior water levels (Fig. 3a).

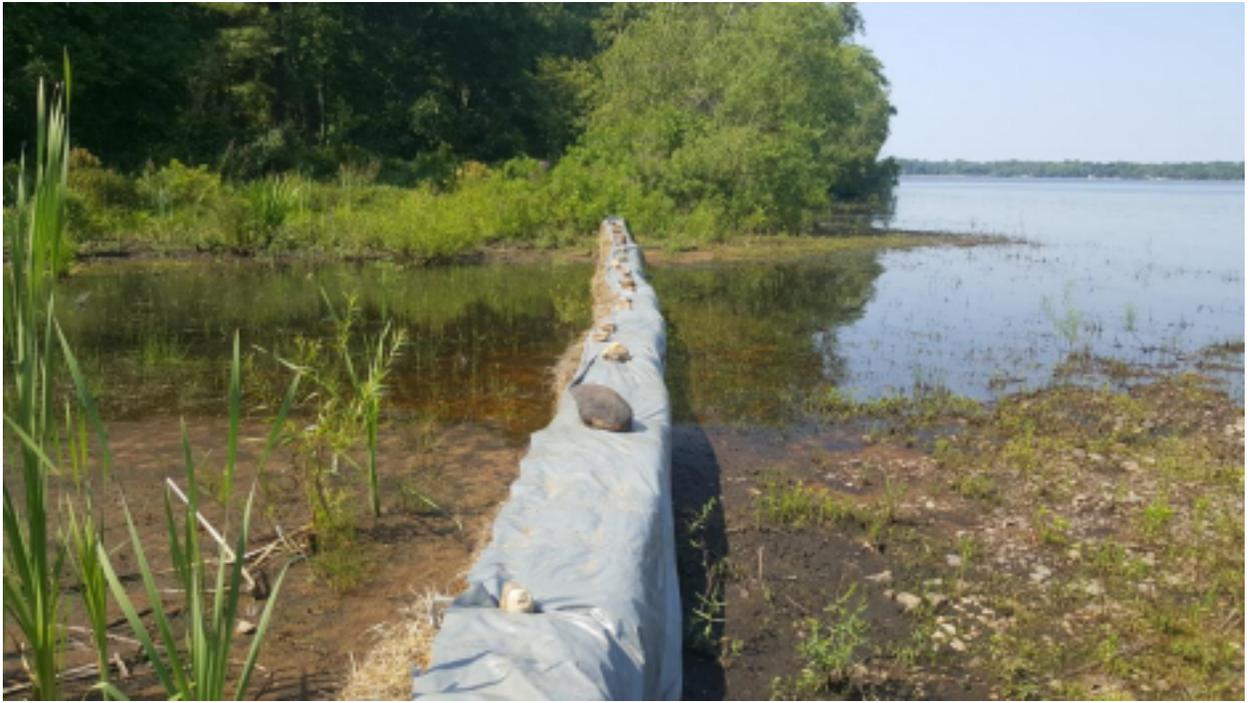
Figure 2. Protective haybale barrier, note the degree of exposed shore area (08/05/18).

(purple to transparent-colored vegetation) from the herbicide (Fig 4). The cove water level had dropped 3.5 inches from the July 16 inspection, exposing sections of the cove and lake shore (Fig. 2 & 3b). Water around the barrier was hot to the touch (~100°) but appeared to have no effect on the aquatic and emergent vegetation. Several small plants resembling toothcup were observed on the exposed shores; unfortunately, identification could not be verified at the time due to lack of fully developed leaves, flowers/fruits.

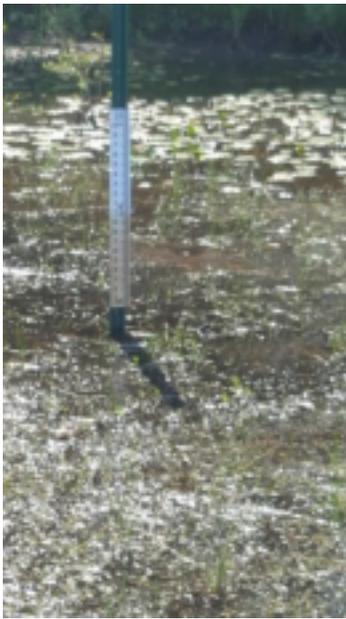
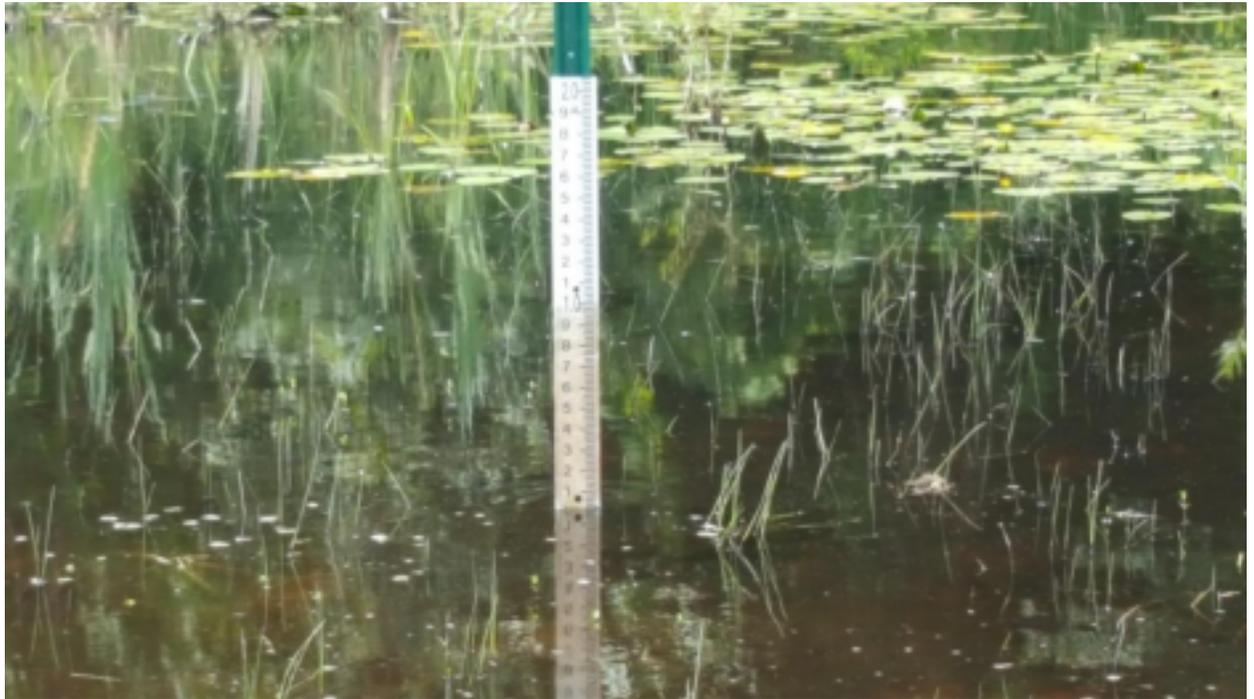
Figure 3(a) water level gage set to “zero” the day the barrier on 07/16/2018; (b). water level roughly 3.5 inches below the previously level on 08/05/18.

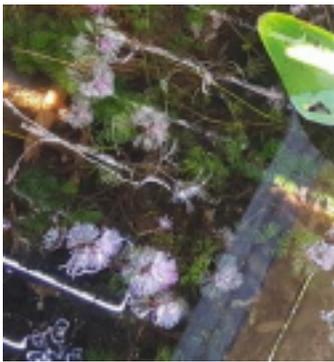
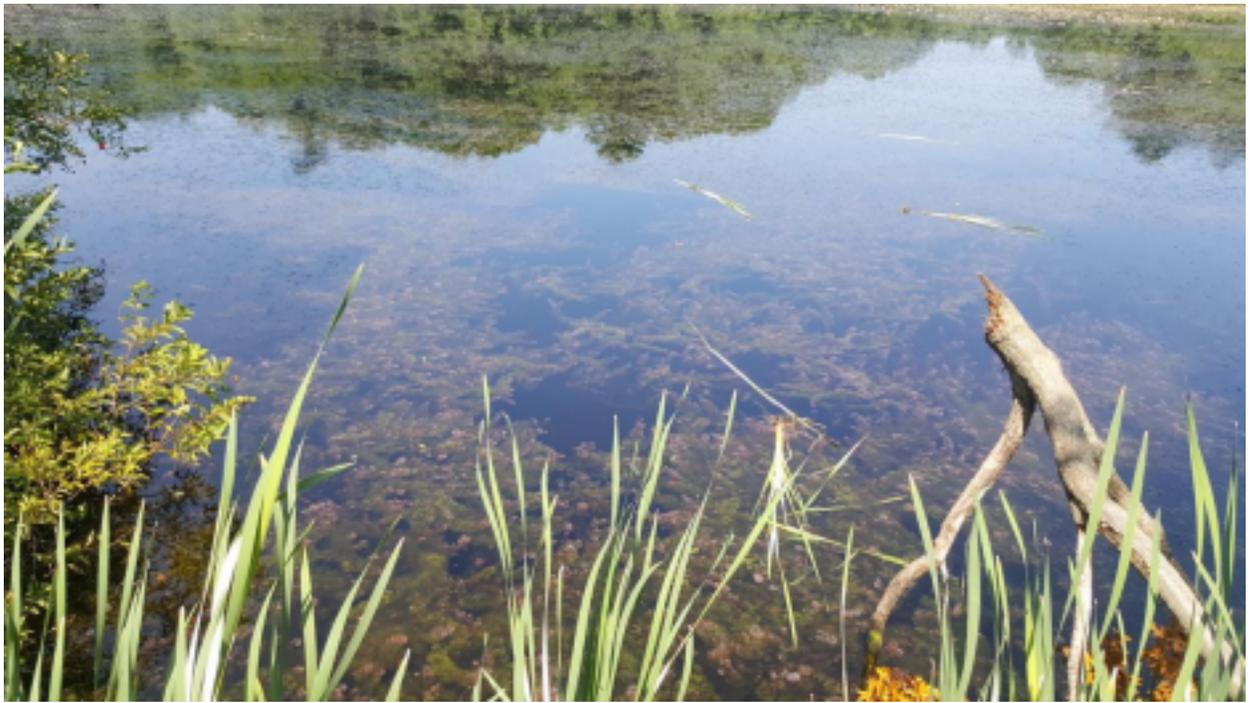
Figure 4. (a) Dense fanwort in the lagoon area showing signs of stress from herbicide absorption with close up of purple-colored vegetation (b).

August 6, Amanda conducted a mid-treatment inspection per agreement with NHESP. The lake level was approximately 9.7 ft and up-stream sources to the lagoon again remained dry. At this time, the fanwort (*Cabomba caroliniana*) within the lagoon showed evidence of decline

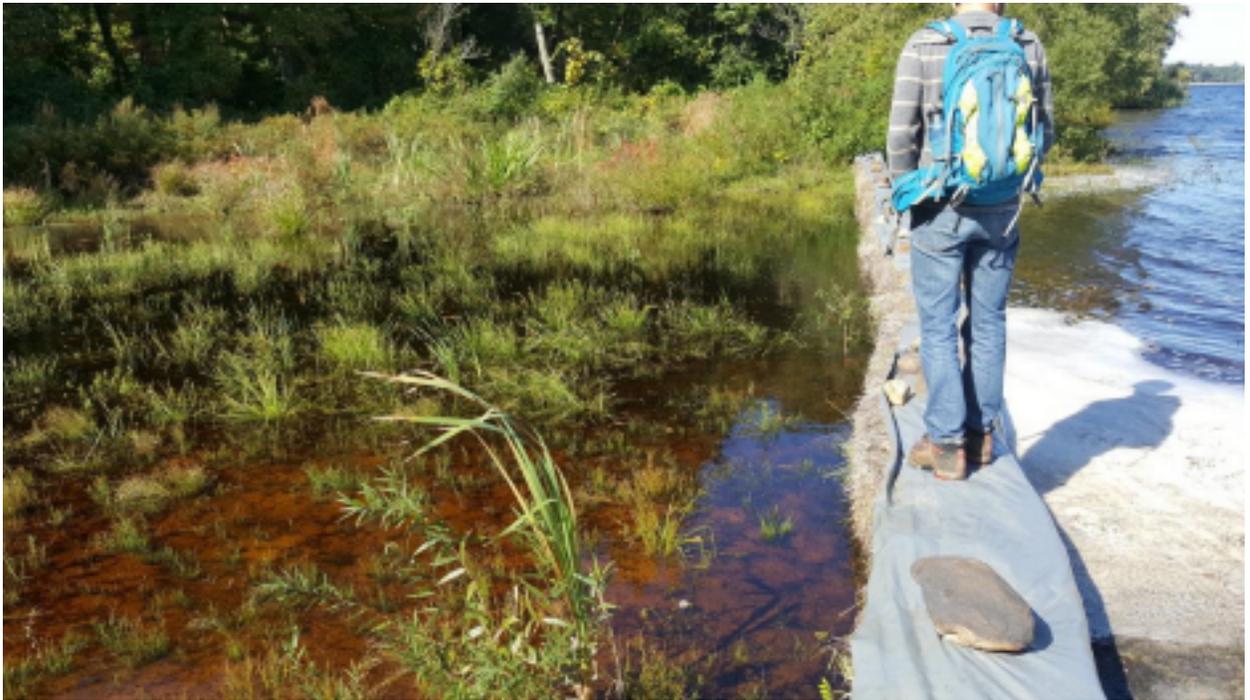
Figure 5. water level in the cove on 10/5/18; note the lack of exposed shore.

October 5, A. Weise returned to the site to complete the final inspection and toothcup survey. At this time the herbicide application was complete and the lagoon spillway was once again open and flowing. The lake level was approximately 9.8 ft and up-stream sources to the lagoon were dry but showed evidence of somewhat recent water flow, likely from heavy rainfall that occurred in mid-September. The water level of the cove had increased, returning to gage level zero (a 3.5-inch increase from Aug. 6) (Fig. 5).

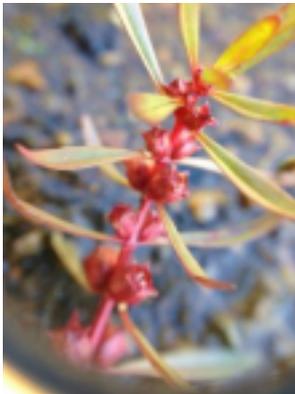
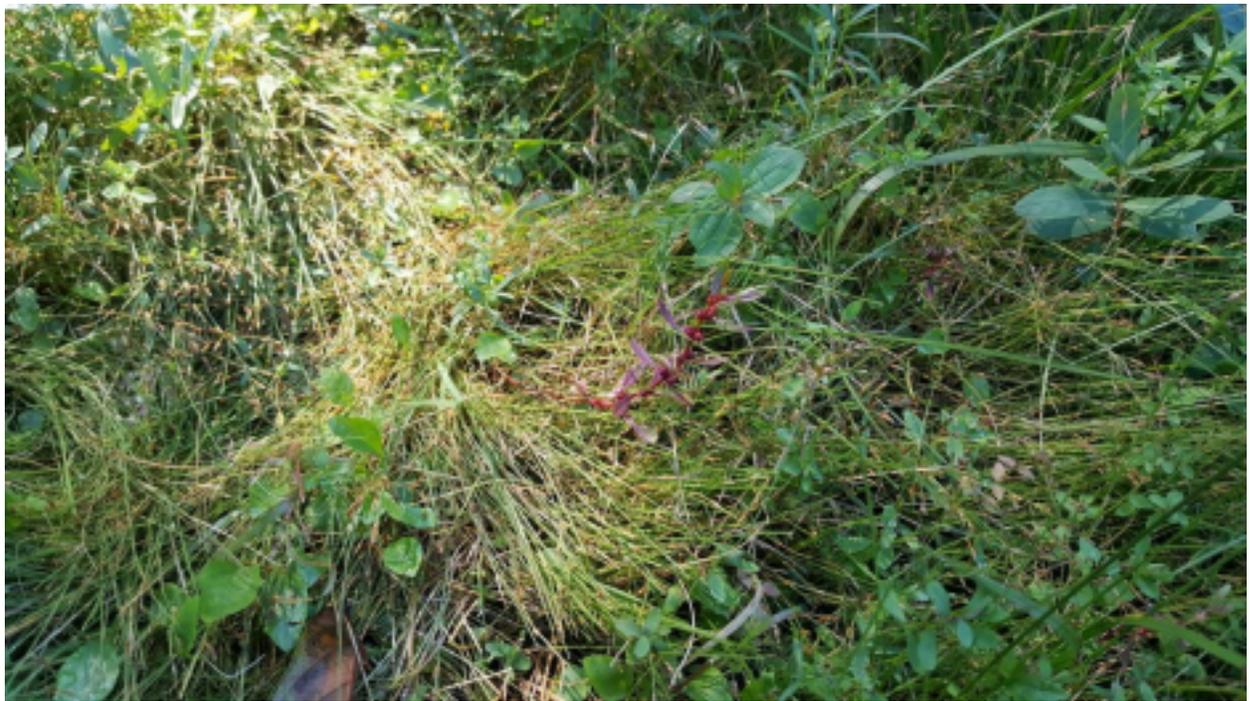
Figure 7. (a) An individual toothcup plant in a shaded back-area of the cove with (b) a closeup of the maturing seed capsules (10/05/18).

up to the north-easternmost shore of the cove. Plants were most abundant near the cove mouth and were observed on either side of the haybale barrier. Near the mouth, plants occur on shore as well as in shallow water (3-5 inches deep). Plants primarily occurred in full sun although approximately 7 plants were found inside the cove along the southeast edge near the shaded tree line (Fig. 7). Plants were both single stemmed and multi-stemmed – the latter demonstrating a branched, prostrate form. All plants, regardless of size, possessed capsules with unripe seeds (Fig. 7).
