DIAGNOSTIC/FEASIBILITY STUDY
LAKE MASSAPOAG
SHARON, MASSACHUSETTS

March 1984

Prepared For
Town of Sharon
Sharon, Massachusetts

Prepared By
IEP, Inc.
Northborough, Massachusetts

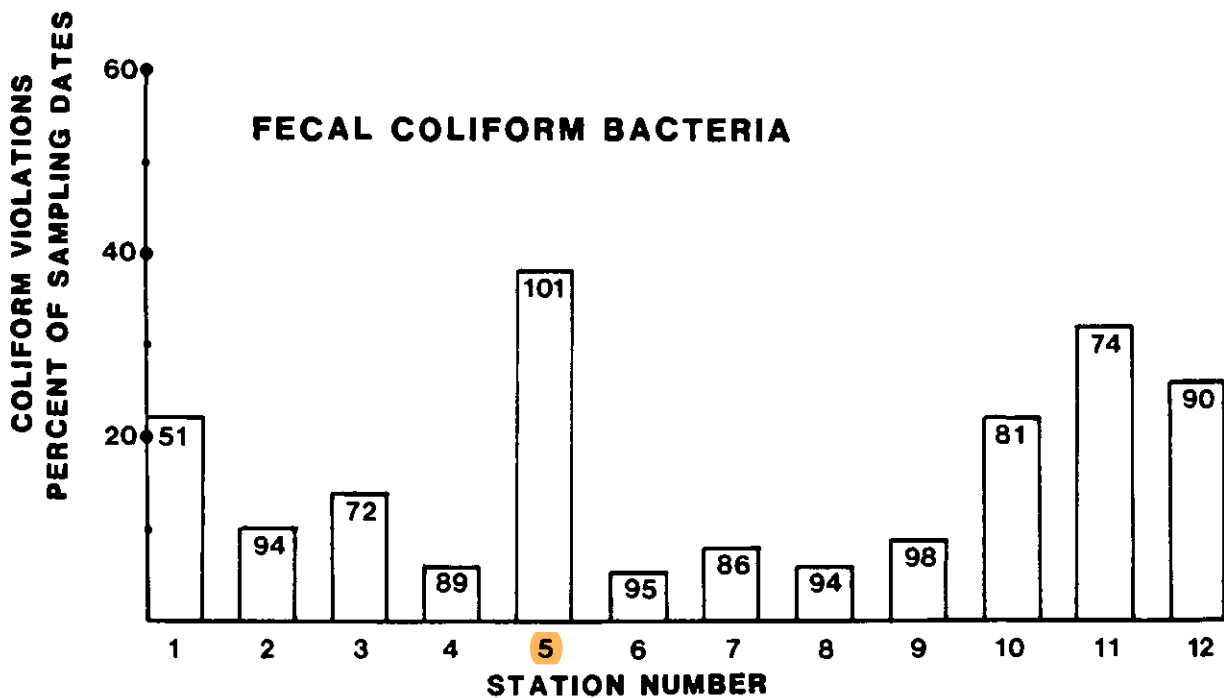
FIGURE 14 RESULTS OF SURFACE WATER QUALITY SAMPLING: LAKE MASSAPOAG
TOWN OF SHARON

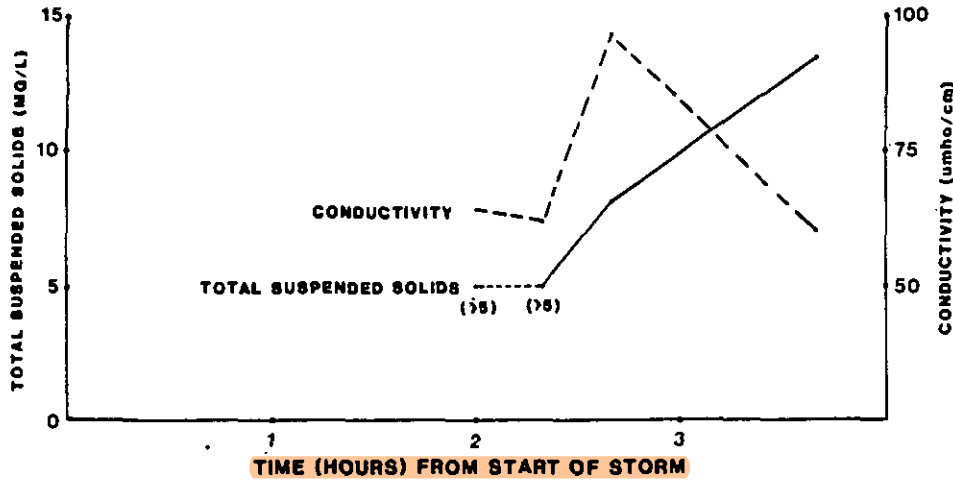
Figure 16. Pollutographs
 from storm sampling results: Lake Massapoag
 8/25/82 storm event, station 9

POLLUTOGRAPH OF 8/25/82 STORM EVENT
 BACTERIA STATION 9

POLLUTOGRAPH OF 8/25/82 STORM EVENT
 SOLIDS STATION 9

POLLUTOGRAPH OF 8/25/82 STORM EVENT
 NUTRIENTS STATION 9

Due to the intermittent, low intensity pattern of the August event, prediction of the time of concentration was difficult. Stormwater sampling began within an hour of the start of precipitation on August 25, and continued an hour or more after rainfall had stopped. Flow measurements show that runoff remained steady or gradually increased during the sampling period. Pollutographs (Figure 16) developed from the time-variable grab samples taken at station 9 show a general increase in fecal coliform, suspended solid concentrations, and nutrient concentrations. Conductivity measurements show a peak about 2 1/2 hours after the start of the storm event.
