## Report of Findings

**SHARON PUBLIC LIBRARY**  
**PROPERTY CONDITION ASSESSMENT**  
**ENERGY AUDIT**  
**FUTURE USE STUDY**

**RBC File No: 100027408**

**SHARON PUBLIC LIBRARY**  
**11 NORTH MAIN STREET**  
**SHARON, MA 02067**

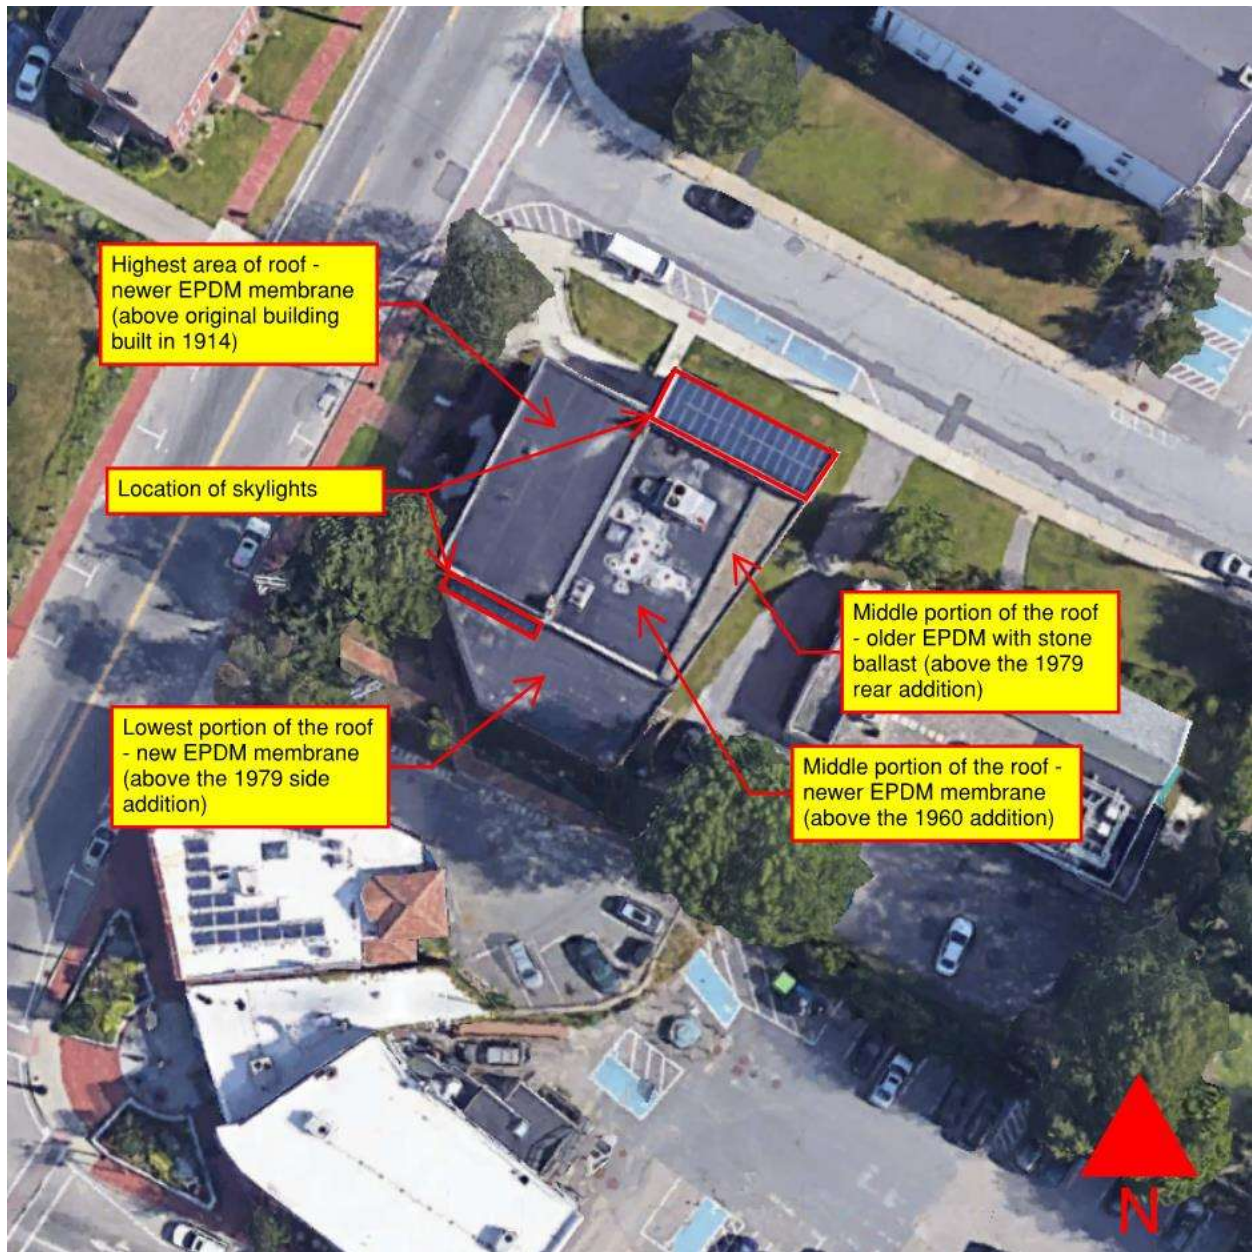
Figure 2 - Google Earth map 3-1: Building roof with notes (image taken prior to membrane replacement)

The building footprint was covered by a combination of a three-level, low-sloped roof system and skylights **(Figure 2)**. The highest level of the roof covered the original 1914 building footprint; the middle level covered the 1960 addition and the rear portion of the 1979 addition; and the lowest level of the roof included the two 1979 side additions. The roofing consisted of a fully adhered, ethylene propylene diene monomer (EPDM) single-ply membrane that covered all the roof areas except the roof covering on the rear 1979 addition consisted of a ballasted EPDM roof covering **(Photograph 16)**. All three levels of the roof drained toward the existing roof drains. There were no existing emergency overflow drains or scuppers. Based on our review of available documents, the roof membrane and portions of the decking had recently been repaired/replaced to stop reported ongoing leaks. According to our conversation with Matthew Baldassari, Facilities Manager, since the repairs, the roofs have not shown signs of leaking.

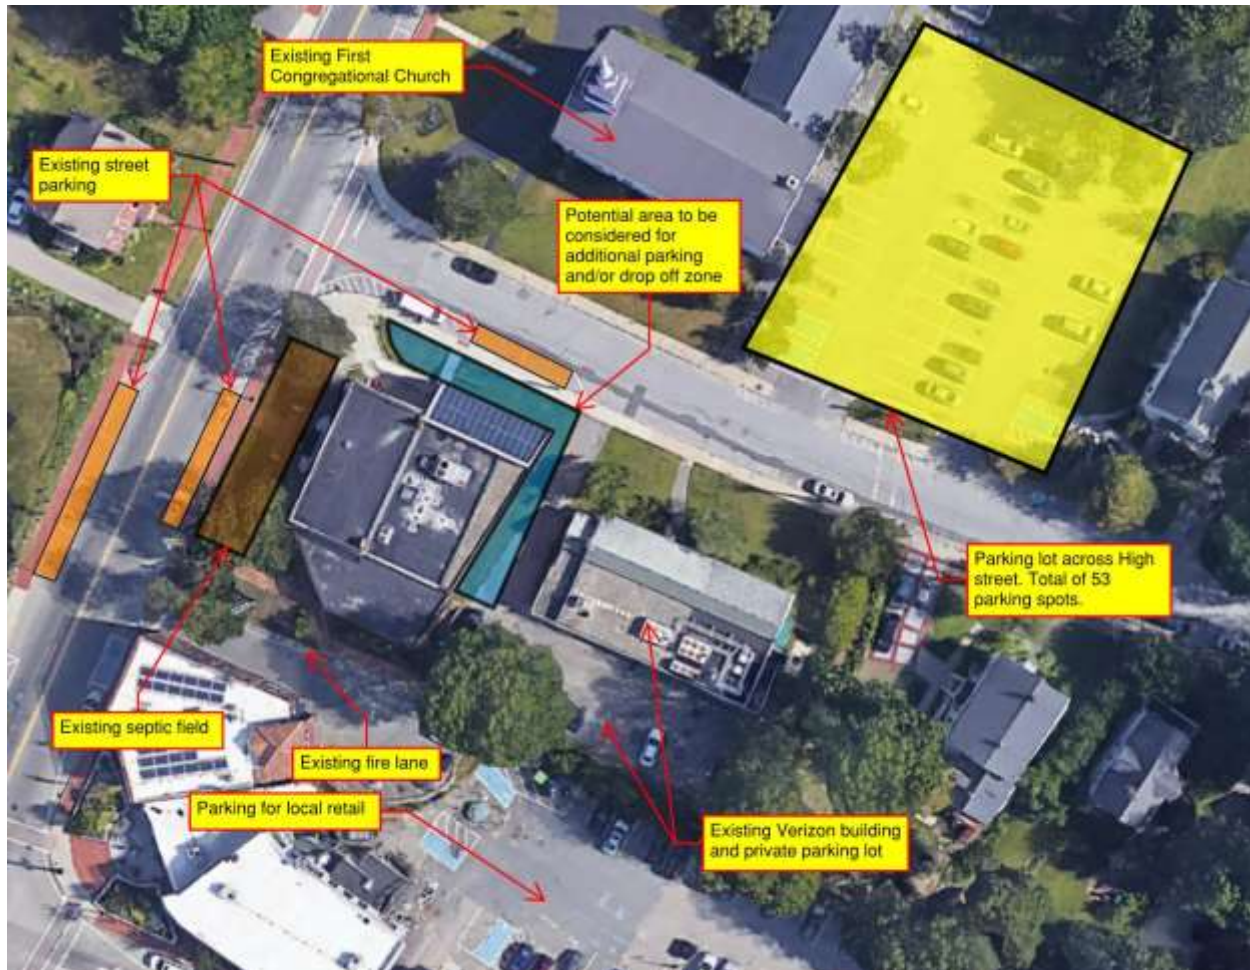
Figure 4 – Existing and potential new parking

Designated parking spaces are required for the apartment units. In this case, since there is no on-site parking currently available, we suggest the Town of Sharon propose designating a section of the parking lot (owned by the Town) across High Street that would be reserved for the future tenants (**Figure 4**). This proposal would have to be reviewed and approved by the zoning department as an acceptable alternative for not having directly on-site parking. For ten apartment units, ten parking spaces would be required including one ADA accessible space. It is our understanding that the First Congregational Church uses the adjacent parking lot on Sundays only. Currently, it is

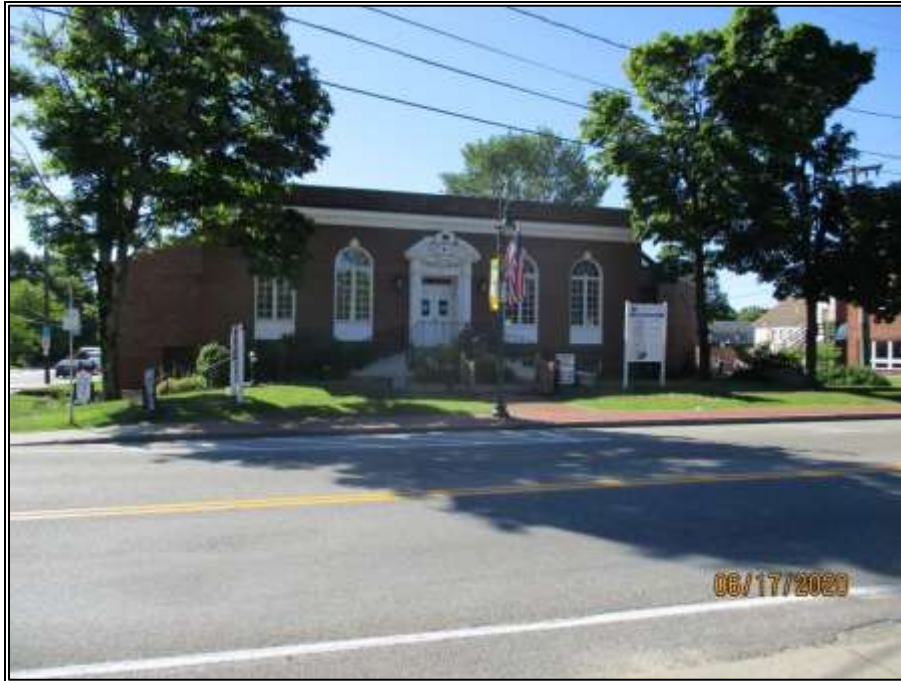
**Photograph 1**

Pedestrian access was provided to the building via entrances on the northwest and north sides of the building. The main entrance located on the northwest side (facing North Main Street) had stairs leading up to the upper level and was not an ADA compliant entrance (**Photograph 1**). The secondary entrance on the north side (facing High Street) had stairs and a ramp leading down to the lower level that was partially below ground; this entry appeared to be ADA complaint (**Photograph 2**). Existing paved sidewalk ran along the

View of the front entrance on the northwest side at the upper floor of the original 1914 building.

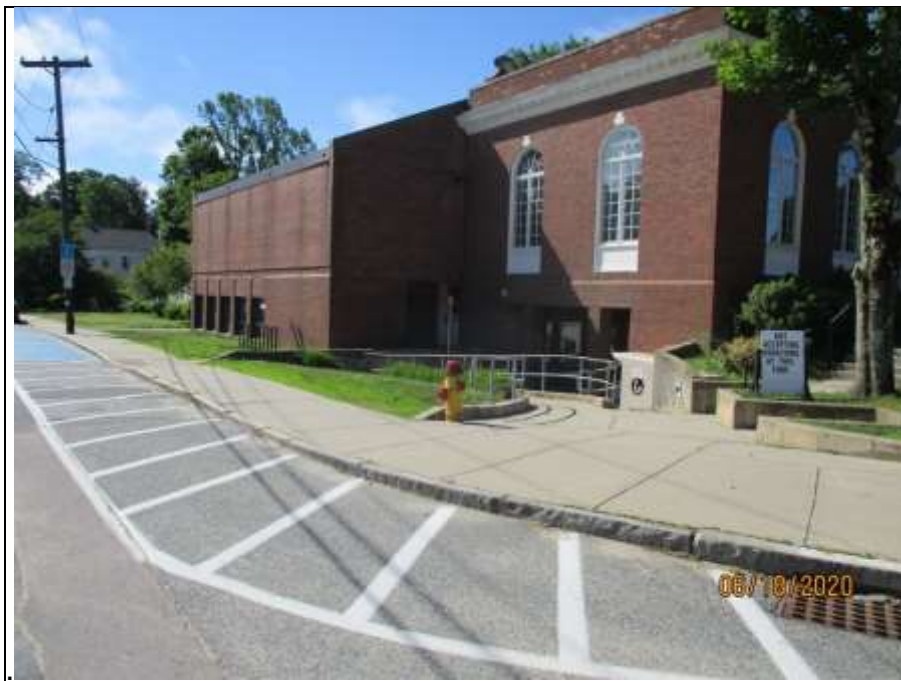
**Photograph 2**

View of the secondary entrance on the north side at the lower level of the original 1914 building.

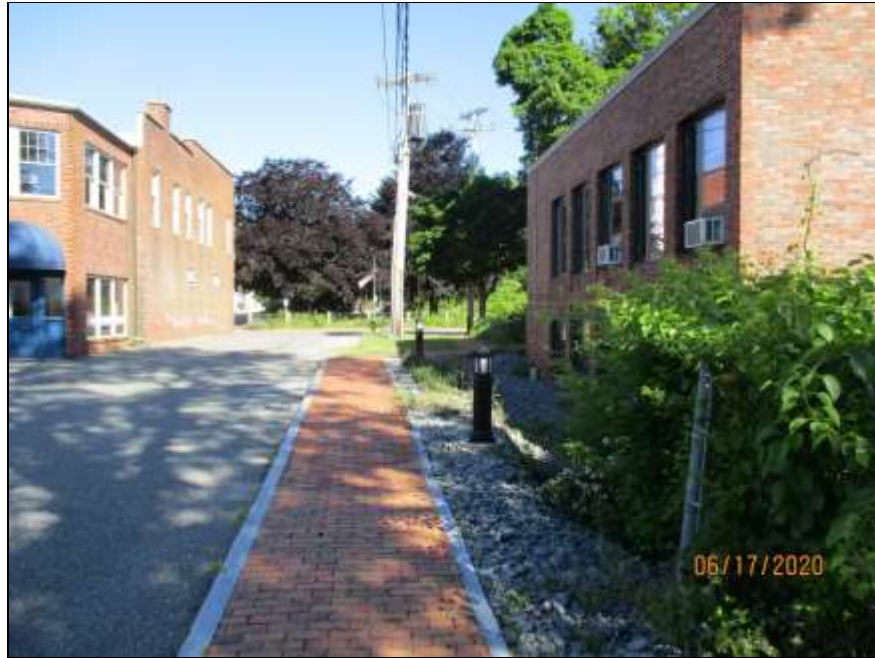
**Photograph 3**

south portion of the building connecting to the network of sidewalks on the Property **(Photograph 3)**. There were two non-ADA compliant emergency exit doors, one on the north side from the exit stairway and another on the southeast side at the back of the building **(Photograph 4)**.

Partial view of the southwest side of the 1979 addition and the fire access drive from North Main Street.

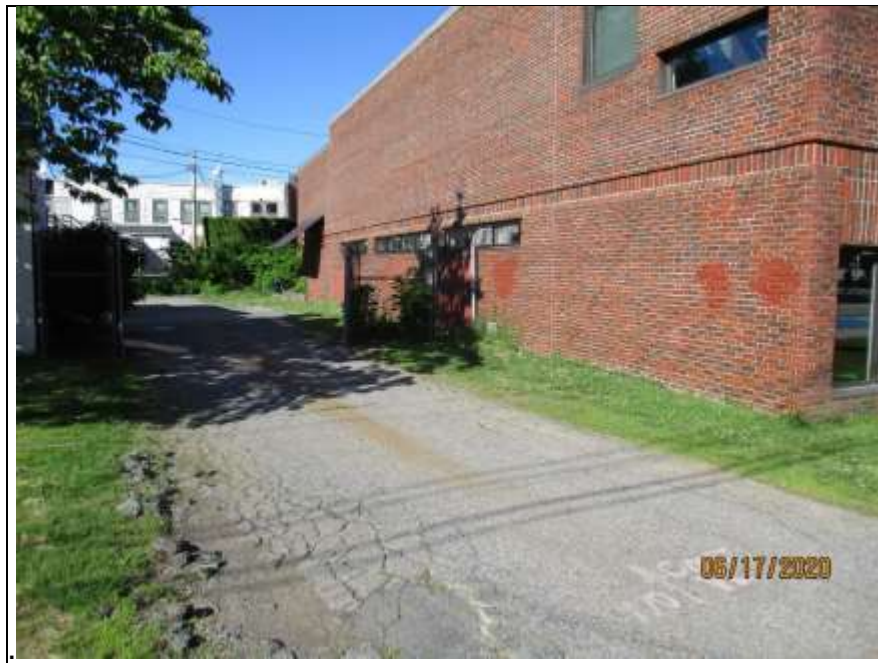
**Photograph 4**

View of the southeast side of the 1979 addition and rear access drive.

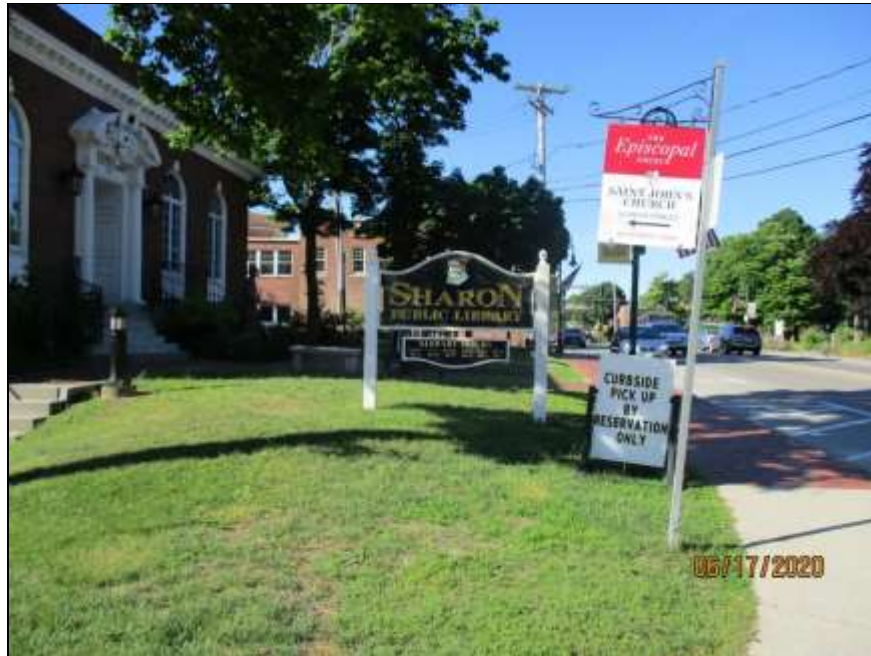
The Property contained a monument sign **(Photograph 5)** for the library at the north side of the Property and a bronze statue of Deborah Sampson **(Photograph 6)** in front of the main entry. The statue was fronted and flanked by paved sidewalks as well as two sit-down benches. There was landscaping behind the statue and in front of the curved entry stairs consisting of various mature bushes **(Photograph 7)**.

**Photograph 5**  
Monument sign of the Sharon Public Library.

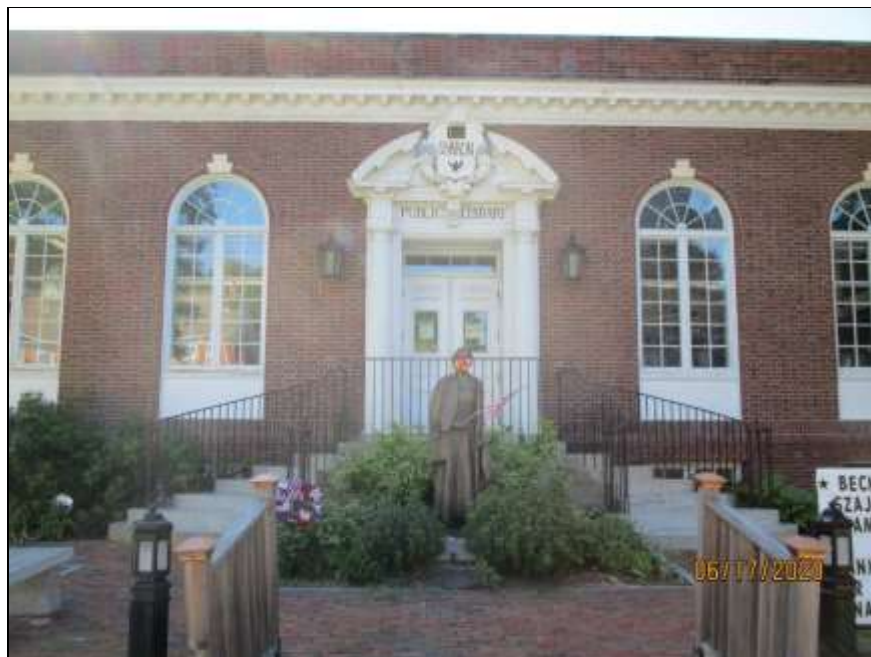
**Photograph 6**  
Bronze statue of Deborah Sampson at front of the main entry.

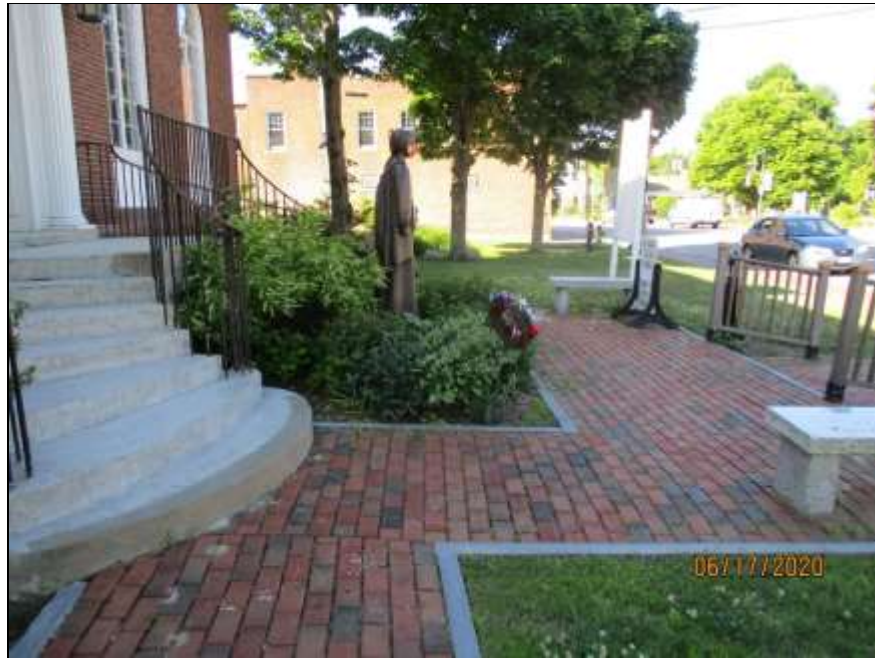
**Photograph 7**

Existing staircase to the main entry surrounded by mature landscaping.

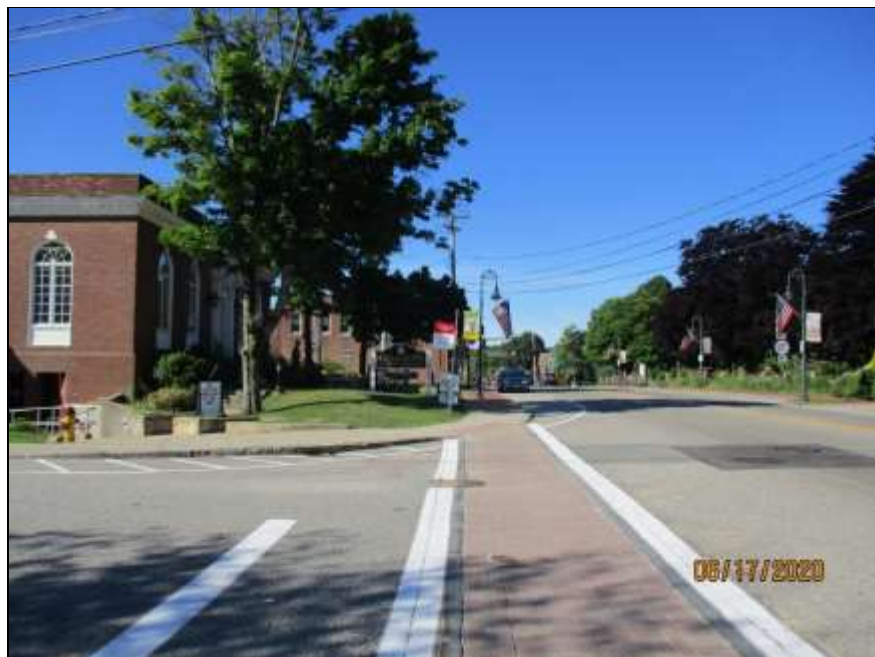
**Photograph 8**

Site lighting was provided by two light poles along North Main Street and pathway lights along the paved sidewalks of the Property **(Photograph 8)**. There was additional wall mounted lighting on the building exterior at the entry doors that appeared to be in working condition.

Site lighting was provided by streetlight poles and light bollards along the paved walkways.

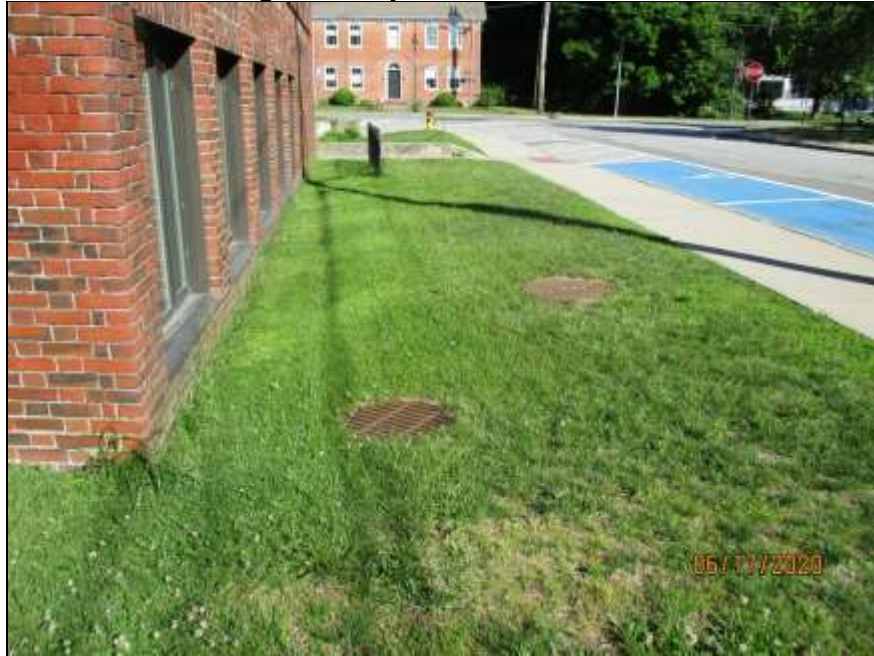
**Photograph 9**

Stormwater was collected in surface-recessed grated catch basins and conveyed to the underground stormwater management system.

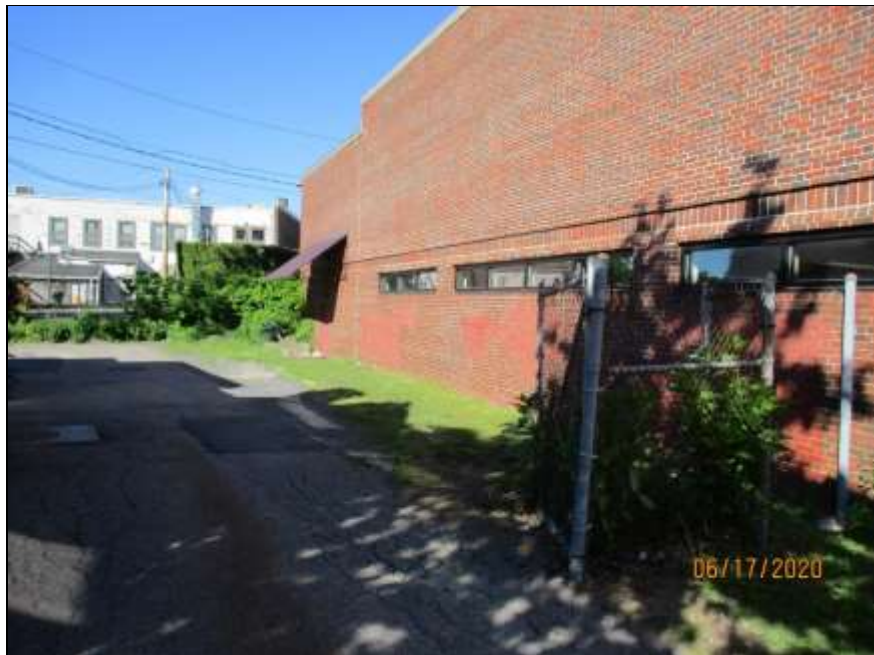
**Photograph 10**

There was a chain-link fence, gate, and asphalt roadway at the rear of the building that was shared with the neighboring Verizon building and used mostly for loading purposes at the back door **(Photograph 10)**.

The chain-link fence, gate, and asphalt roadway at the rear of the building observed.

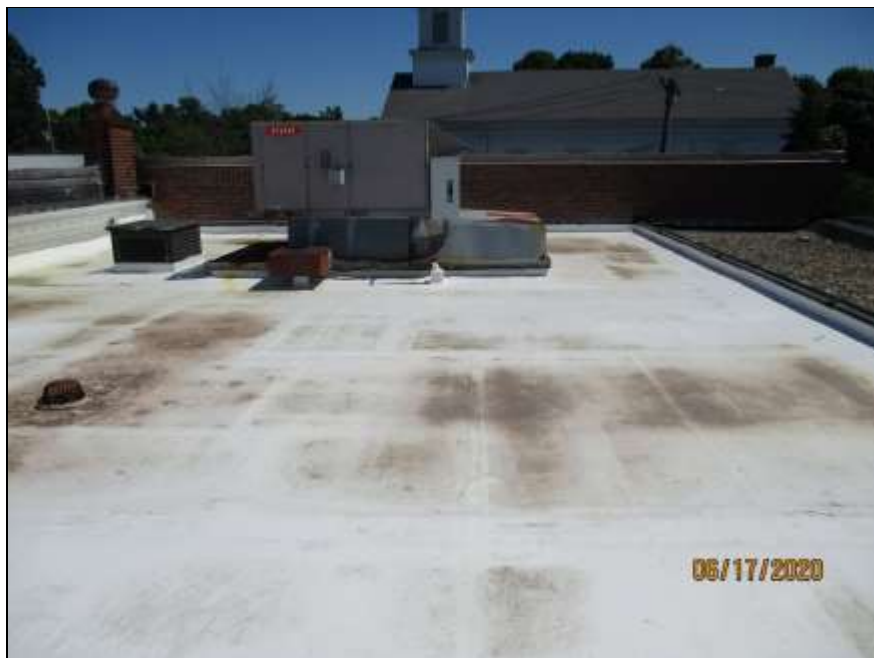
**Photograph 16**

Recently installed EPDM roof membrane and older EPDM membrane with stone ballast over the rear portion of the 1979 addition.

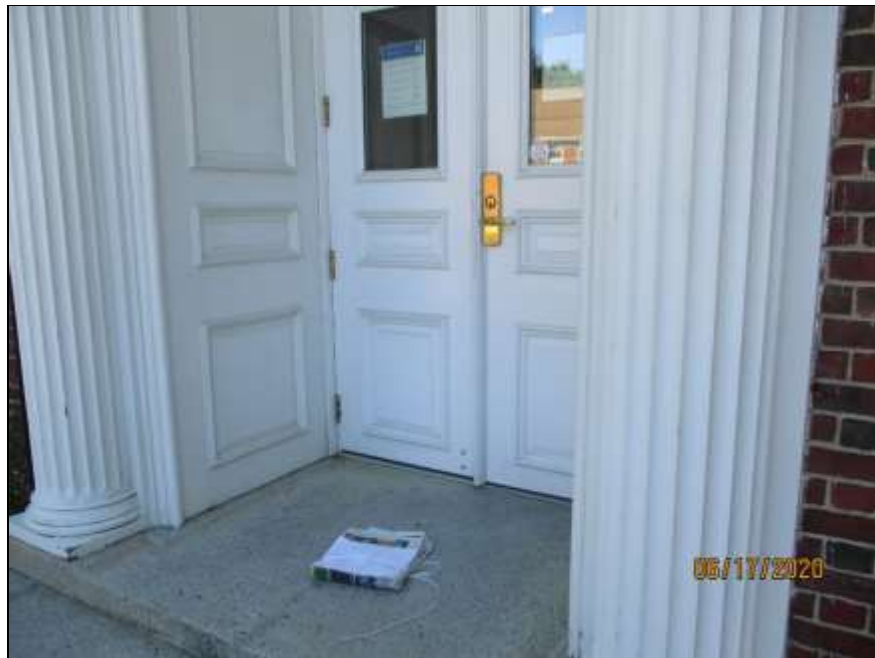
**Photograph 22**

Front portico and entry doors.

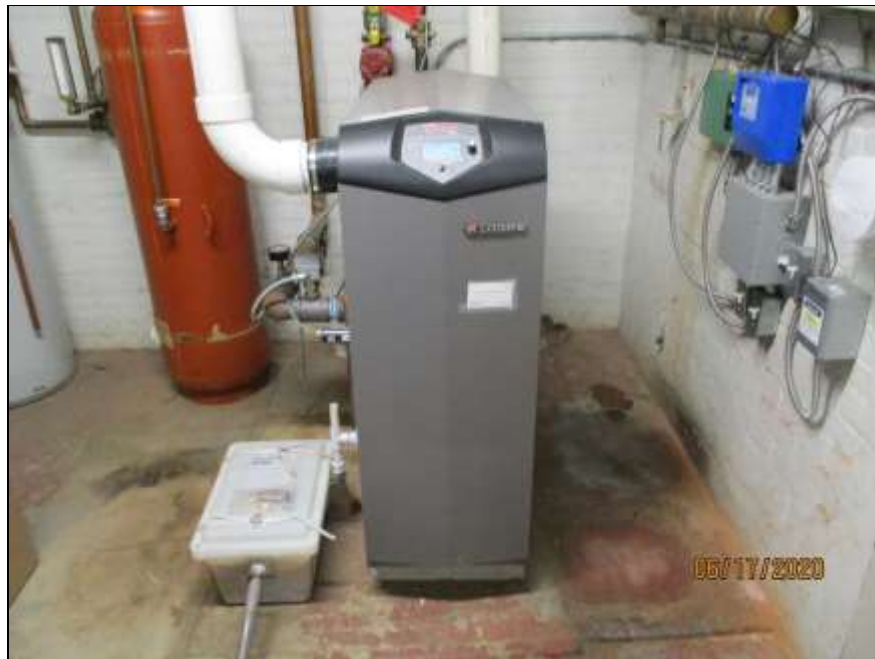
**Photograph 25**

Recently installed Knight XL Commercial condensate gas fired boiler with Smart System controls.

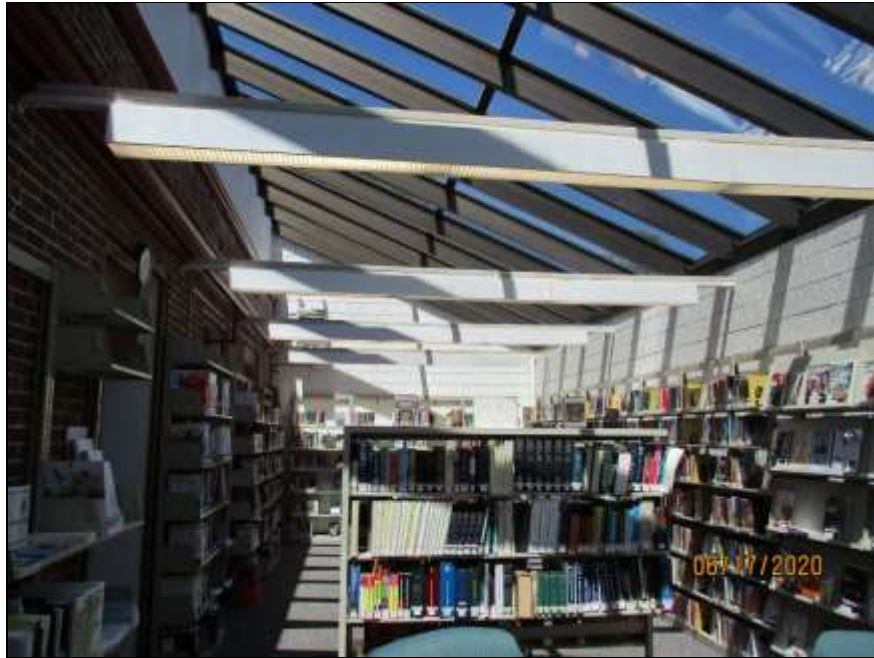
**Photograph 27**

Interior area under large skylight.

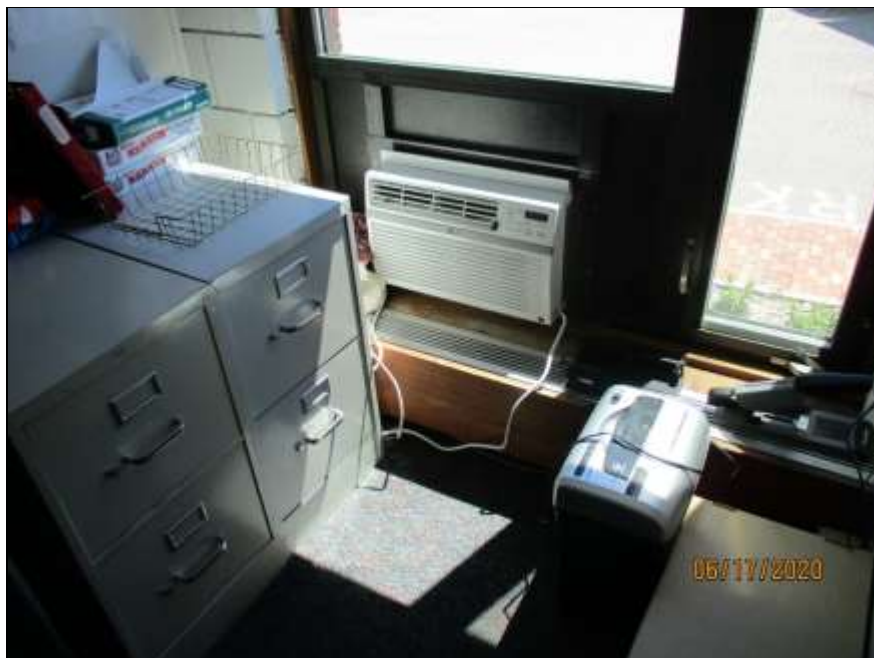
**Photograph 28**

Window AC unit observed inside the upper level office room.

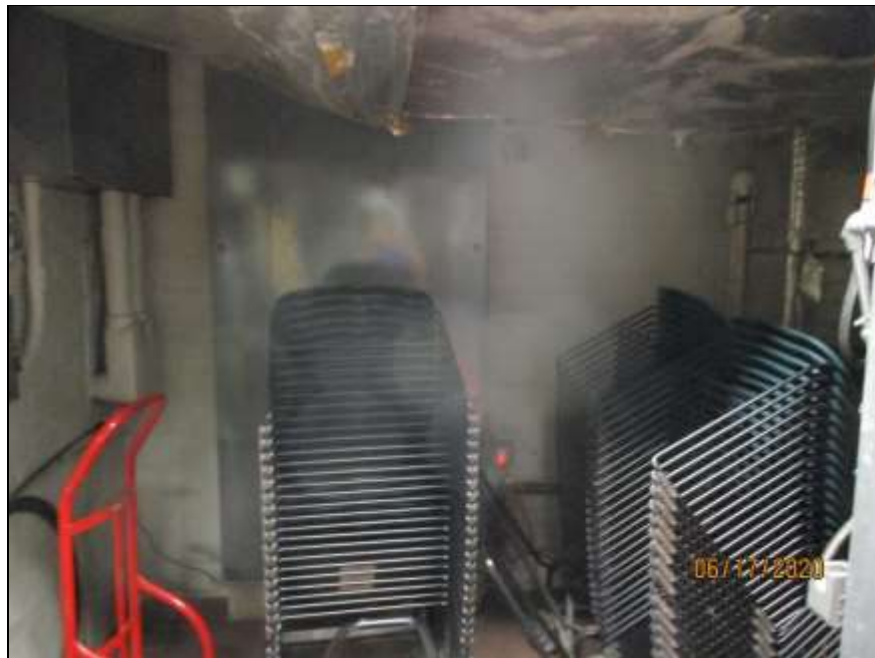
**Photograph 30**

Panelboards were primarily rated at either 225-amps, 120/208-volts and 600-amps, 120/208-volts. There was one main panelboard in the electric room (**Photograph 30**) and two other panelboards in the public areas of the building, one on each floor.

Main electrical panel inside mechanical/electrical room.

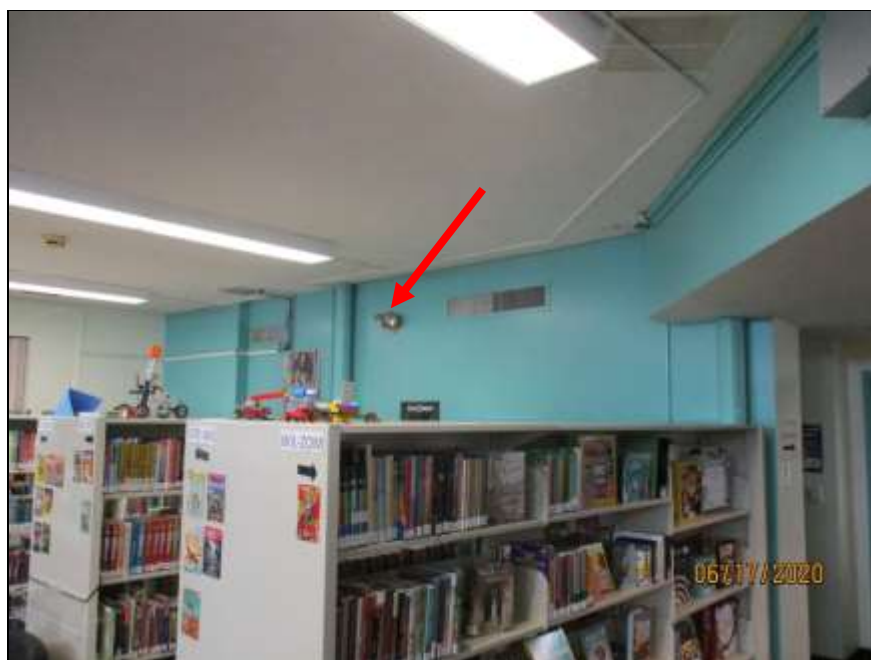
**Photograph 32**

Location of wall mounted emergency egress light in lower level.

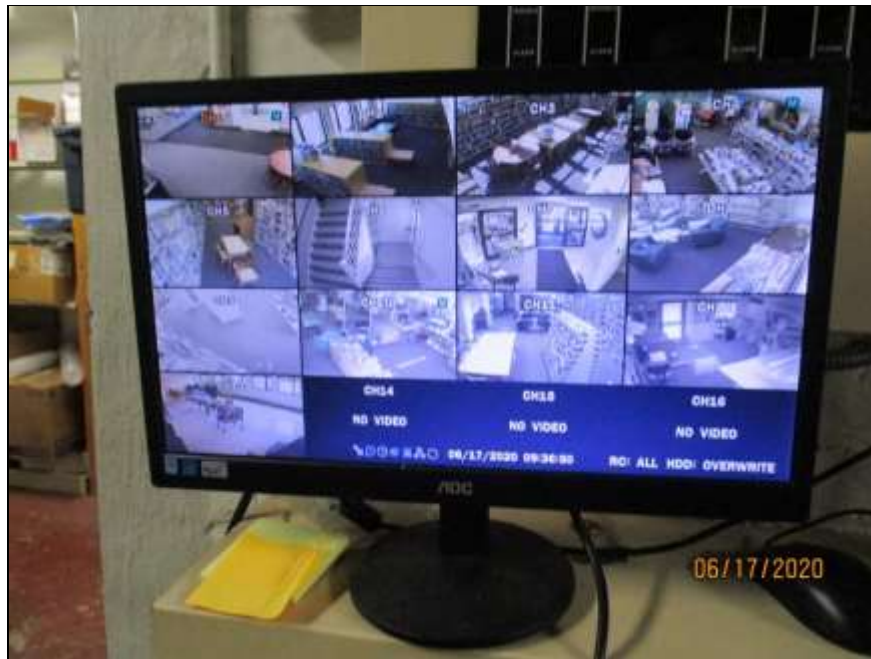
**Photograph 33**

The Property was protected by electronic security systems consisting of security cameras with a digital video recorder (**Photograph 33**). There were security cameras mounted

Security cameras monitored from mechanical/electrical room.

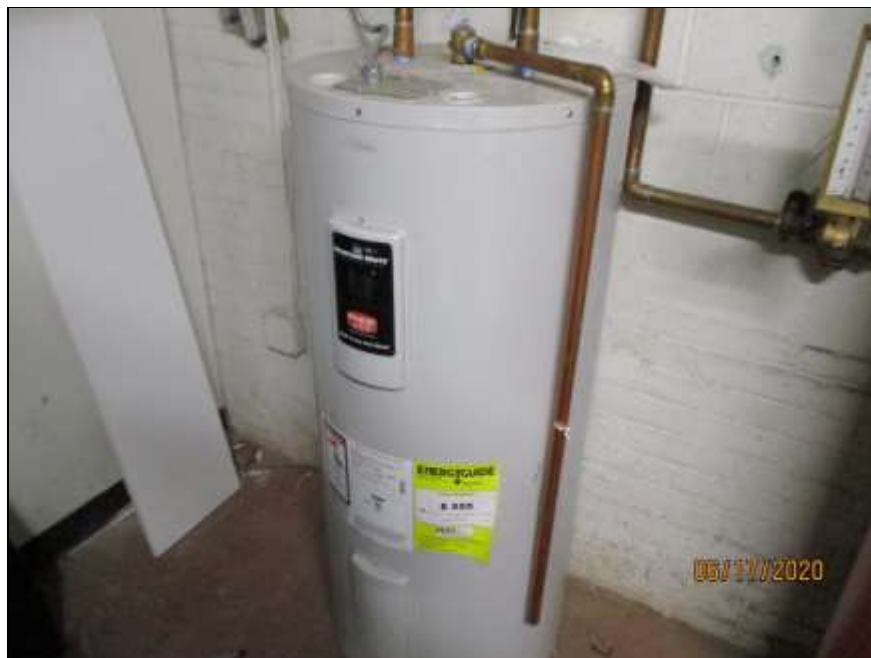
**Photograph 34**

heater was manufactured by Bradford White (**Photograph 34**). From the mechanical/electrical room, hot water was fed to each fixture.

Domestic hot water heater in mechanical/electrical room used to heat water for bathroom and break room fixtures.

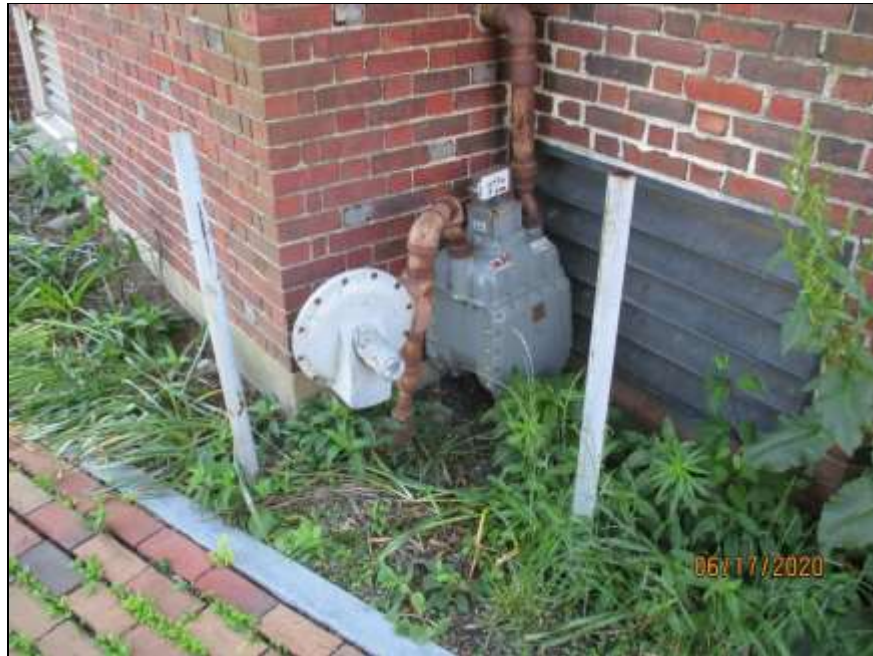
**Photograph 35**

Natural gas service was provided and routed from a service main to the service meter on the southwest elevation near the mechanical/electrical room (**Photograph 35**). From the service meter, a steel pipe was routed through the exterior wall at the mechanical/electrical room and branched to the equipment.

Gas service entering on the southwest side of the building

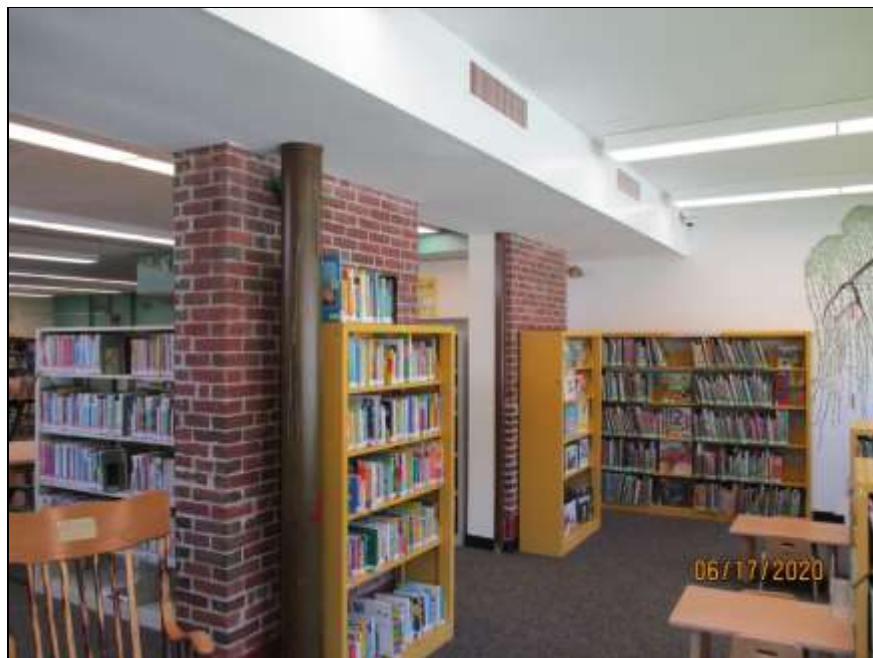
**Photograph 36**

Interior load bearing walls of the original construction had exposed brick finish and non-load bearing wall partitions were mostly finished with painted gypsum board.

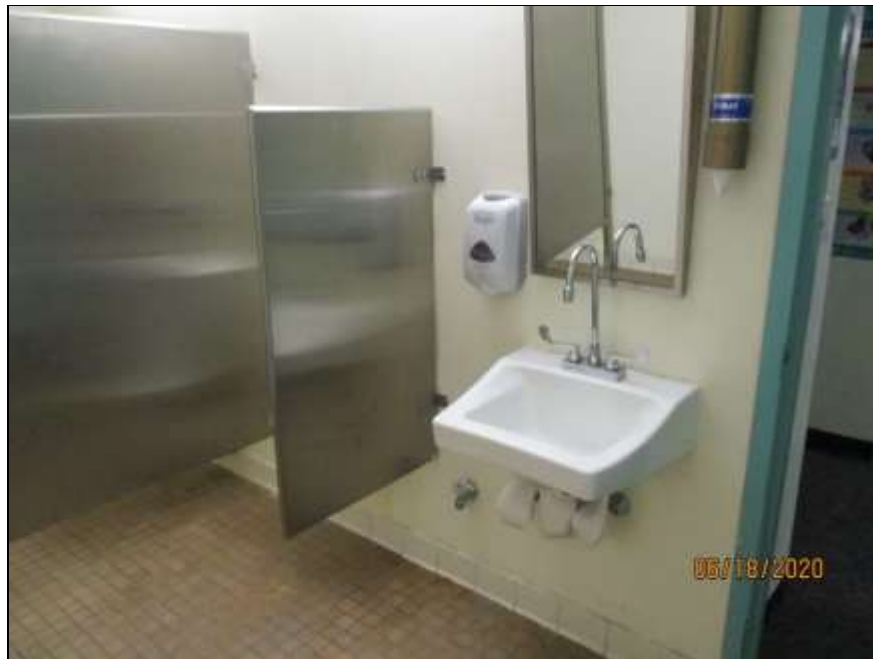
**Photograph 37**

Public bathrooms in the lower level had tile floors and painted gypsum board walls.

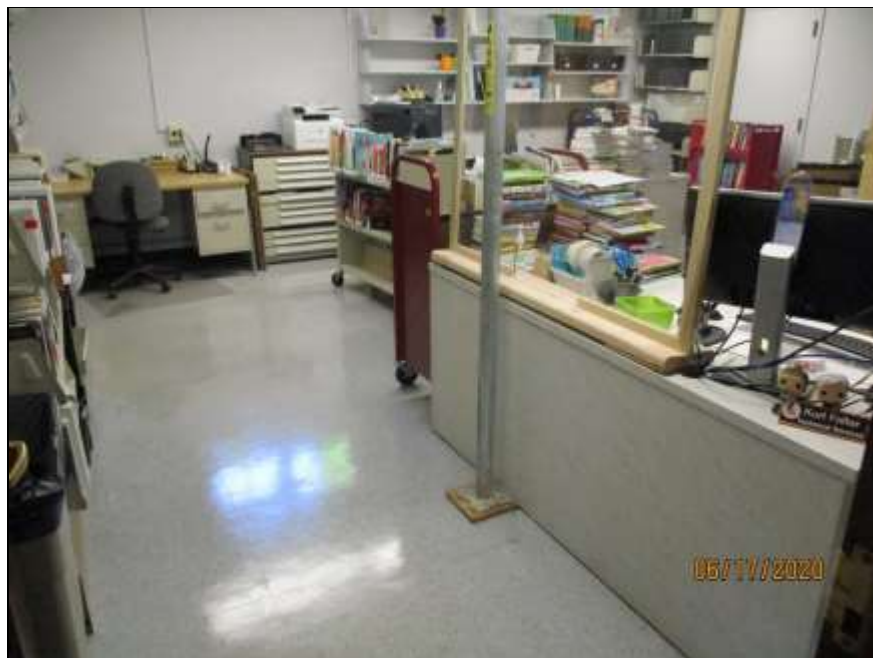
**Photograph 38**

Lower level offices, break rooms, and private bathrooms had vinyl floor finish.

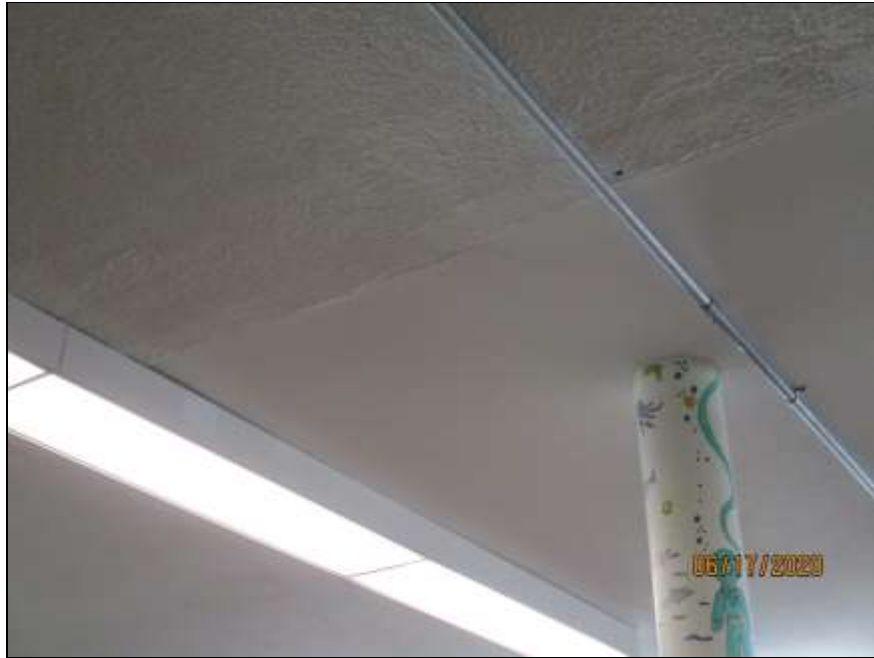
**Photograph 39**

There was a change in ceiling materials (plaster to gypsum board) between the 1960 addition and the 1979 rear addition.

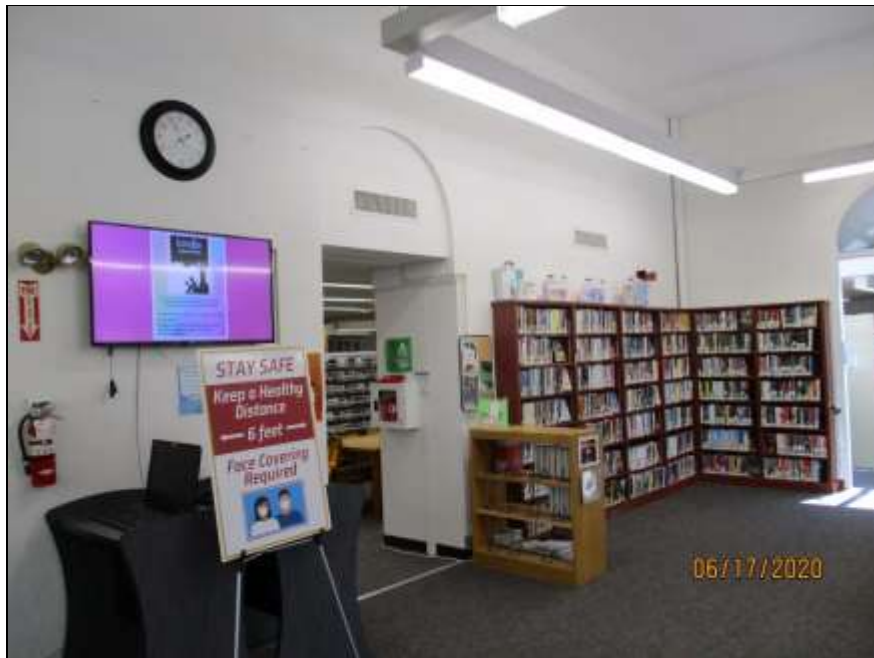
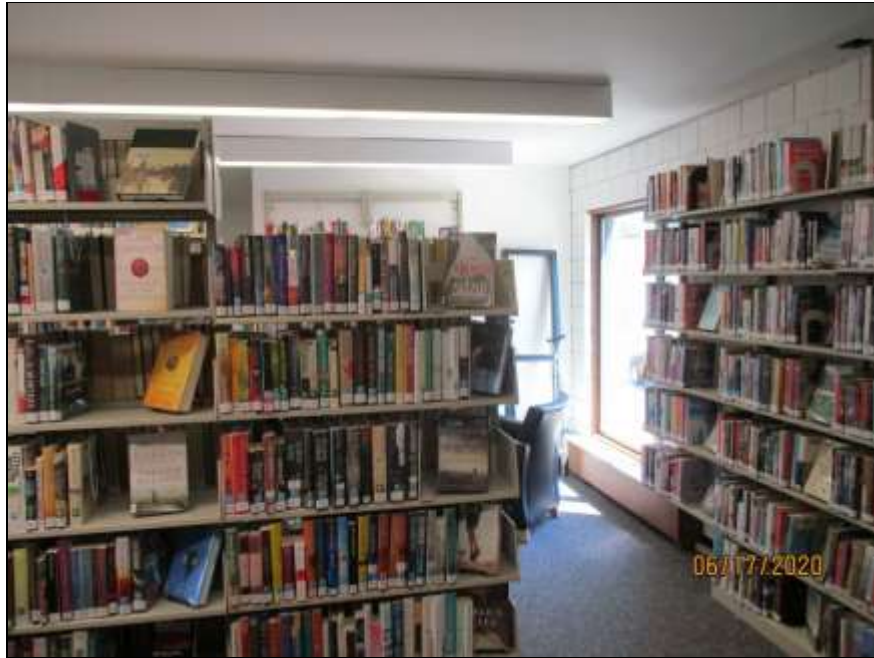
**Photograph 40**

The main library and reception desk areas featured carpet floors, exposed brick and block walls, and painted gypsum board interior partitions and ceiling.

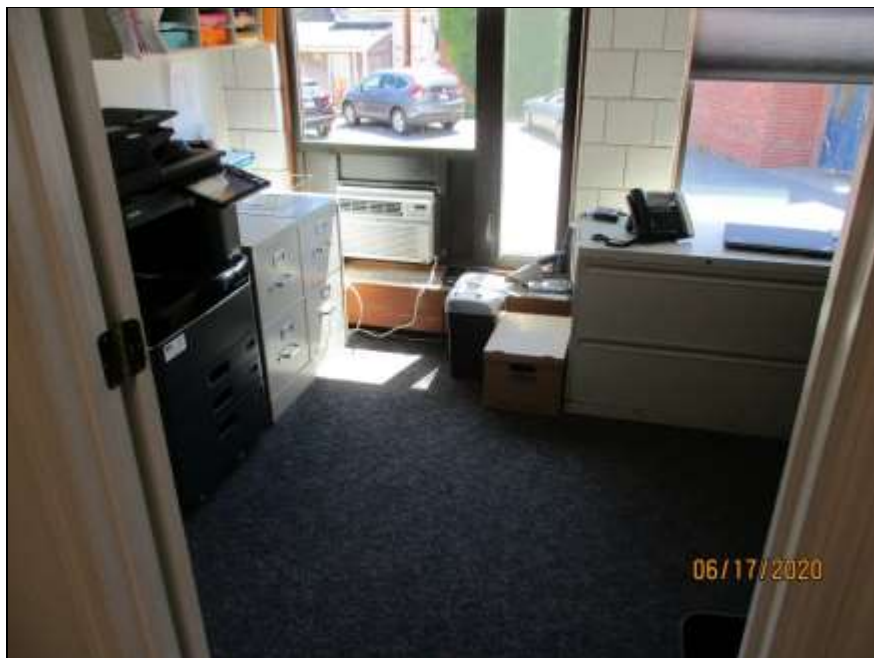
**Photograph 41**

The upper level of the building consisted of an entry vestibule, a reception desk area, main library with book stacks and reading spaces, a computer area, and two small offices. The main library and reception desk areas featured carpet floors, exposed brick and block walls, and painted gypsum interior partitions and ceiling (**Photograph 40**). The offices had carpet floors, exposed and painted exterior block walls, and painted interior gypsum walls and ceiling (**Photograph 41**).

The offices had carpet floors, exposed and painted exterior block walls, and painted interior gypsum board walls and ceiling.
