Town Hall Accessibility & Building Renovation Study

Sharon, Massachusetts
December 2, 2015

KAESTLE BOOS
associates, inc

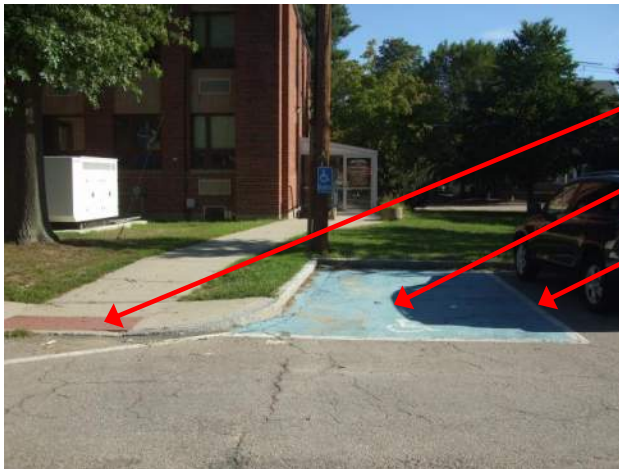
HC parking on southeast of town hall.

The final ADA space is located south east of the Town Hall. This space is 18' x 10'-3" but does not have a specific loading zone. The curb cut for the space is located at the end of the sidewalk to the rear of the space. There is a 5% slope within the parking space.

Curb cut to side walk
Slope over 2%
No separate loading zone

1. Modify ADA parking spaces to provide correct slopes, signage and access paths.
2. Remove access ramp to south door and build an accessible ramp to the door.
3. Provide the necessary clearances to Town Hall office door that is accessible from the outside.
4. Provide curb cut and ramp at corner of Bradford and East Chestnut Street.
5. Provide concrete stoops at fire department building accesses and widen the doors to provide clearance.
6. Provide crosswalk at front entrance and/or passenger loading zone striping and signage.

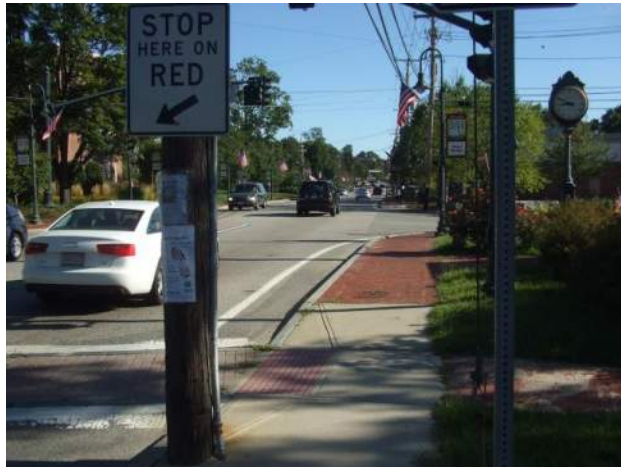
Sidewalk & Curb cut at South Main Street

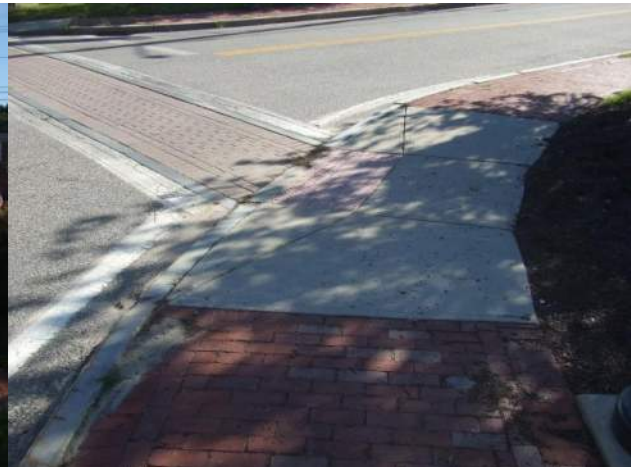
Curb cut at South Main and E. Chestnut

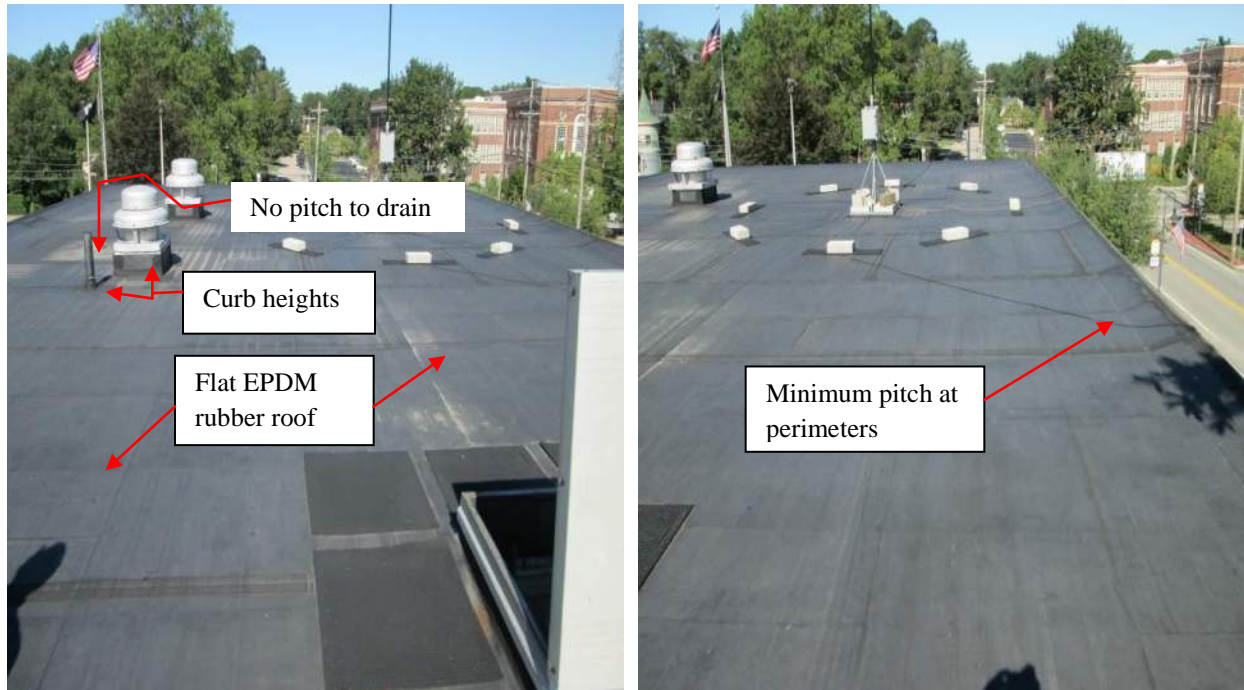
The upper roof membrane appears to be in good condition. The curb heights for the mechanical units and the heights of the vent stack comply with industry guidelines.

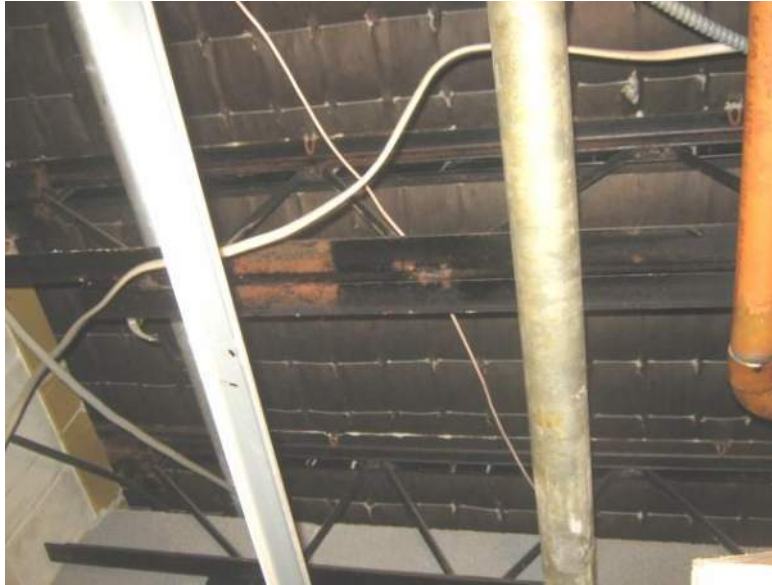
Floor Framing with Steel Joists and slab viewed from the underside

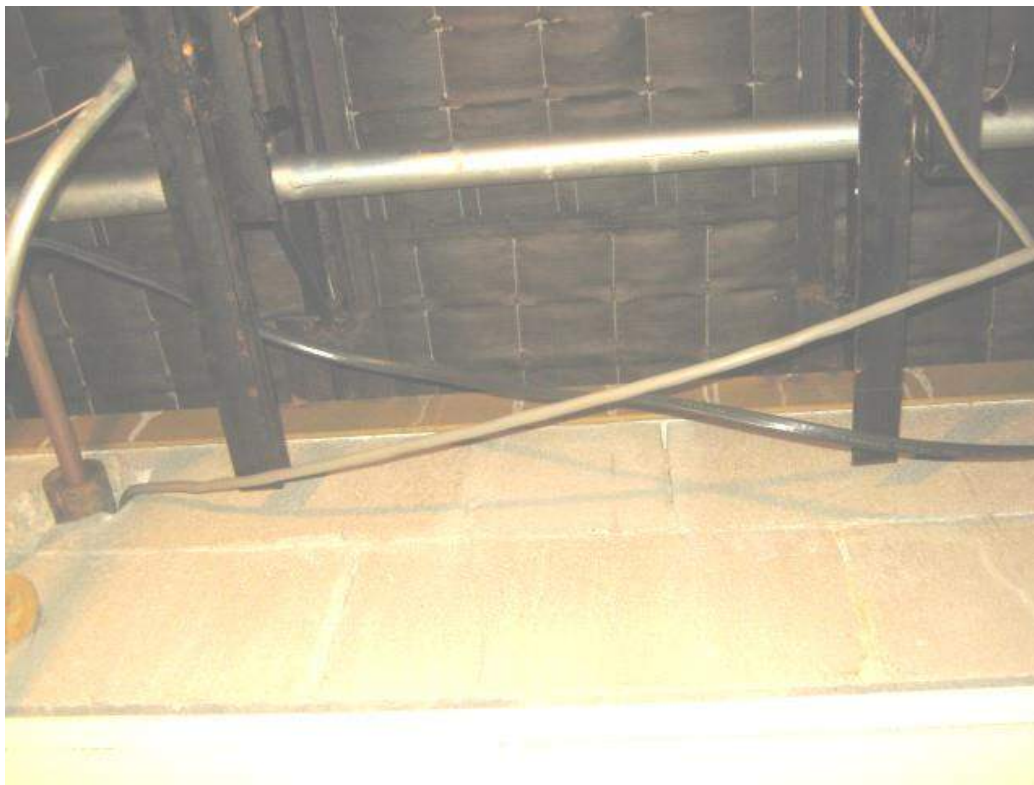
View of steel joists bearing on interior masonry bearing wall

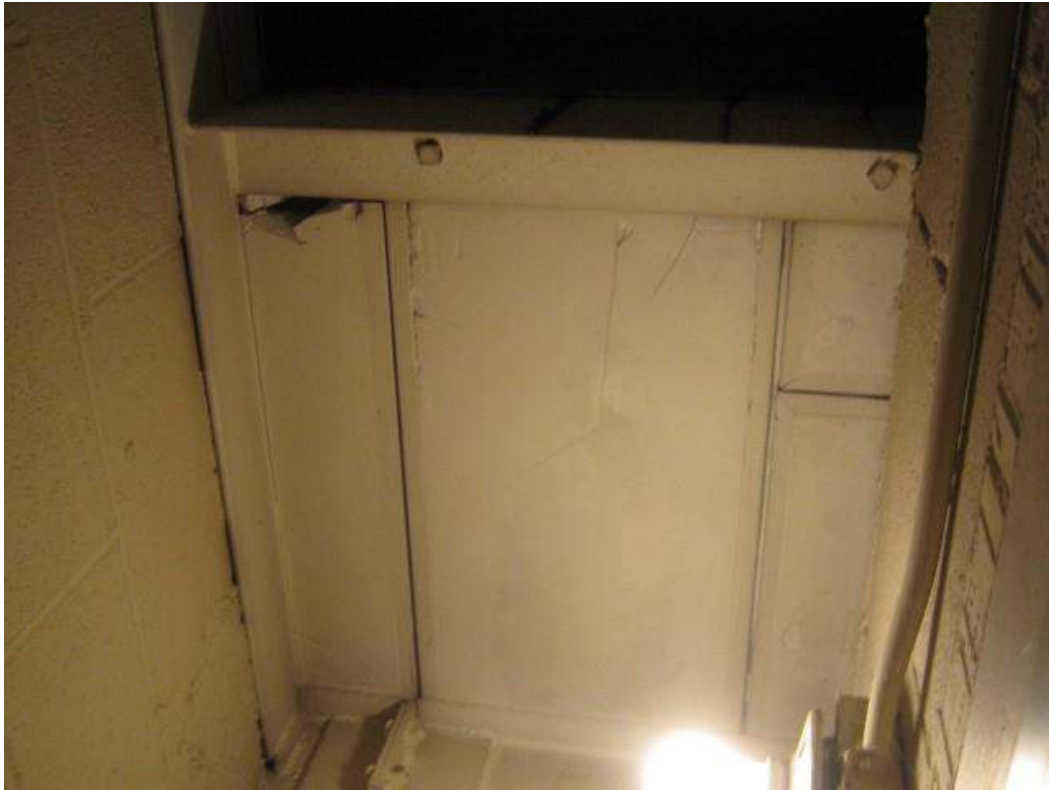
Roof deck adjacent to hatch access to roof

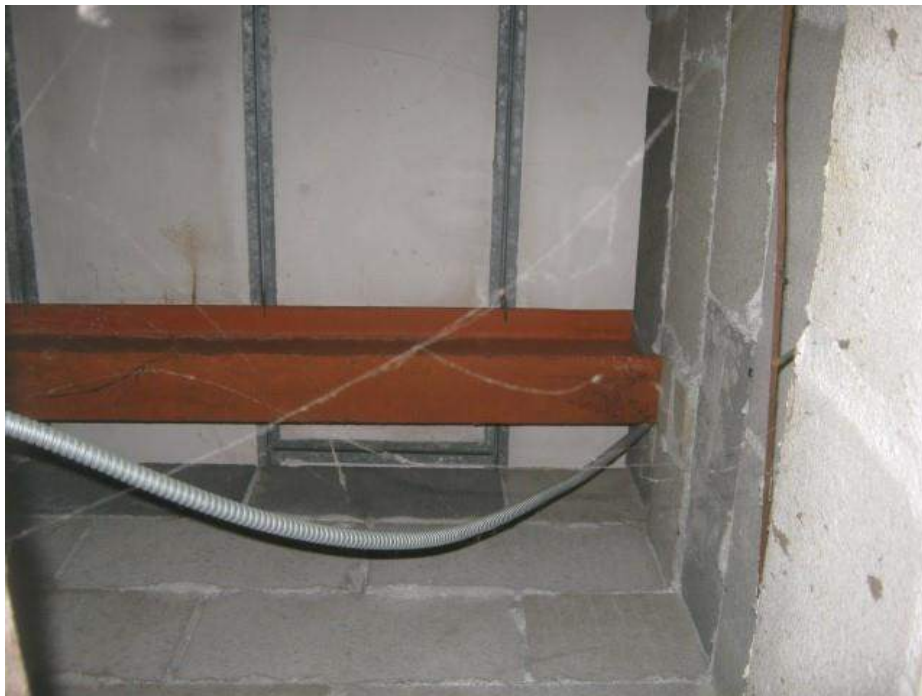
Gypsum prefabricated roof panels supported by steel beam
